# **Yukon River Restoration and Enhancement Fund**

**CRE 28 02**

## **Mica Creek Salmon Habitat Restoration**

**September 29, 2003**

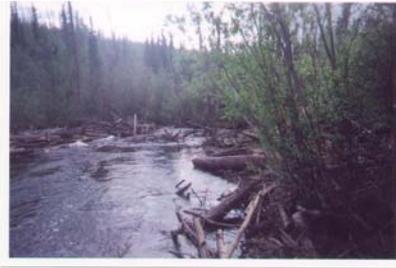
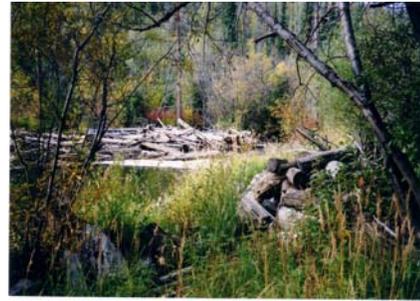
**Waypoint 006 N62\* 46.717 W136\* 33.182**

<i>waypoint</i>	<i>latitude</i>	<i>longitude</i>	<i>notes</i>
6	062.77862	-136.55303	Breached dam with debris
7	062.77838	-136.55230	Breached dam with debris
8	062.77362	-136.53138	Clear breached dam
9	062.76708	-136.52957	Clear breached dam
10	062.76667	-136.52890	Small new dam
11	062.76635	-136.52868	Small new dam
12	062.76635	-136.52780	Clear breached dam
13	062.76505	-136.52473	Clear breached dam
14	062.75650	-136.52008	Clear breached dam
15	062.74368	-136.51268	Breached dam with debris
16	062.74368	-136.46857	Beaver house

The breaching of some obstructions in the creek was successful by the crew. (See appendix C) Six dams have been breached to date.
