CRE - 86 - 02

RESTORATION OF PLACER MINED STREAMS: IDENTIFICATION OF STRATEGIES TO EXPEDITE RECOVERY

Prepared by:
M. MILES & ASSOCIATES LTD.
645 Island Road
Victoria, B.C.
V8S 2T7
Phone: 250-595-0653
email: mmaa@coastnet.com

MAY 2003

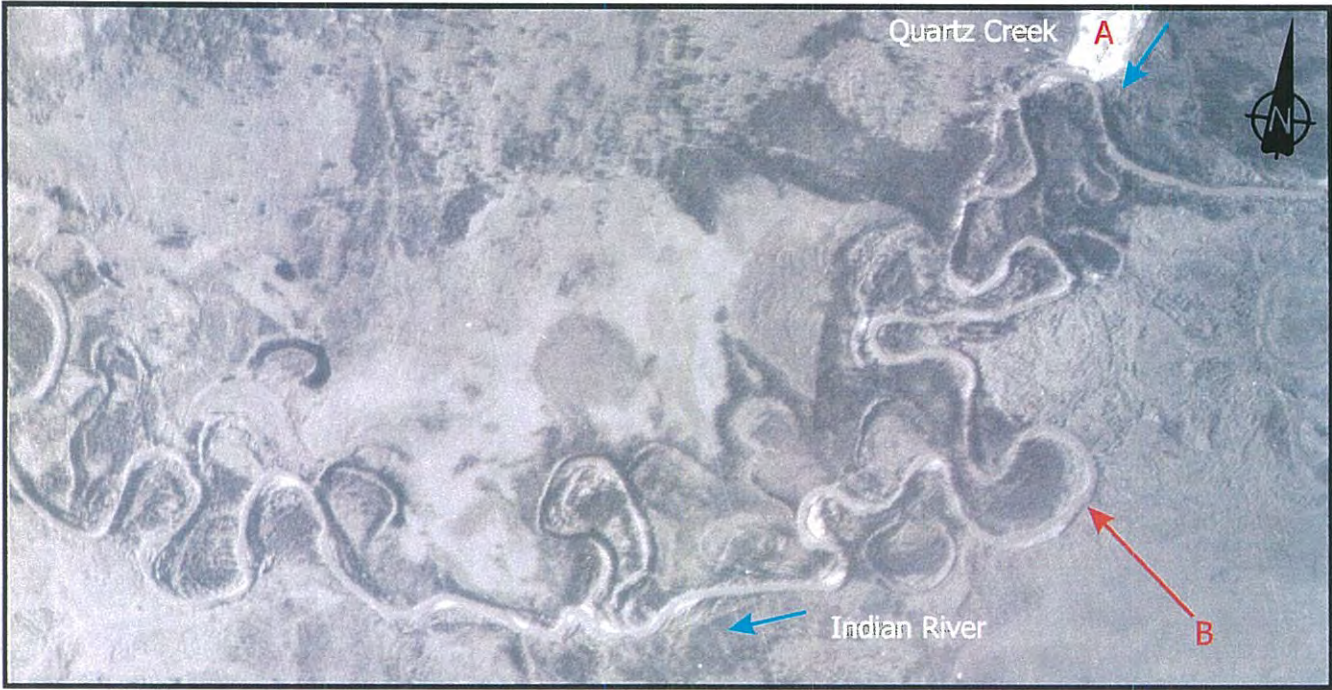
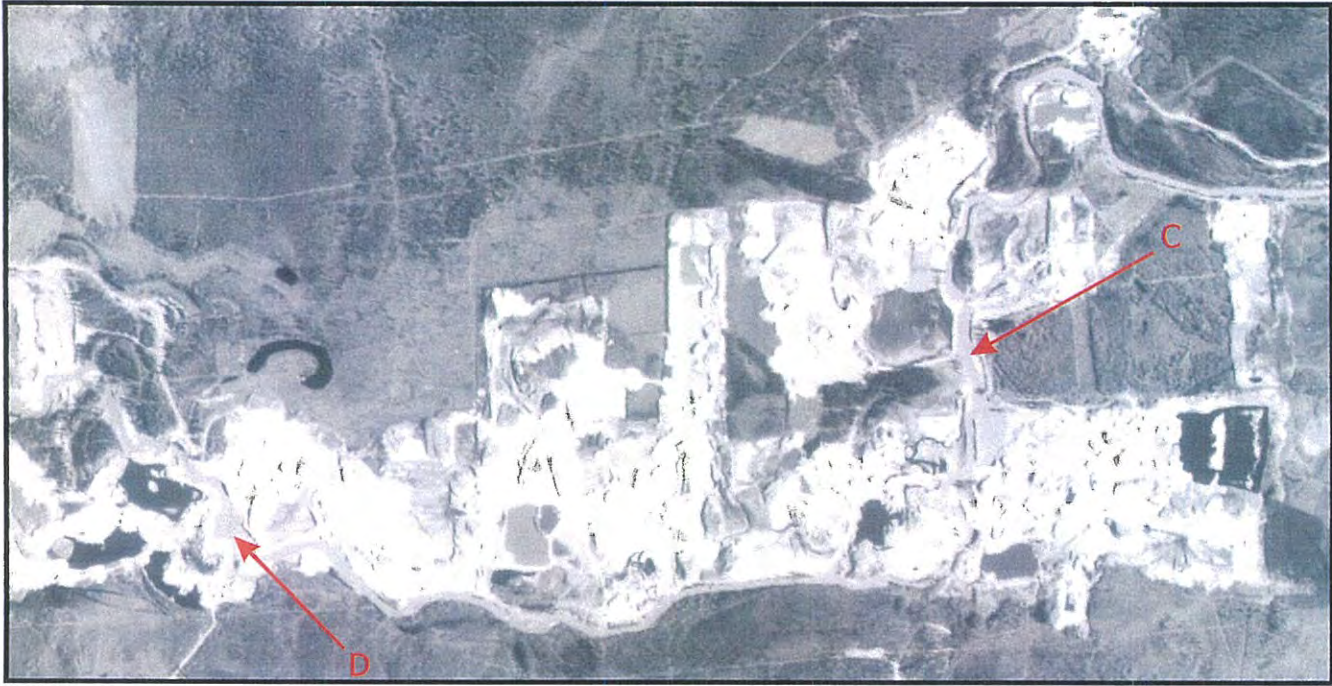
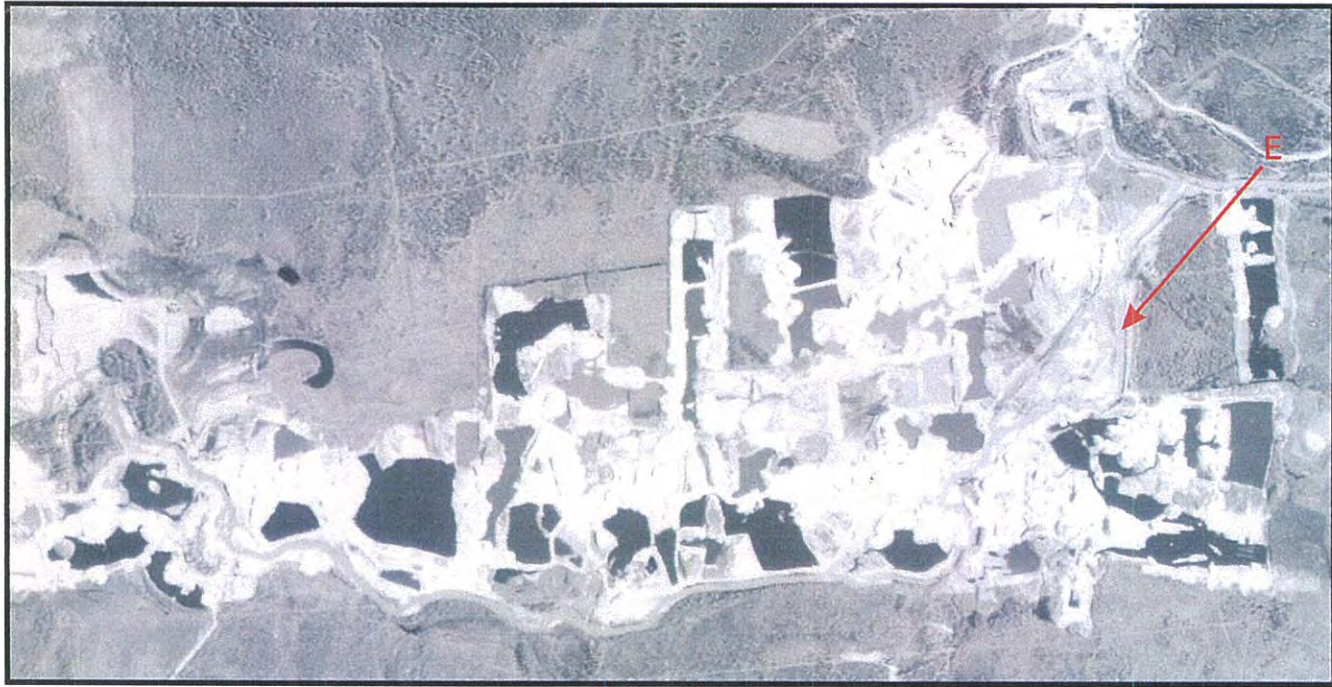
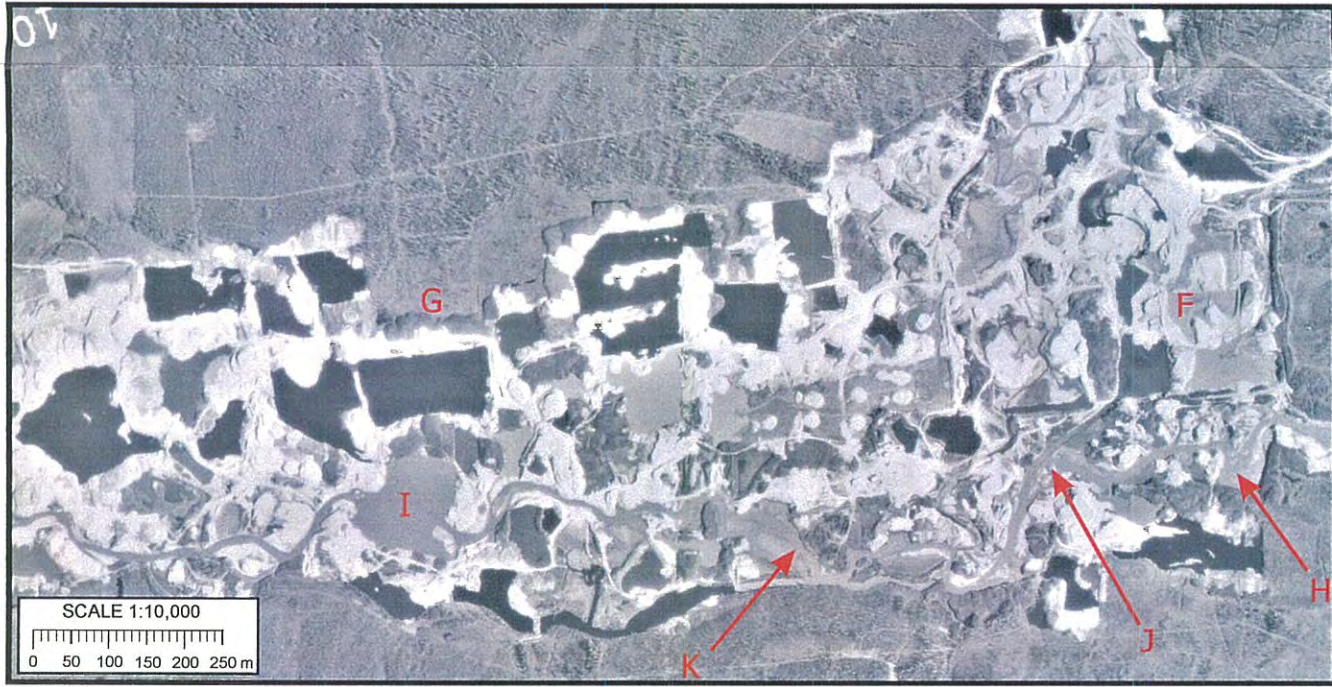
Figure 4.2.7: Historical changes in channel morphology, Indian River downstream of Quartz Creek. F - 15

- Recent dredging activities on Quartz Creek (A).
- Pre-mining channel conditions in Indian River (B).

- Extensive mining development including pits, settling ponds and spoil pits.
- Diverted sections of Indian River (eg. C & D).

- Sections of Indian River diverted between 1988 and 1999 (E).

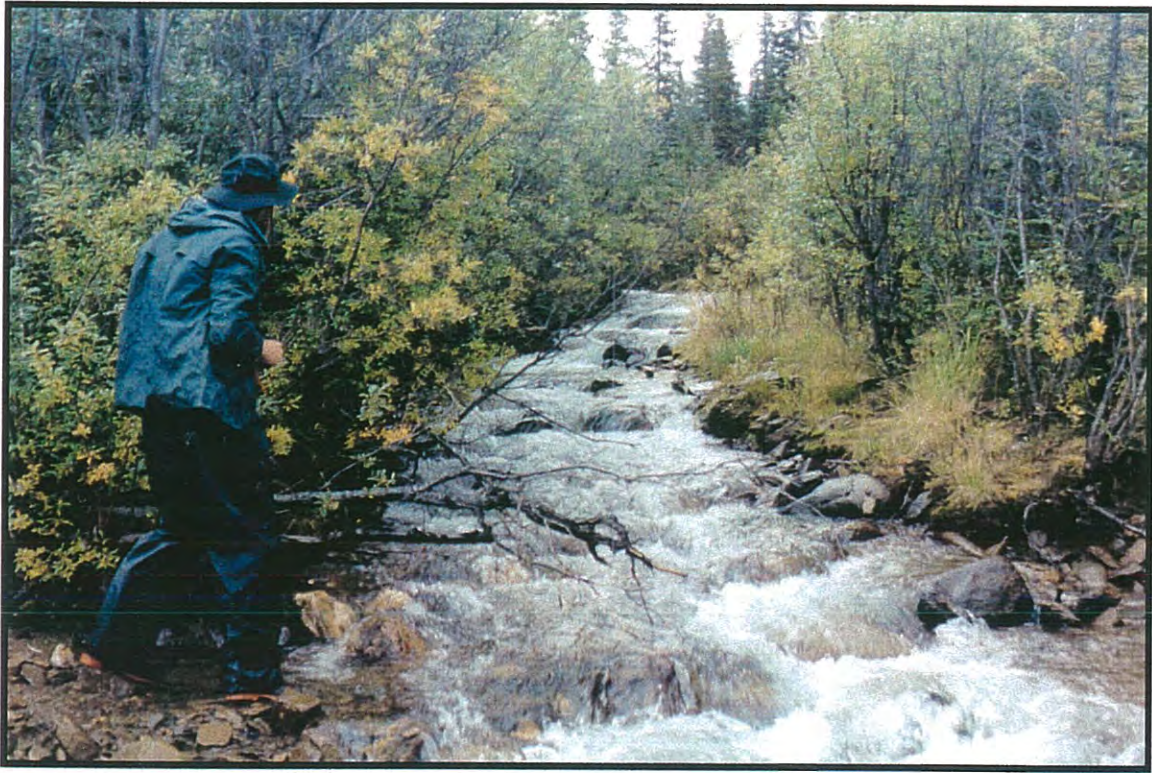
MM 02 - 70 - 19A

Plate 4.1.1: Looking upstream along Upper Left Clear Creek, showing undisturbed channel conditions.

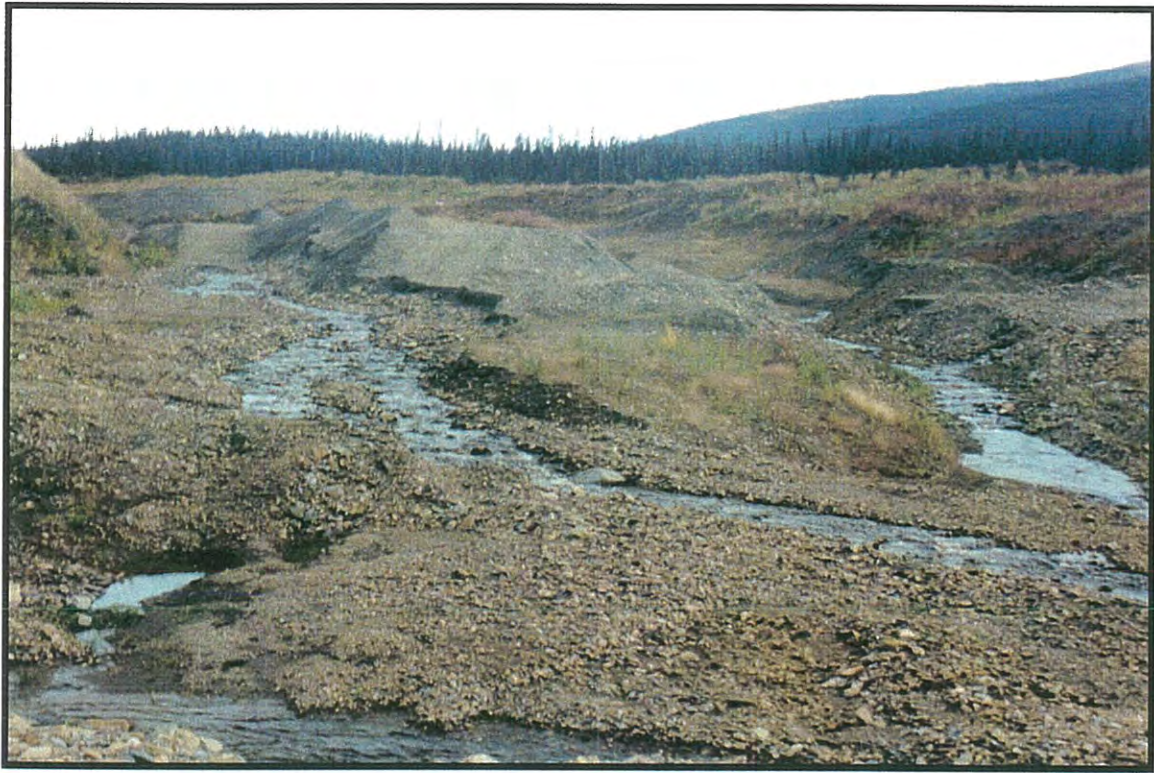
MM 02 - 72 - 14A

Plate 4.1.28: Lateral and vertical channel shifting along mined sections of streams will result in elevated rates of sediment production until the streams form a stable profile and riparian vegetation re-establishes.

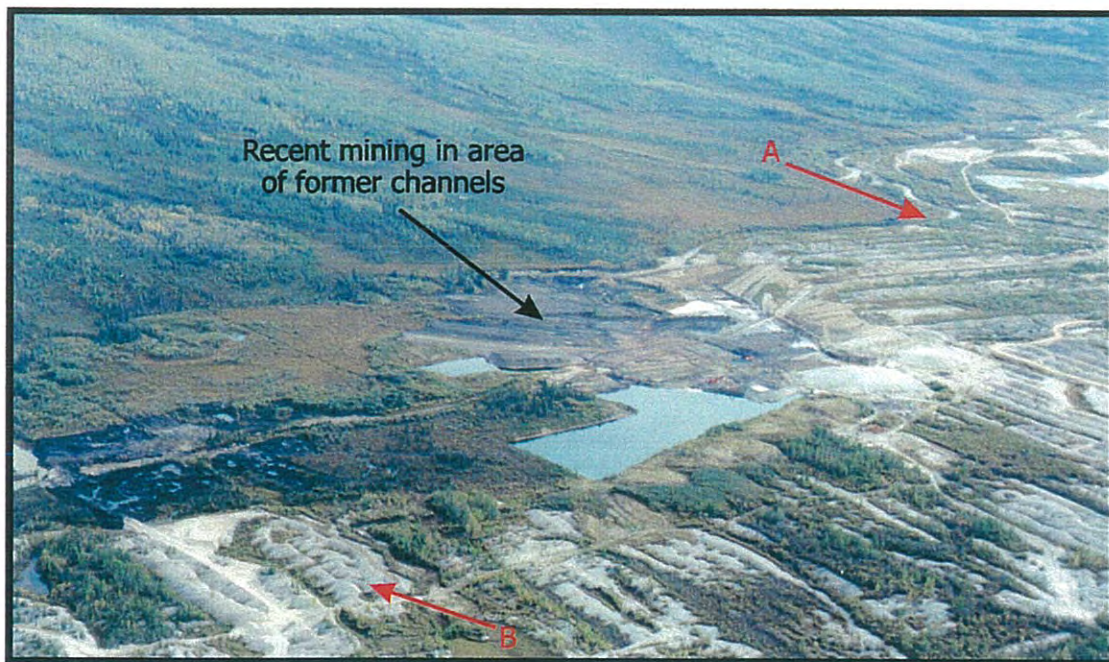
MM 02 - 78 - 05

Lower Sulfur Creek and the adjacent area of Dominion Creek have also been extensively dredged. The changes in channel conditions and the expansion of mining activities between 1949 and 1995 are illustrated on Figure 4.2.5. Valley bottom vegetation is beginning to become established on post-1949 dredge spoils in lower Sulphur Creek (Plate 4.2.11). Nevertheless, this photo indicates that the residual channel is still confined to narrow areas at the base of both valley walls. This channel confinement continues across the Dominion Creek valley flat (Plate 4.2.12). Plate 4.2.13 illustrates vegetation development and the formation of wetland areas in old pits or settling ponds in the Dominion Creek valley flat just downstream of the Sulphur Creek Confluence. Mining activities are continuing in this area and have resulted in the on-going loss of secondary stream channels (see Plate 4.2.14).

Plate 4.2.14: Looking downstream on Dominion Creek showing the changes in valley flat conditions opposite Sulfur Creek in the period between 1992 and 2002. GPS Location 80.

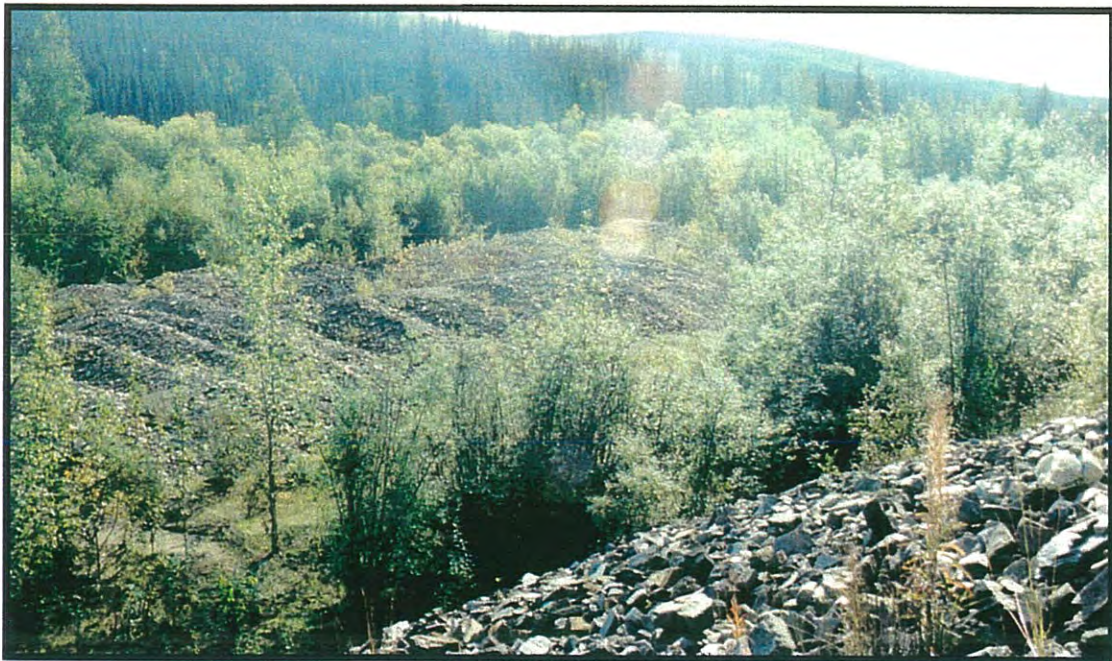
MM 02 - 73 - 10

Plate 4.2.26: Low-lying moist areas between dredge spoil piles in Lower Quartz Creek support well established deciduous vegetation.

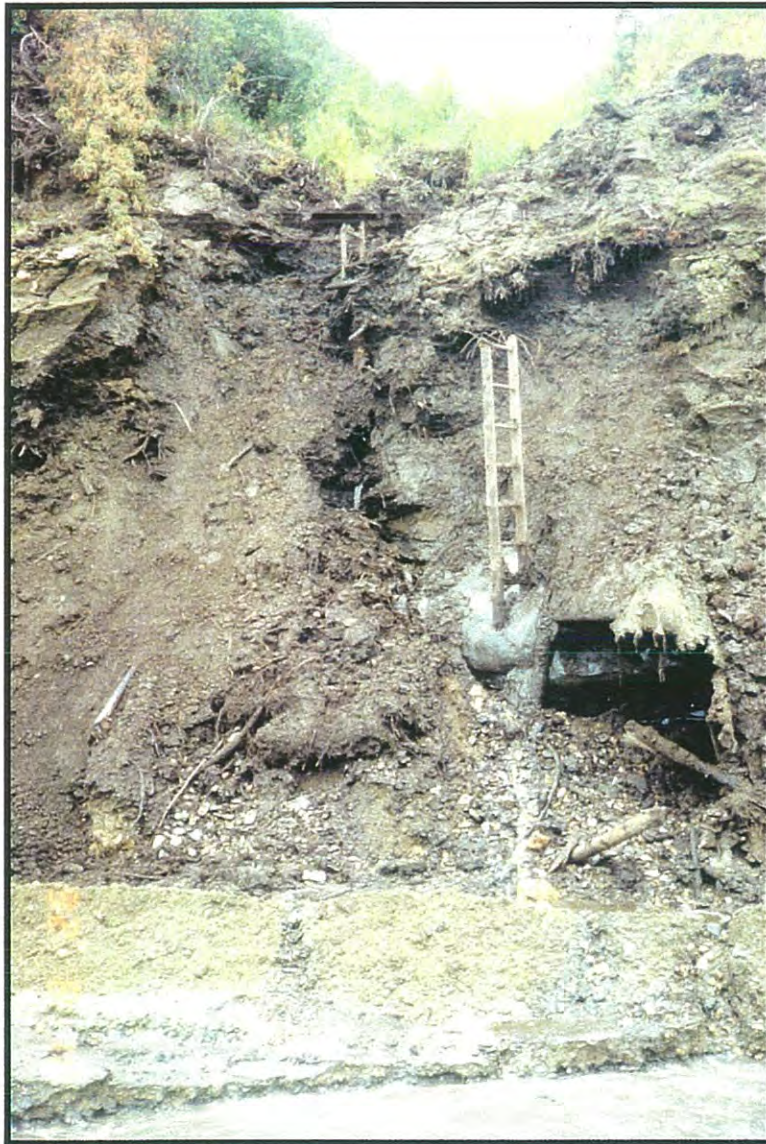
MM 92 - 40 - 01

Plate 4.2.34: Hydraulic sluicing has removed substantial quantities of overburden. This photograph shows old access ladders exposed following hydraulic sluicing on Blanch Creek.

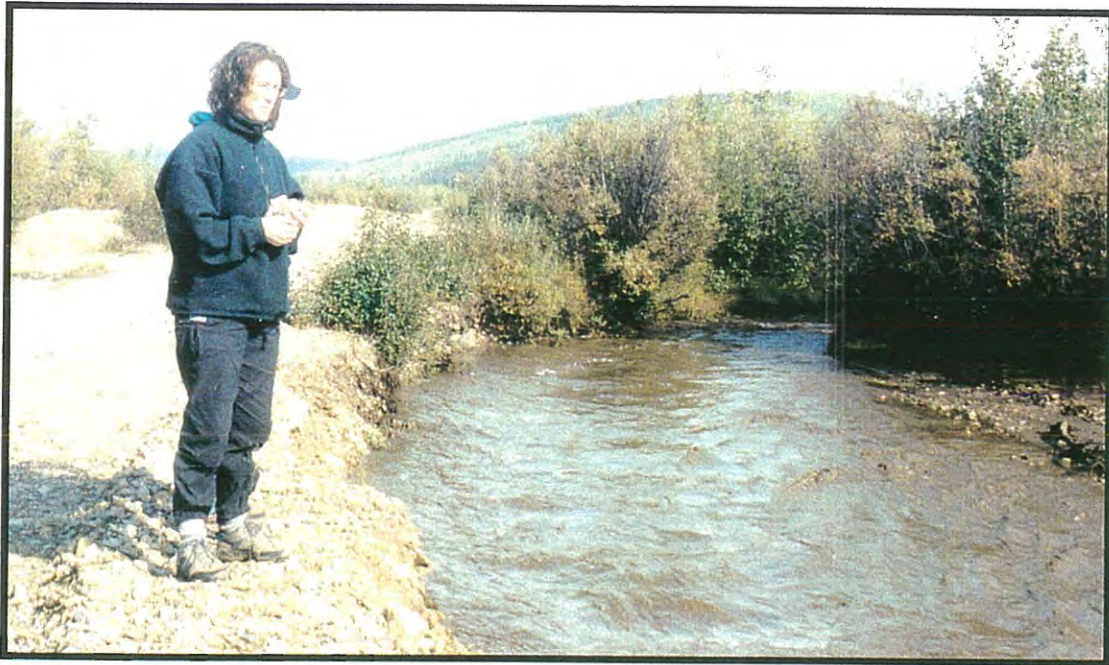
MM 02 - 73 - 13

Plate 4.2.35: Ground sluicing is resulting in very high suspended sediment concentrations in Quartz Creek. These flows are directed into a large settling pond on the Indian River Valley Flat.

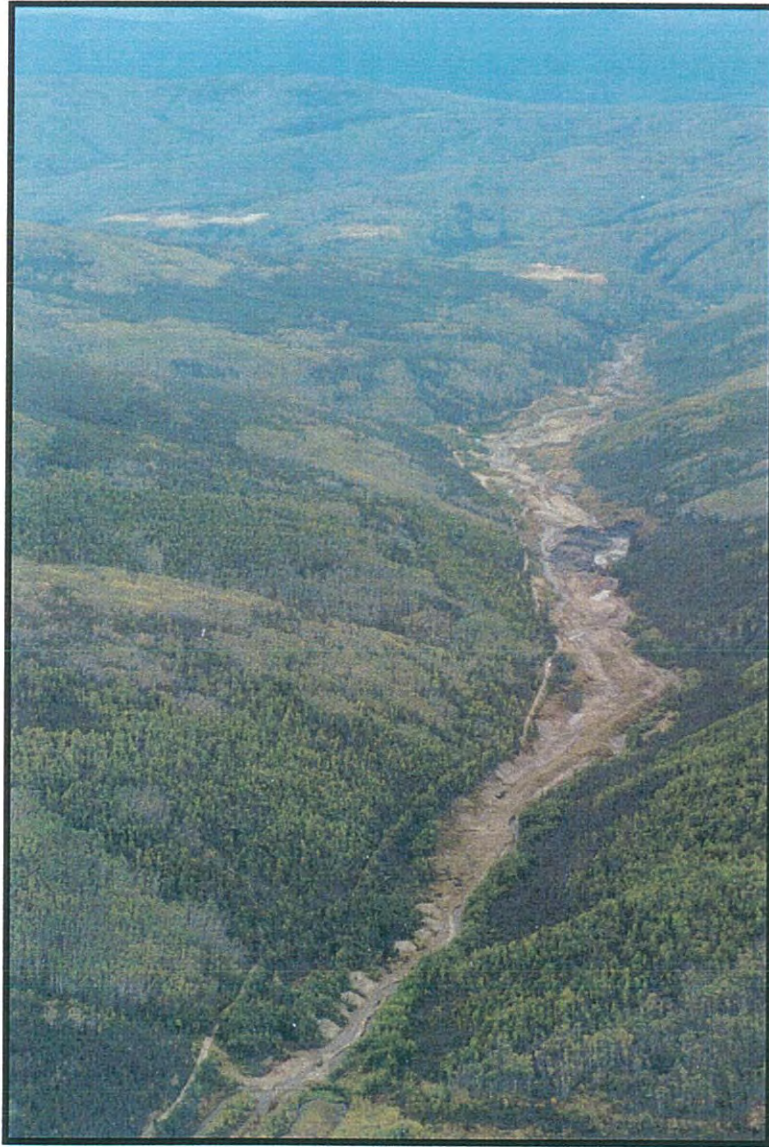
MM 02 - 80 - 35A

Plate 4.3.1: Looking downstream on Gold Bottom Creek from GPS Location 123.

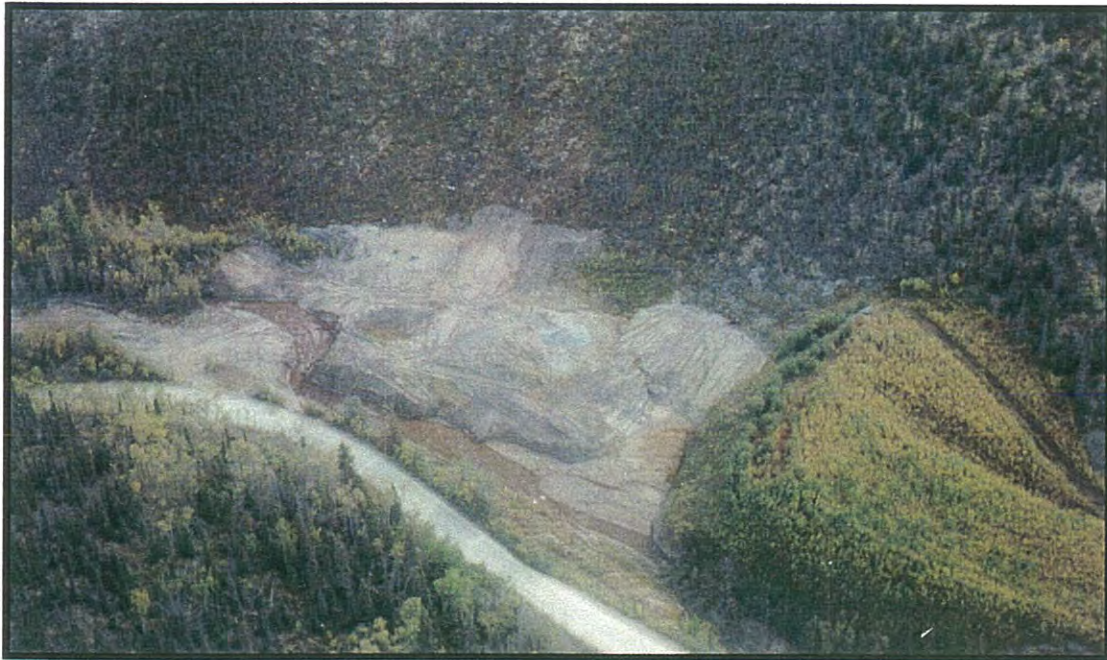
MM 02 - 77 - 12

Plate 4.3.4: Bank erosion was commonly observed on both newly reclaimed areas and on older over-steepened sites with second growth vegetation. [GPS Location 56.]

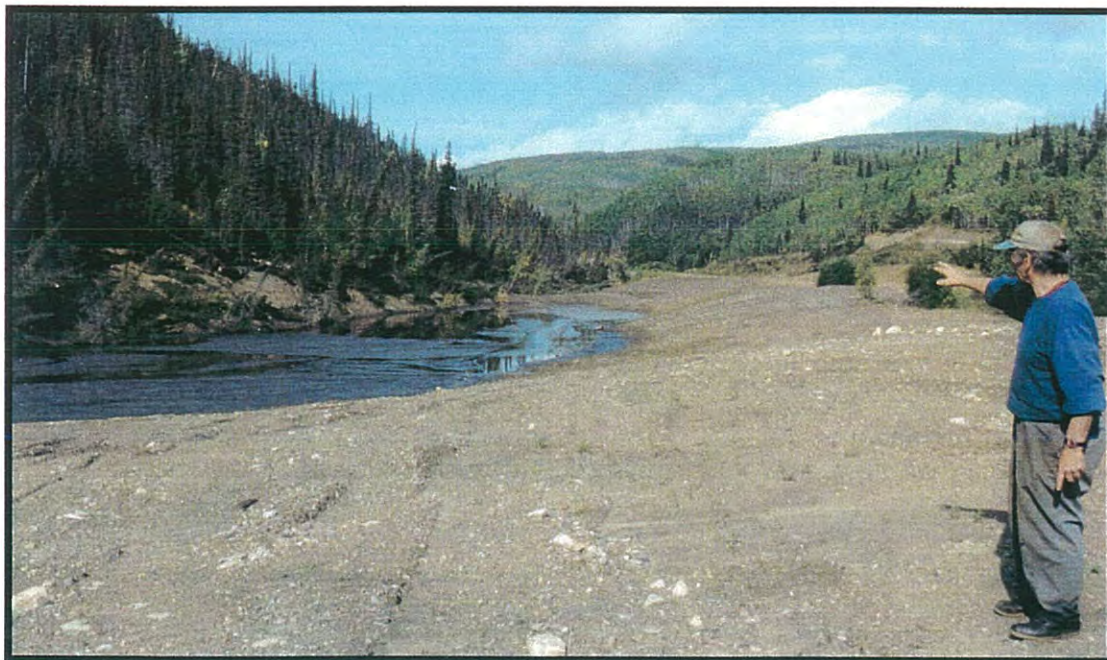
MM 02 - 76 - 04

Plate 4.3.5: Looking downstream showing the failing left bank valley wall at the Marsden Reclamation Site.

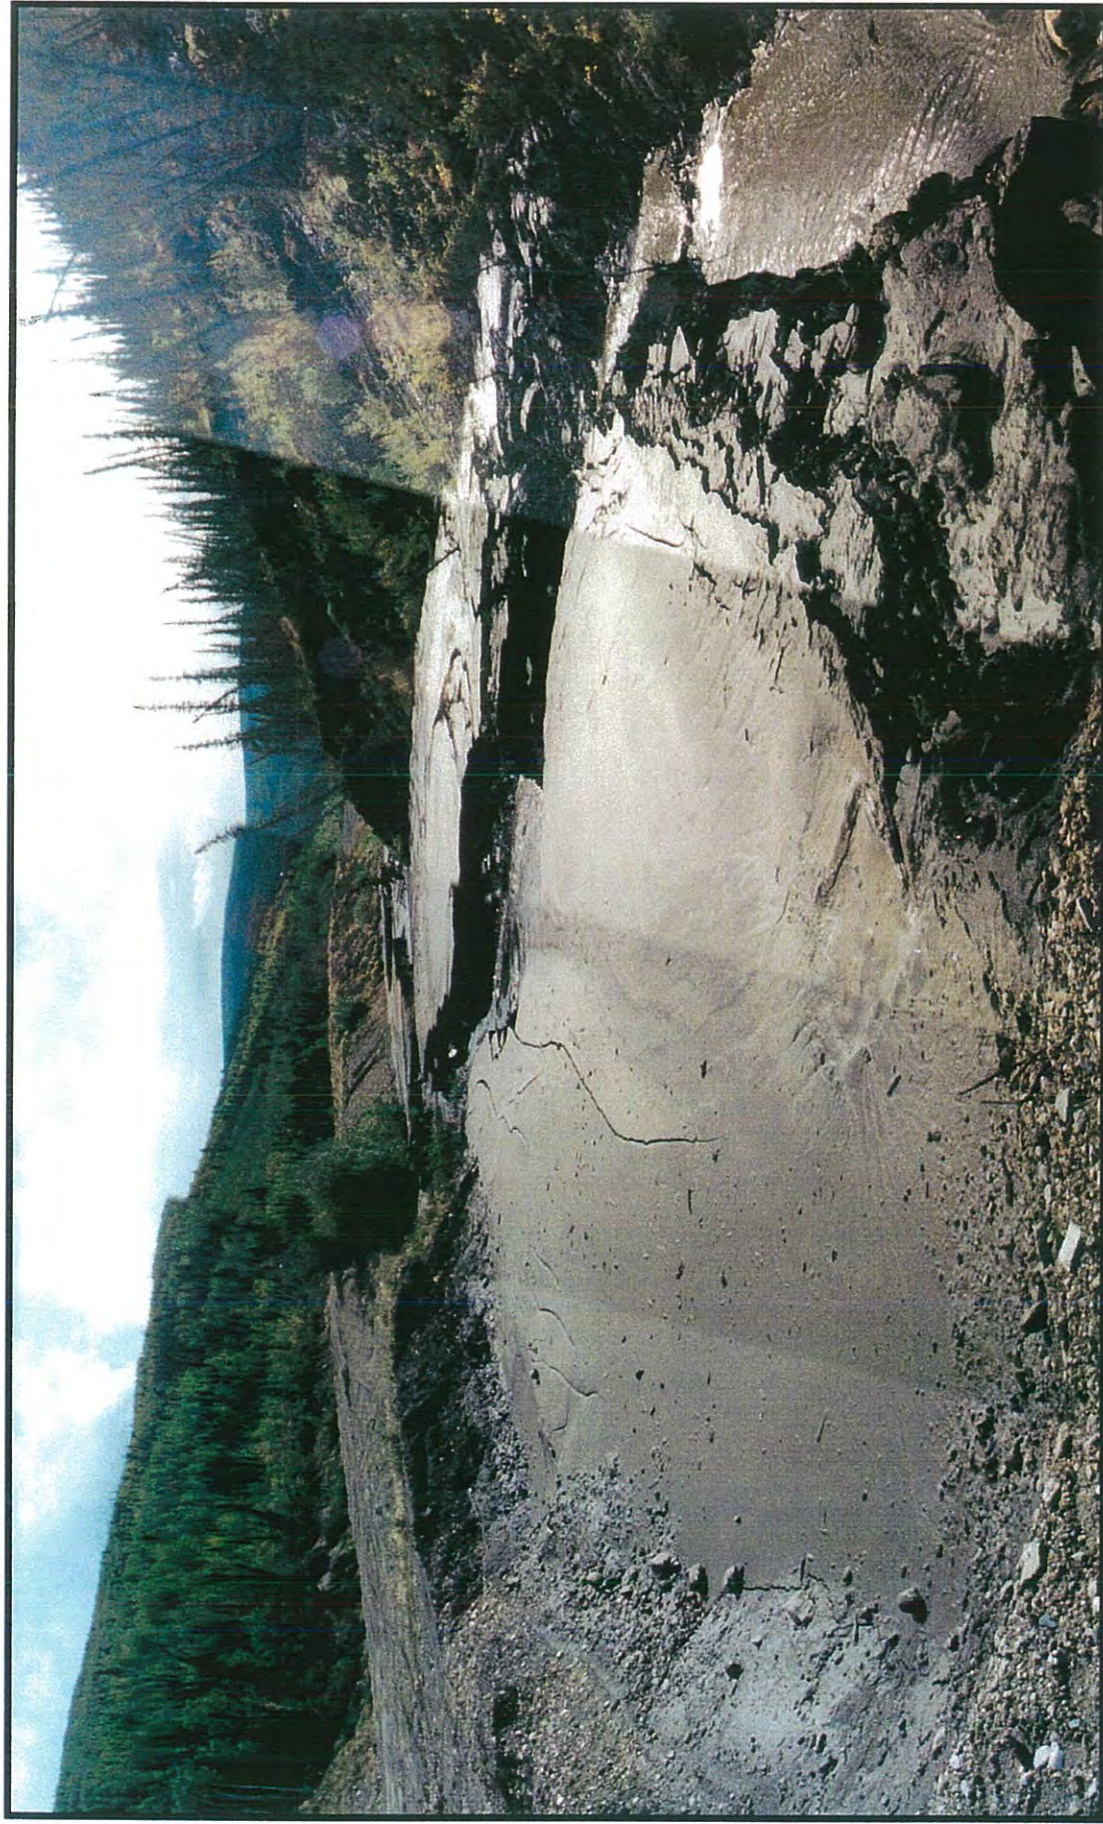
MM 02 - 76 - 06/09

Plate 4.3.6: Looking upstream showing how failing sections of the left bank valley wall have infilled the settling pond.

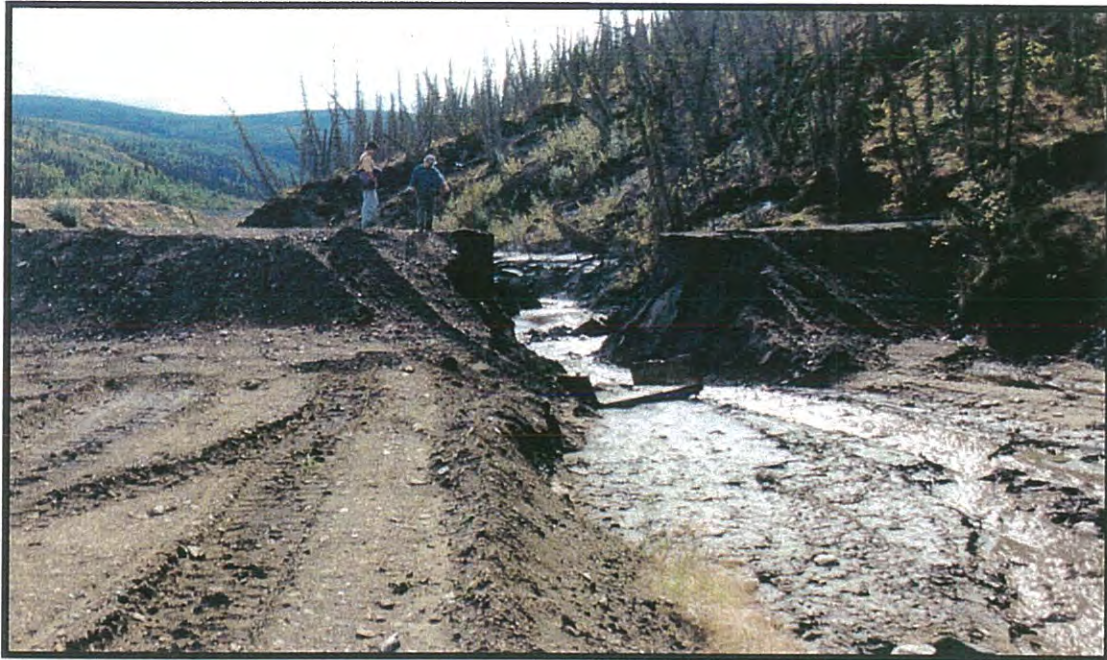
MM 02 - 76 - 13

Plate 4.3.7: Looking upstream to the failed settling pond outlet.

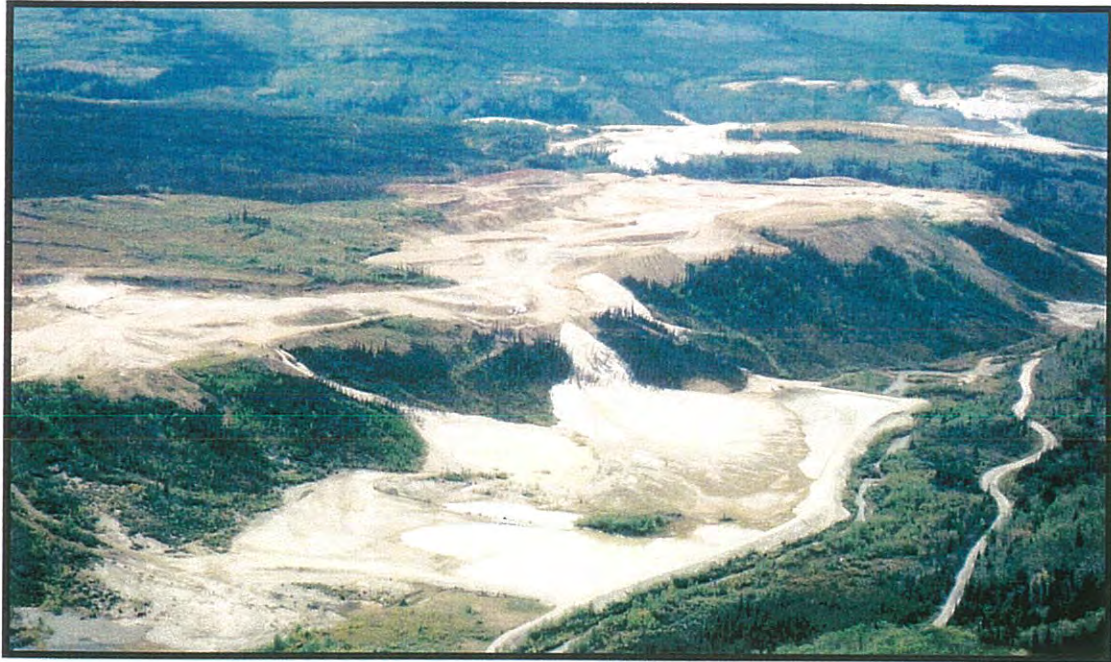
MM 02 - 81 - 06

Plate 4.3.16: Looking downstream on Lower Hunker Creek showing upslope mining activity and large settling ponds in the Hunker Creek valley bottom. [GPS Location 125.]

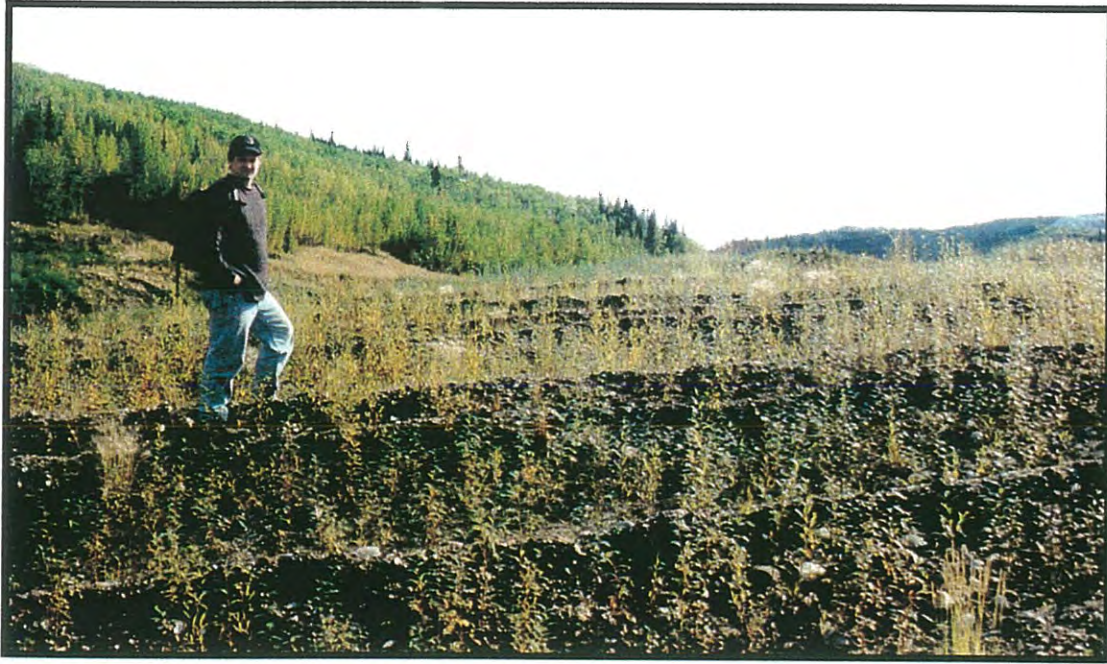
MM 02 - 75 - 33

Plate 4.3.20: Annual and perennial vegetation is establishing on many stable re-contoured surfaces.
