**CHINOOK SALMON HABITAT ASSESSMENT AND RESTORATION
ENHANCEMENT POSSIBILITIES FOR SELECTED TRIBUTARIES OF THE
PELLY RIVER IN THE VICINITY OF PELLY CROSSING, 1998.**
(Needlerock, Mica, Willow and Grayling Creeks)

The Yukon River Panel

Jane Wilson & Associates

December, 1999

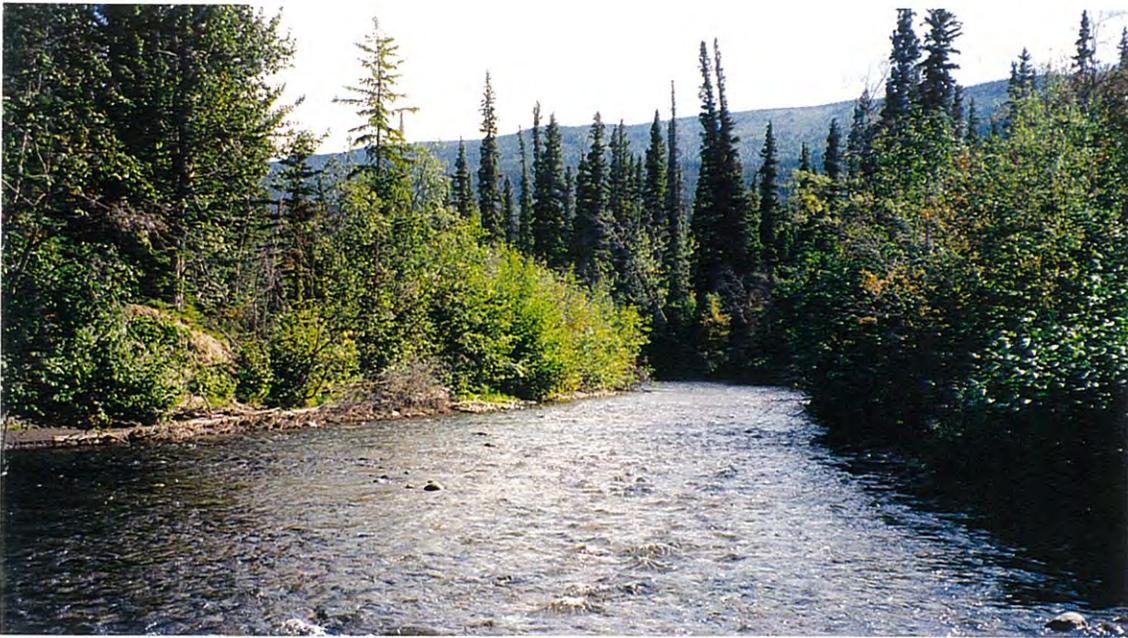
Photo 1. Viewing upstream in Reach 1, Needlerock Creek showing excellent habitat for Juvenile chinook salmon (August 4, 1998).

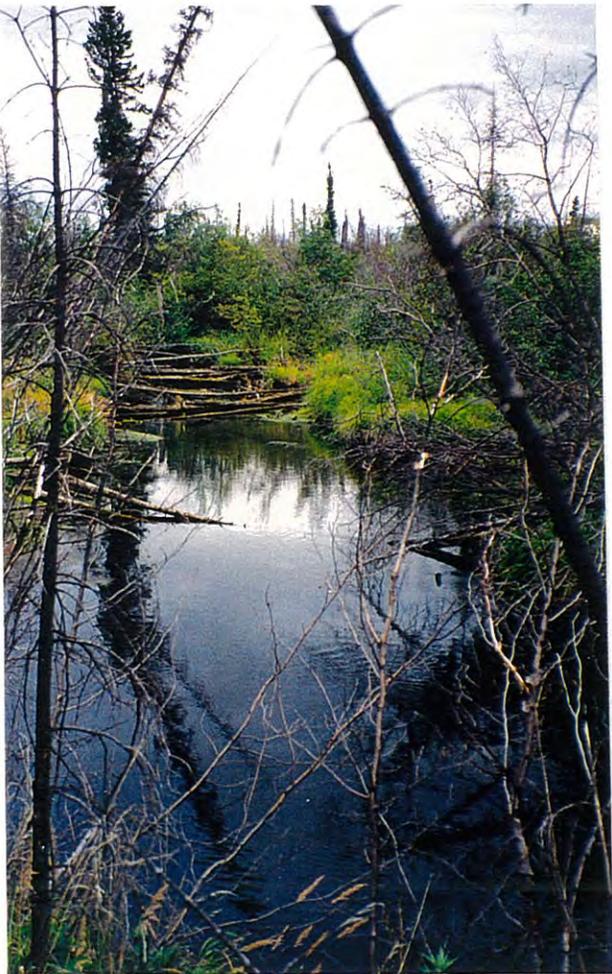
This reach was affected by the fire in 1995 which burned a large area adjacent to Needlerock creek. Stream conditions have been altered as a result of logjams created by deadfall and from subsequent erosion of weakened banks. Hence, most of the reach was characterized by deep pools and runs formed by the holding back of water by logjams and large areas of deposited sand and silt throughout the streambed.

Photo 2. Reach 5 of Needlerock Creek. Note pool type habitat and deadfall across channel as a result of recent fire.

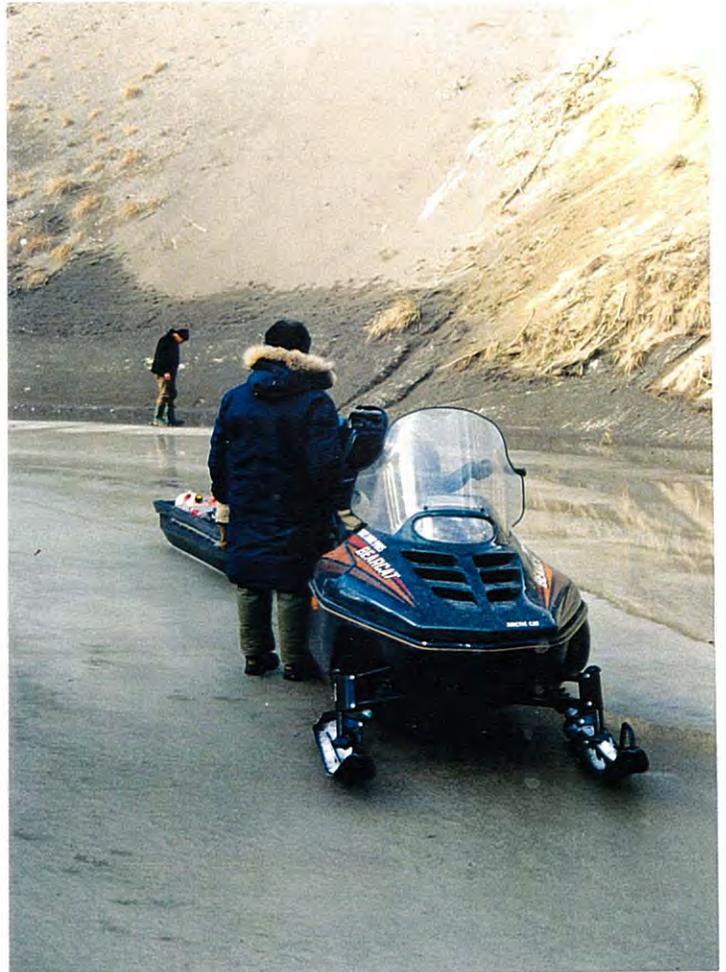
Frozen overflow or "glacier" ice was extensive on this creek. During a reconnaissance of the creek by snowmobile, overflow conditions were observed as far as a site investigated during the summer in Reach 4. It appeared that these conditions continued further upstream. During the summer survey, ground water was observed entering the creek from the embankment at this site in Reach 4. Since ground water outflows are usually several degrees warmer than surface flows it was thought that there might be open water in this area, however no open areas were observed there during the winter survey.

Photo 3. Reach 1 of Needlerock Creek. Note "glacier" ice conditions and unstabilized sandy slopes (April 1, 1999).

Due to the gradient of the slope and volume of sliding material, plants have not been able to take root on these slopes naturally. A stabilization project would therefore require the construction of a berm at the base. Indigenous plant species which are adapted to the soil conditions could then be planted. The Department of Fisheries and Oceans should be

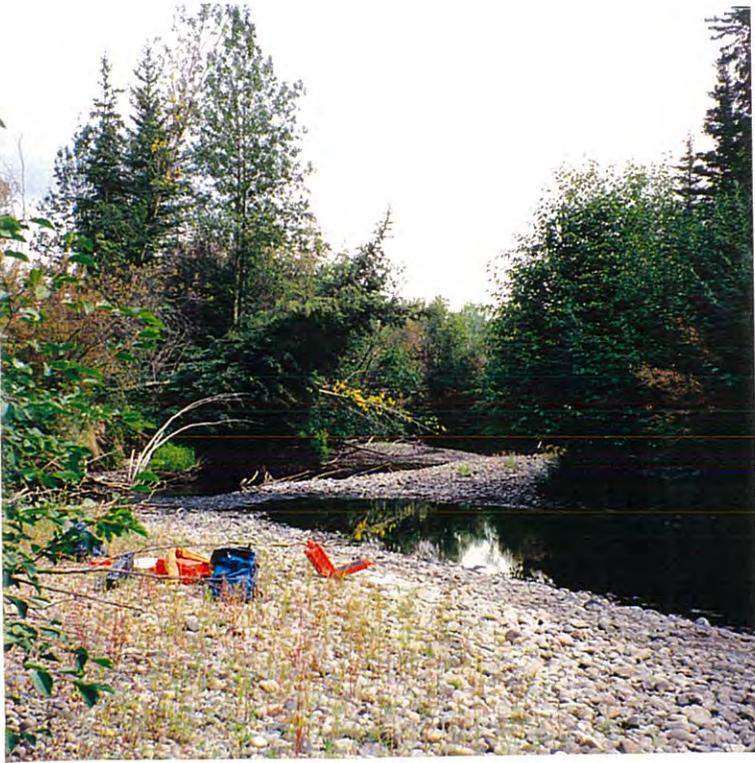
Photo 4. Mica Creek, Reach 1, looking downstream at site 1. Note very low water level (July 29, 1998).

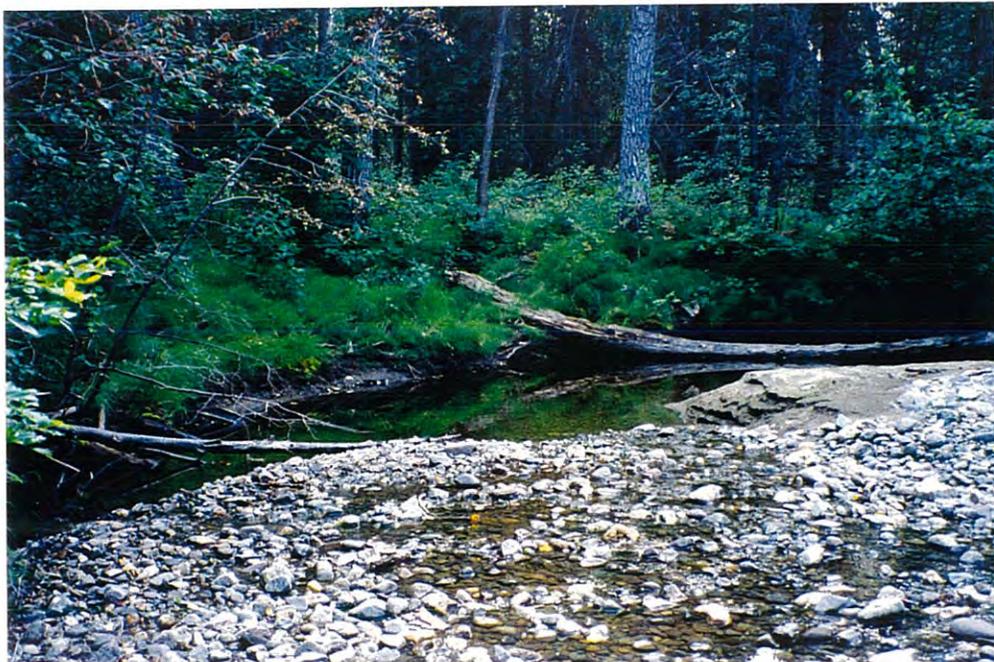
Photo 6. Ptarmigan Creek, a tributary of Mica Creek, near trail crossing, August 6, 1998. Note low water level and excellent habitat for juvenile chinook salmon.

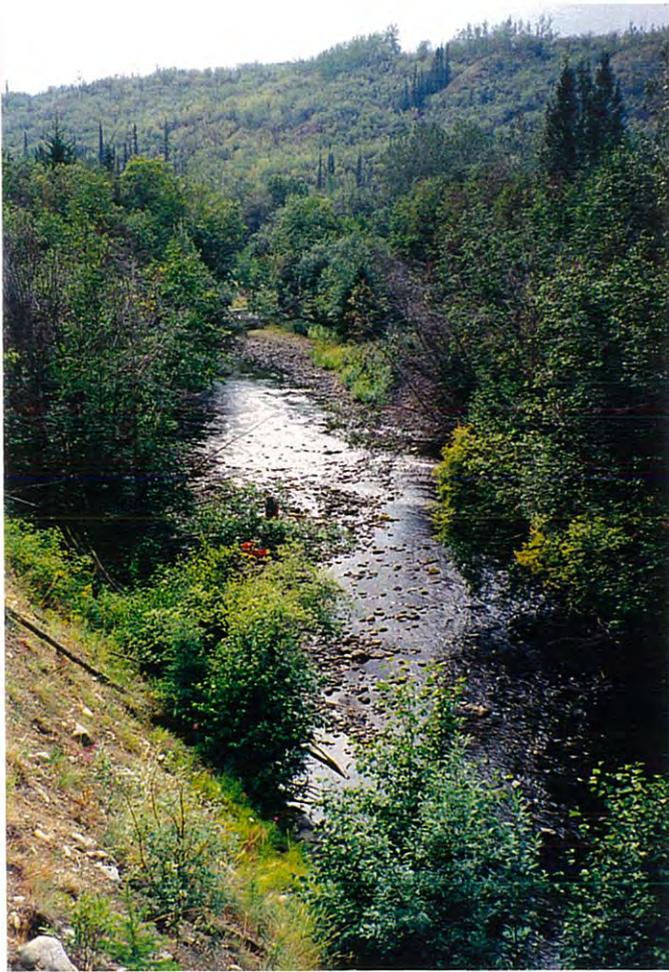
Photo 7. Mica Creek, Reach 2, looking upstream at site 1. Note very low water level (July 29, 1998).

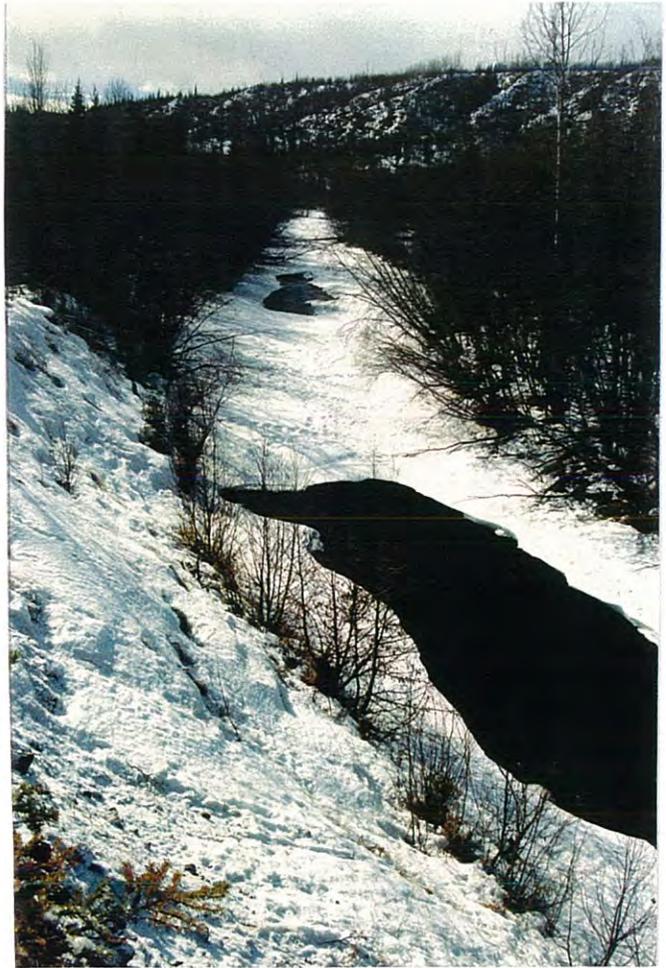
A winter low flow measurement were taken in an area of open water located in Reach 2 at a site investigated during the summer. A good quantity of water with moderate flow was observed here. Several deep pools in this area could provide habitat for over-wintering fish. Using the salt dilution method, the discharge was determined as 0.39 m³/s. Groundwater intrusion is likely along the right embankment as numerous open water areas were observed in this reach.

Photo 8. Mica Creek, Reach 2, looking upstream at site 1. Open water areas on April 2, 1999.

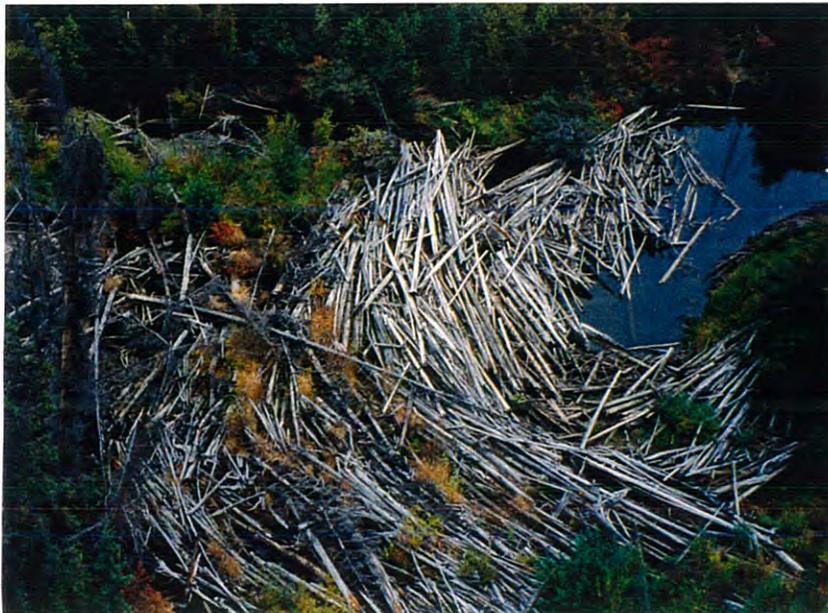
Photo 9. Aerial view of logjam in Reach 3 below site 1.

Two very large logjams were observed below Towhata Lake, during the aerial survey (Fig. 5). In the past these logjams have not obstructed migration of chinook salmon, however they could be cut through to allow easier passage for chinook spawning migrating to sites upstream. Care must be taken in the removal of any part of a logjam as large releases of water and displacement of logs could cause damage to the habitat downstream. The Department of Fisheries and Oceans should be consulted before a logjam removal project is initiated.

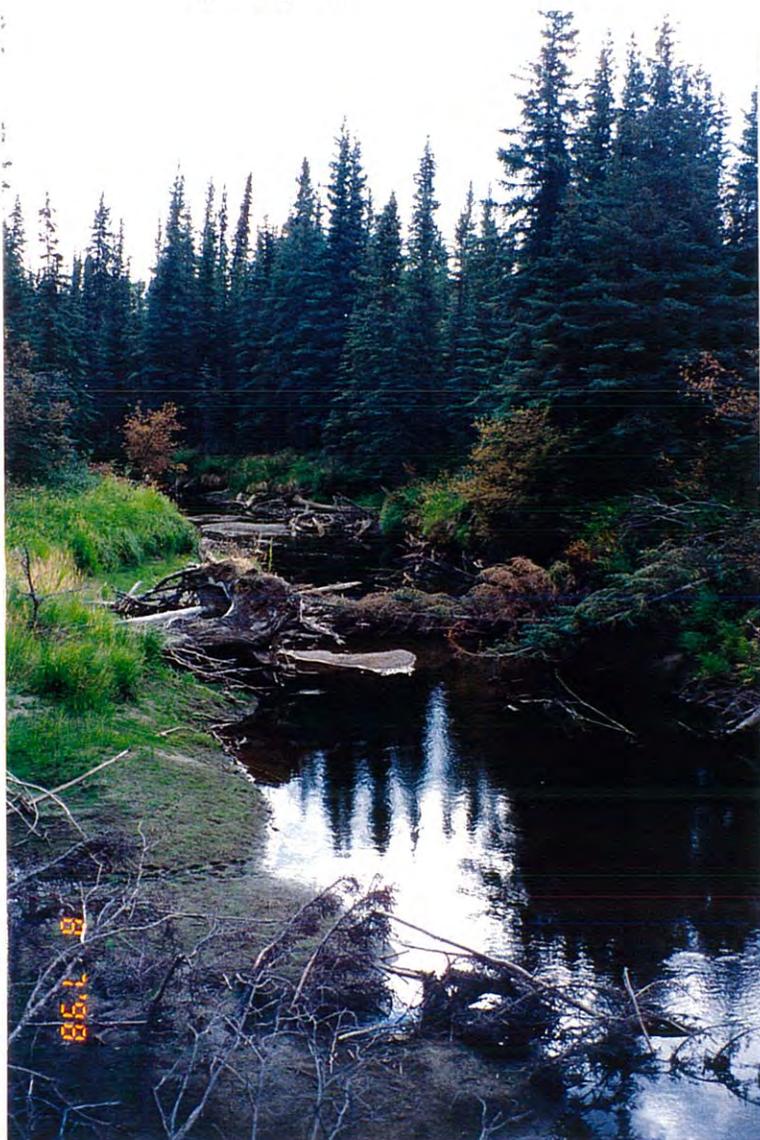
Photo 11. View of Reach 4 below Tatlain Lake. Note heavy sedimentation as a result of extensive beaver activity in this area.

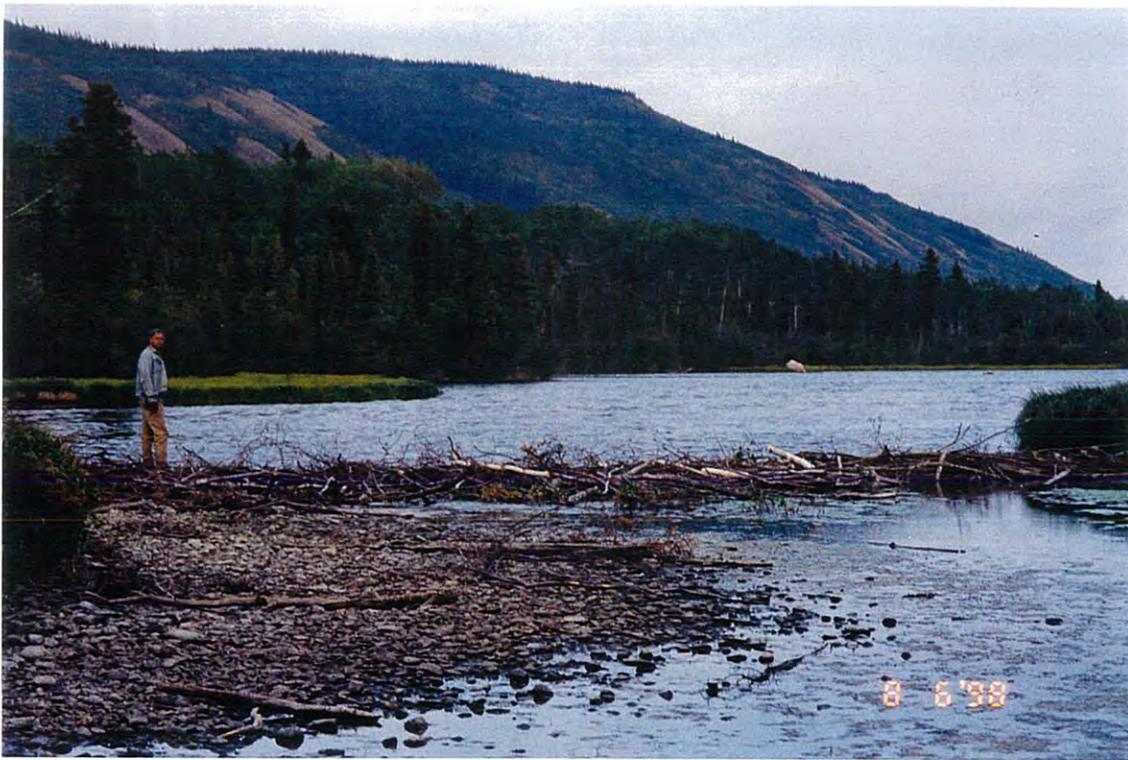
Only a trickle of water flowed through this area; some of it holding in stagnant pools. A low beaver dam spanned the outlet of Tatlain Lake. The streambed was relatively wide and level with an even distribution of moderately compacted gravel and cobble. Three juvenile pike were observed in a deep slow moving pool located at the lower end of the site. Vegetation in this area was comprised of a dense growth of poplar, willow and alder and the occasional white spruce. A lush growth of tall grasses, horsetail and sedges grew along the stream edges. A small rust coloured groundwater source entered the stream on the left bank.

Photo 12. Low beaver dam at outlet of Tatmain Lake, August 6, 1998.

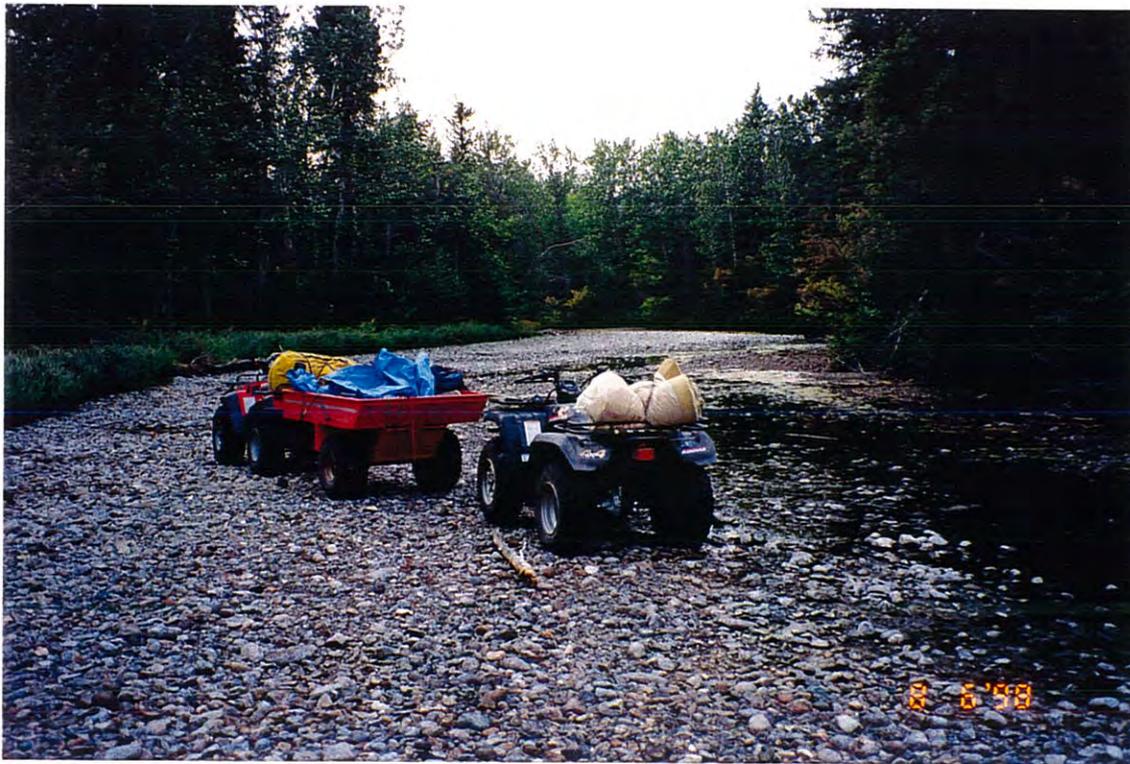
Photo 13. View of Reach 5, below Tatmain Lake. Note flat streambed with very little water flow.

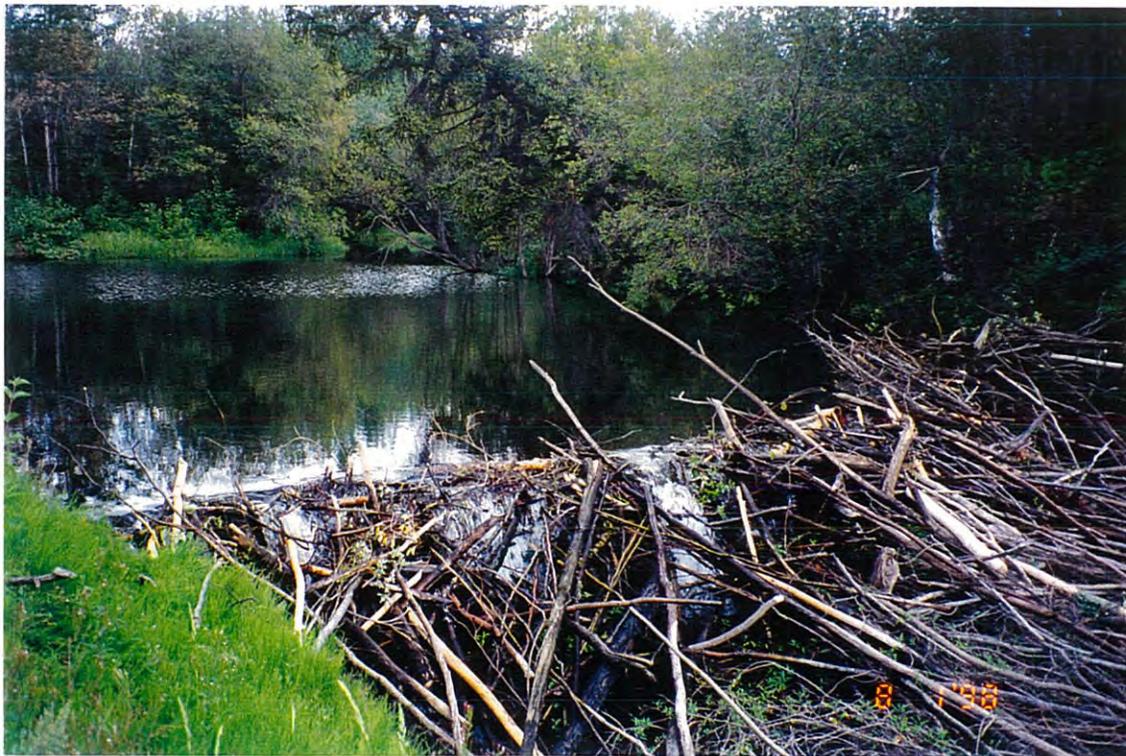
This site was located just upstream from the mouth of Willow Creek. A large beaver dam over 1.0 meter high extended across the main channel and a side channel, flowing in along on the right, separated by a grass and willow covered island of alluvial silt and sand deposits. Below the dam, two channels were separated by a gravel bar; converging near the confluence of the Pelly River. Water from leaks in the dam pooled immediately below the dams then flowed with contributing groundwater in a riffle pattern to the confluence of Pelly River over a moderate gradient of 1.5%, at a velocity of 0.11 m/s. Discharge below the dam was determined as 0.46 m³/s, on August 1.

Photo 14. Beaver dam near mouth of Willow Creek, August 1, 1998. Dam would be a barrier to salmon migrating upstream.

The numerous beaver dams throughout Willow Creek have changed the morphology of the creek and created obstructions to upstream migration. The extent of beaver activity and the ample supply of successional growth aspen and other deciduous species which have grown since a fire in the 60's, would make a beaver control program at this time ineffectual unless an intense trapping or beaver reduction program were initiated. With the low prices of beaver pelts, there may be little monetary incentive for such a program.

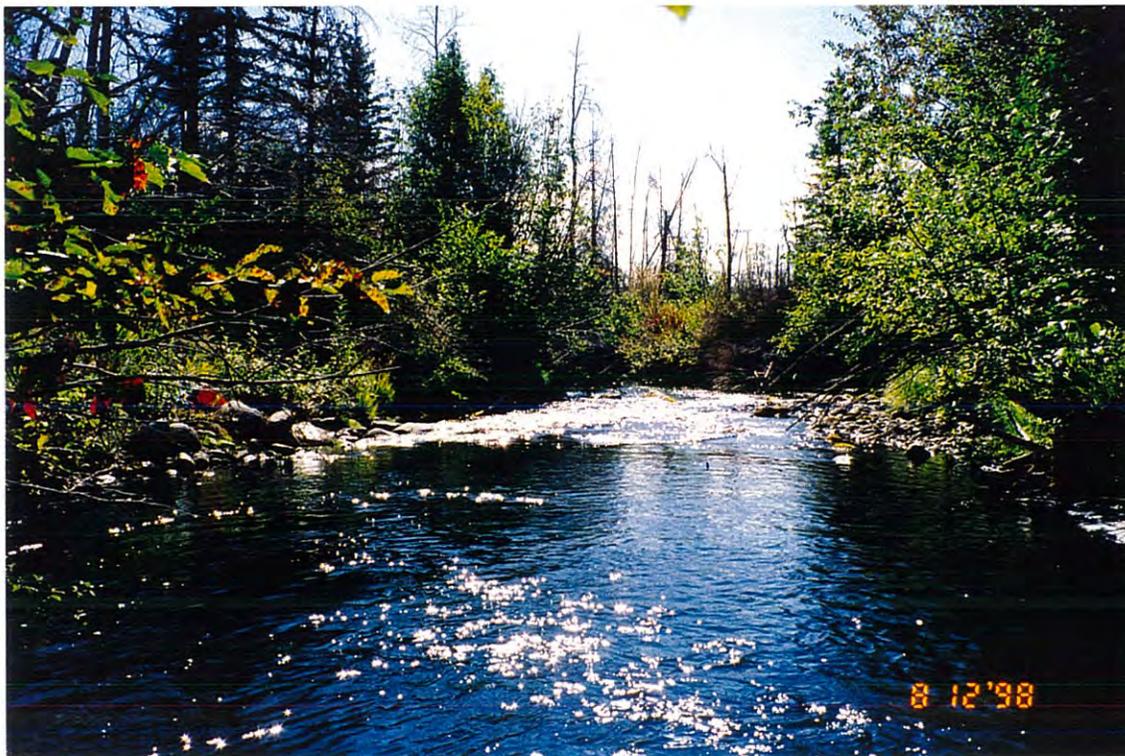
Photo 15. View of potential chinook spawning habitat in Reach 3, Willow Creek. Extensive beaver Activity was observed both above and below this site.

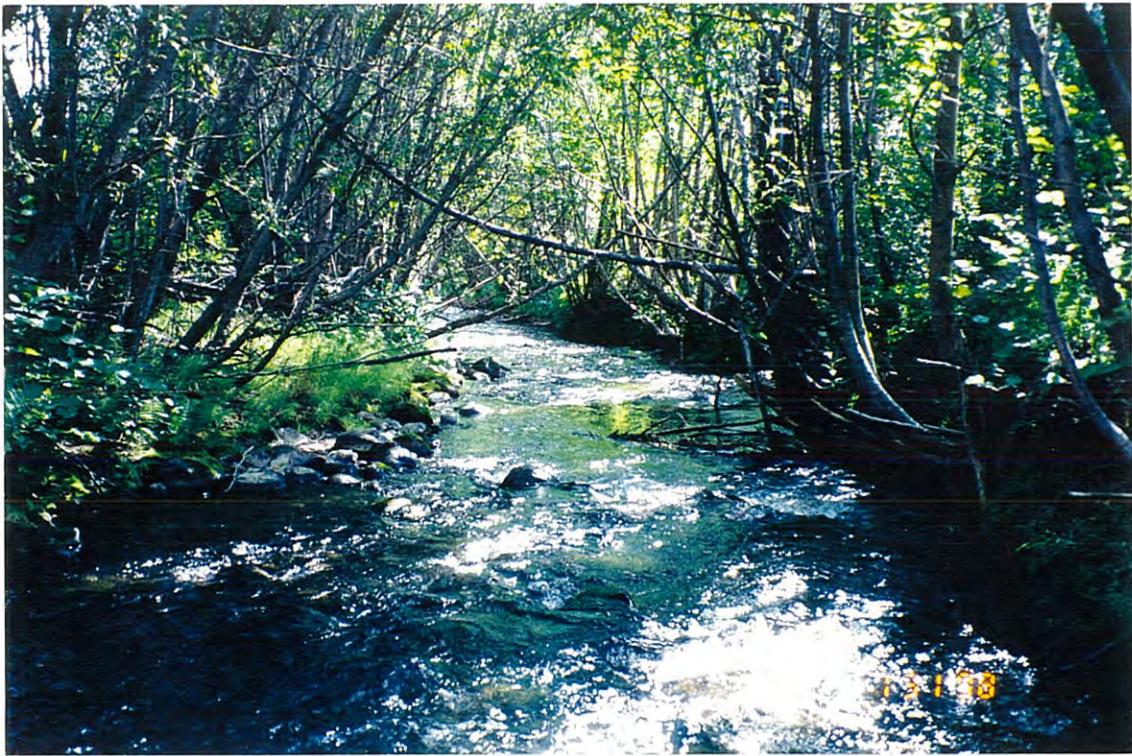
Photo 16. View of Grayling Creek downstream of bridge on Pelly Farm Road. Note stable banks and complete crown cover.

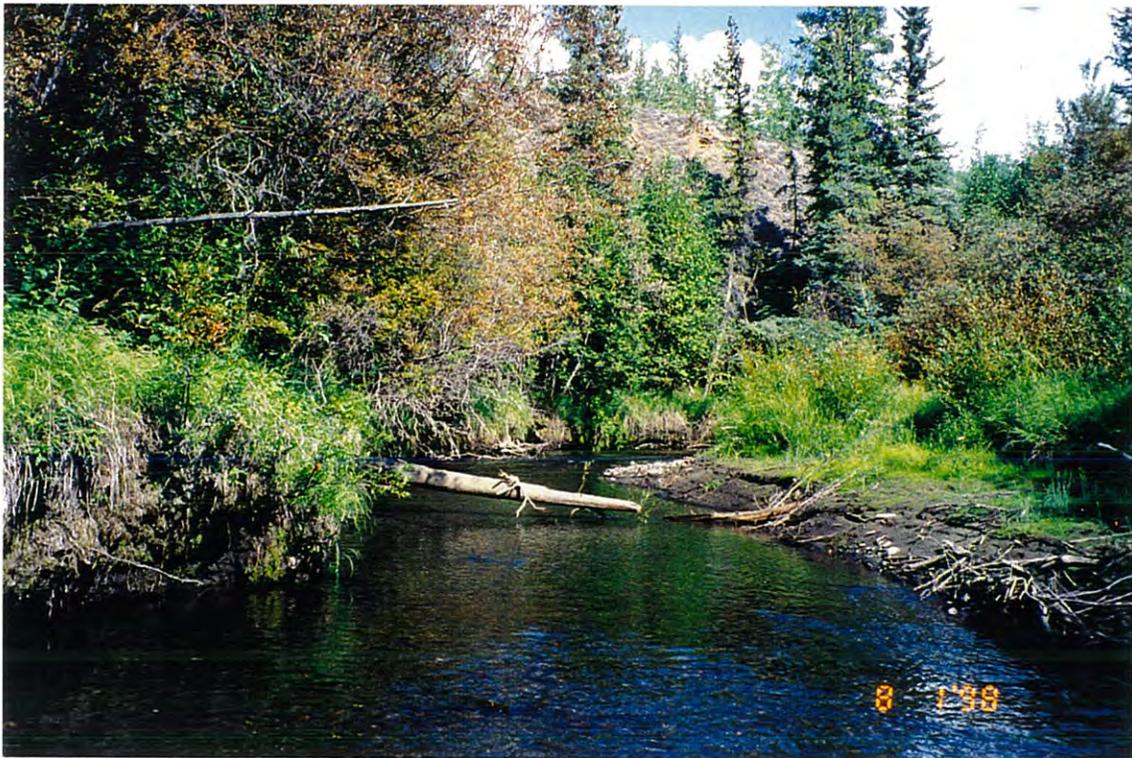
Photo 17. View looking upstream in Reach 1 near the outlet of Grayling Creek. Note cutbanks and LOD providing good cover for juvenile chinook salmon.
