## PROJECT

| <b>Project Name:</b> | Fox Creek Stream Channel Restoration project | <b>R&amp;E Project:</b> CRE-25-13 |
| <b>General Location:</b> | Fox Creek; west side of Klondike Hwy, North of Fox Creek bridge(50km North of Whitehorse, Yk) | <b>Project Dates:</b> June-Aug. 2013 |
| <b>Report Prepared by:</b> | Brian Bell, Ta'an Kwäch'än Council | |

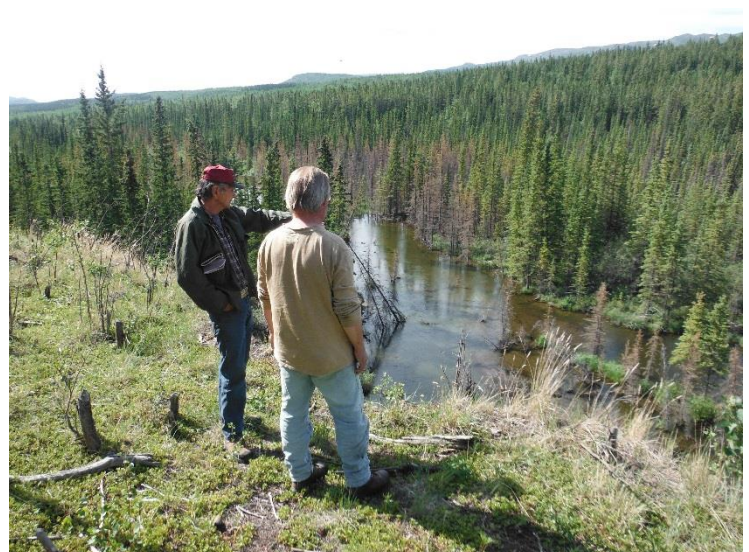
Fig. 2. Norm and Al on top of eroding slope at site 9+100

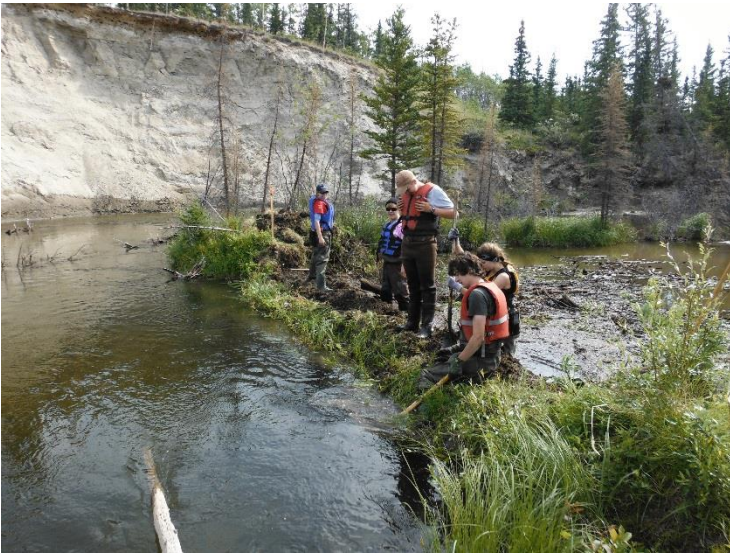
Figures 3 and 4: Environment Yukon's Yukon Youth Conservation Corp (Y2C2) crew removing abandoned beaver dam at site 9+100.

**Fig. 3 Environment Yukon's Y2C2 crew working on abandoned dam at 9+100**

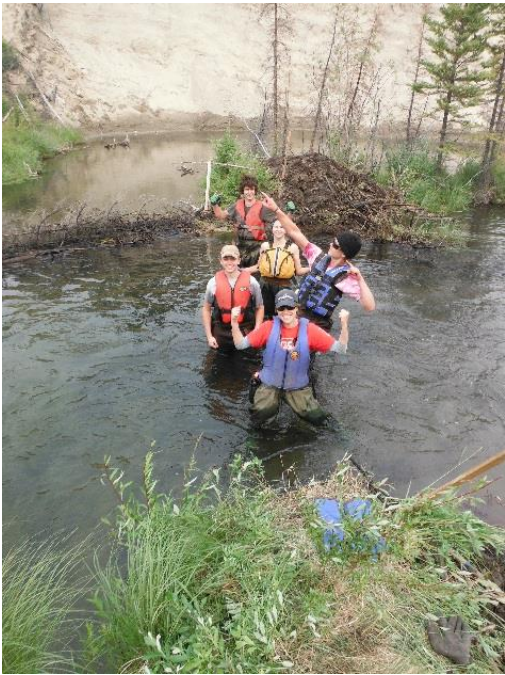
**Fig. 4 Y2C2 crew completion of removal of beaver dam**

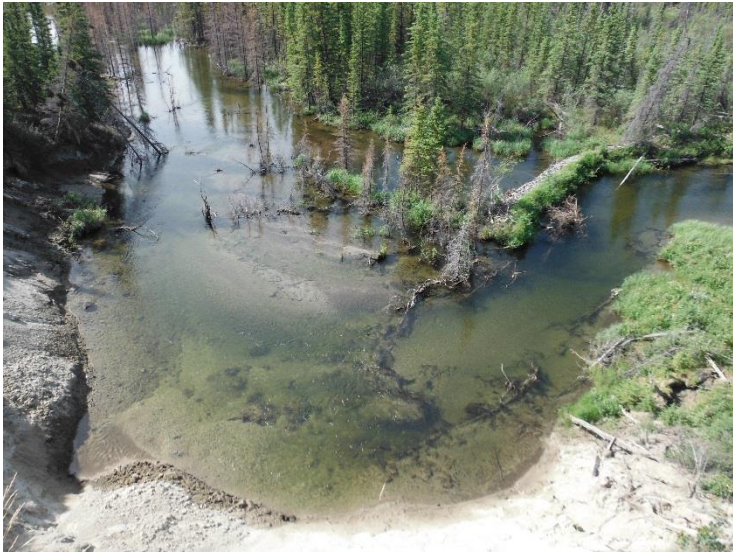
Figures 5 and 6: Before and after photos of site 9+100

**Fig. 5 Site 9+100 before restoration work July 5, 2013**

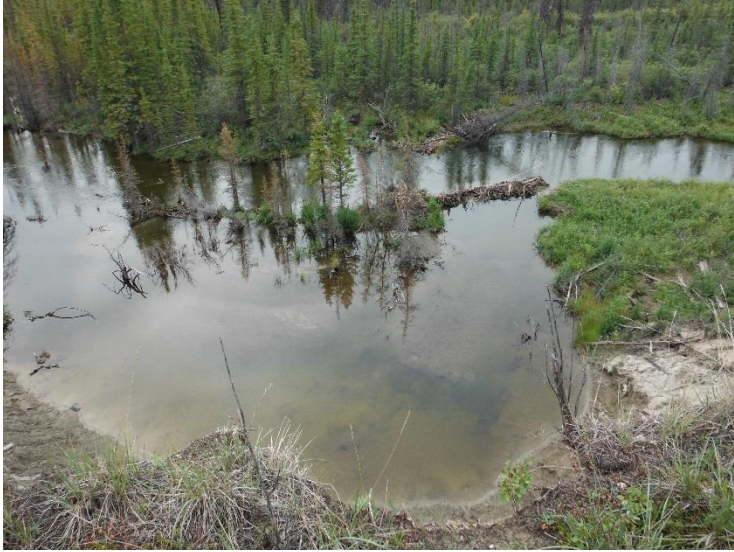
The outcome of the stream diversion at site 9+100 was a total success; visual observations show that sediment moving into the stream from the erosion cliff has ended. The entire main flow of Fox Creek was successfully diverted away from the high erosion area at this site.

**Fig. 6 Site 9+100 after restoration work Aug. 7, 2013**

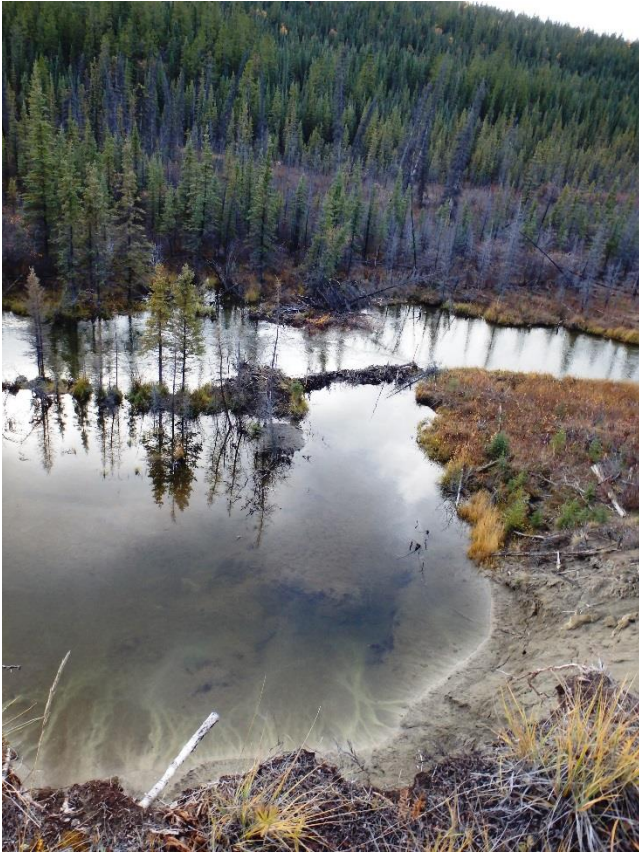
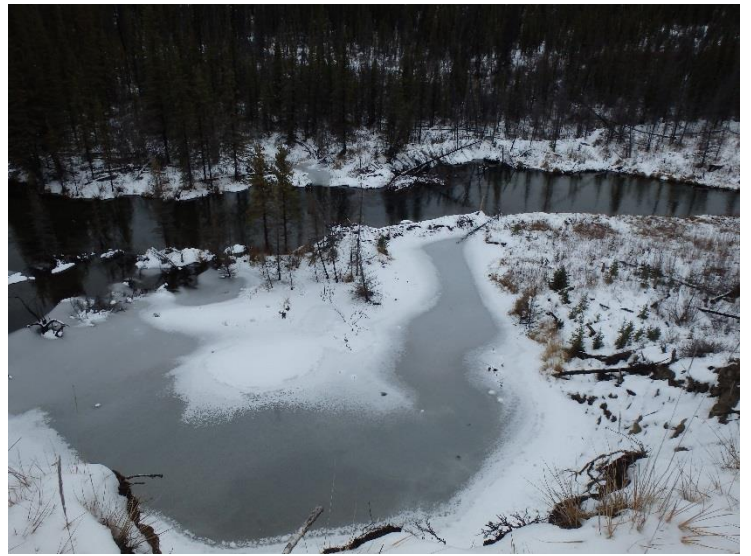
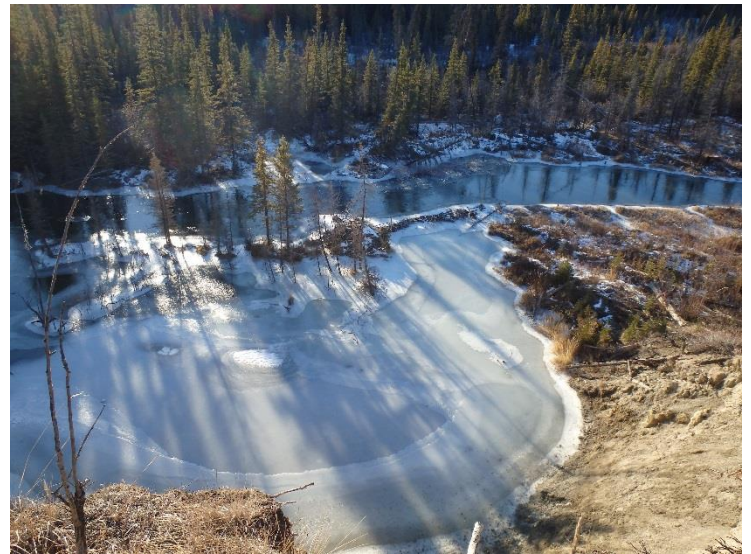
Figures 7, 8, and 9: Site 9+100 after restoration work in fall and winter of 2013

**Fig. 7 Site 9+100 October 5 2013**

**Fig. 8 Site 9+100 October 25 2013**

**Fig. 9 Site 9+100 November 3 2013**

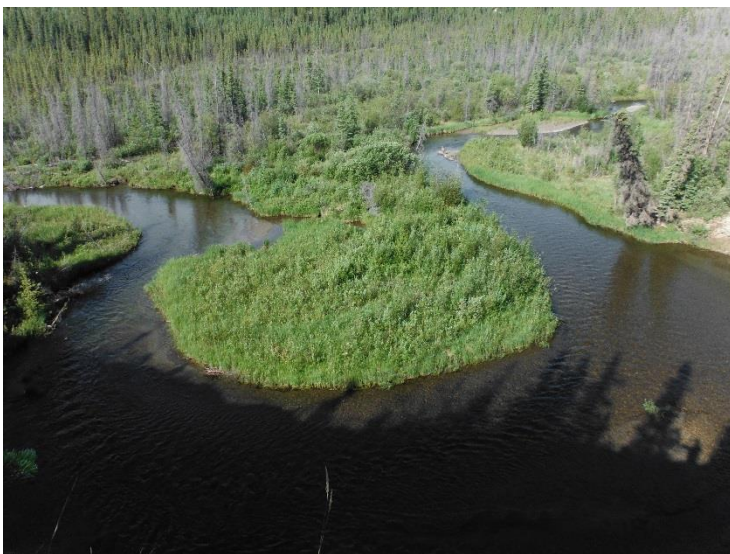
Figures 10 and 11: Before and after photos of site 9+160

**Fig. 10 Site 9+160 before restoration work July 5, 2013**

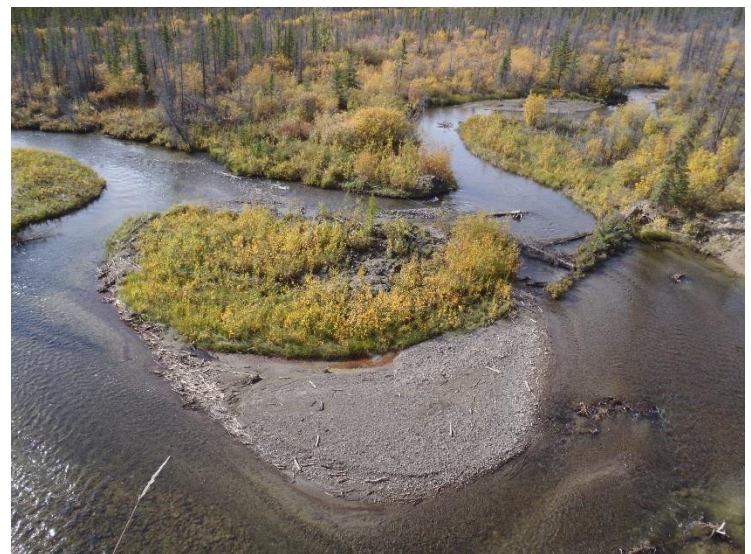
Site 9+160 is also considered as having the desired successful outcome of reduced stream sediment loading. At site 9+160 the contribution of sediments has been reduced to insignificant. At this site a considerable but unquantified stream flow has been directed through the re-established “pre-dam” stream channel. An estimated 85 to 95% of the stream now flows through the excavated channel at site 9+160.

**Fig. 11 Site 9+160 after restoration work September 12, 2013**

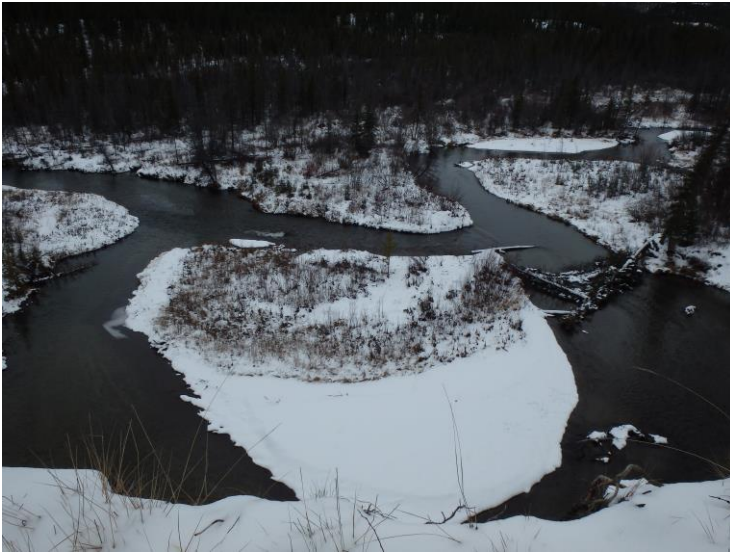
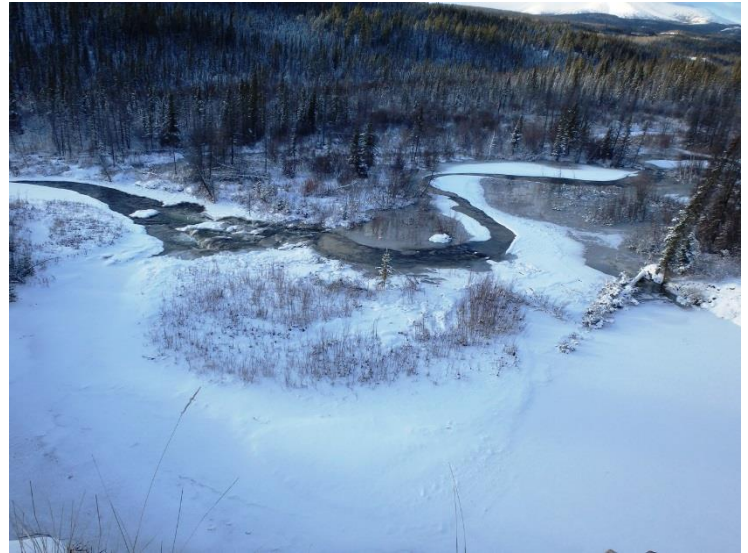
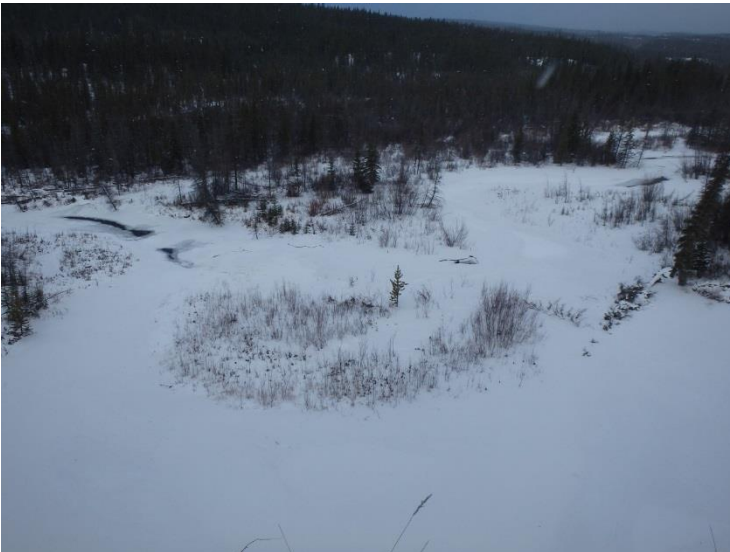
Figures 12, 13, and 14: Site 9+ 100 after restoration work in fall and winter of 2013

**Fig. 12 Site 9+160 October 25, 2013**

**Fig. 13 Site 9+160 November 15, 2013**

**Fig. 14 Site 9+160 Freeze up November 23, 2013**

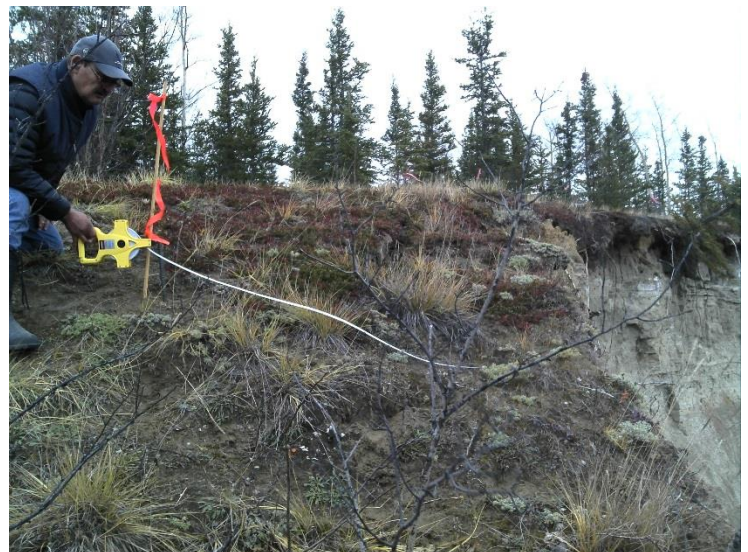
Figure 15: Ta'an Kwäch'än Council citizen Harold Chambers monitoring erosion at a fixed photo monitoring site at the top of eroding streambank at site 9+160.

TKC staff will continue monitoring the erosion and stream diversion sites. The next keystone time period for monitoring will be in the spring of 2014, after the spring freshet. Fixed locations for photo monitoring of the sites have been established to monitor the changes over time (fig. 15).

**Fig. 15 TKC citizen Harold Chambers monitoring erosion from fixed photo site**
