6. Weir Operations

Chandindu River 1999

Subject **OBSERVATIONS: OVERFLIGHT OF CHANDINDU RIVER, JULY 30, 1999**
Object

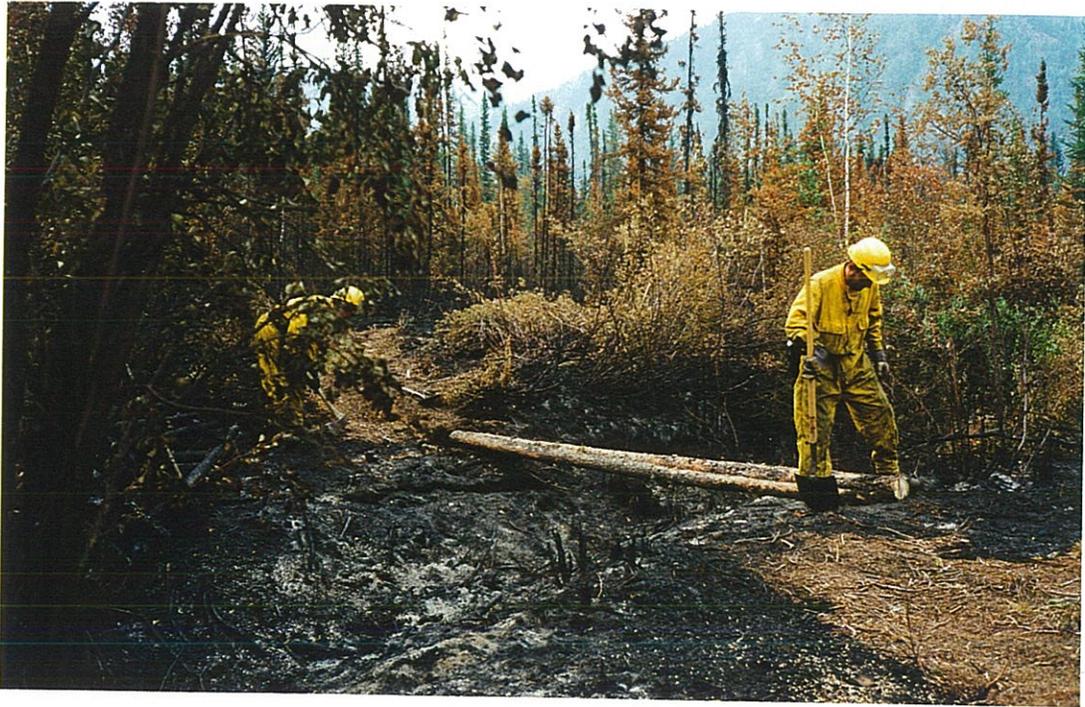
Photo 16

Above: Rebuilding ATV bridges after fires

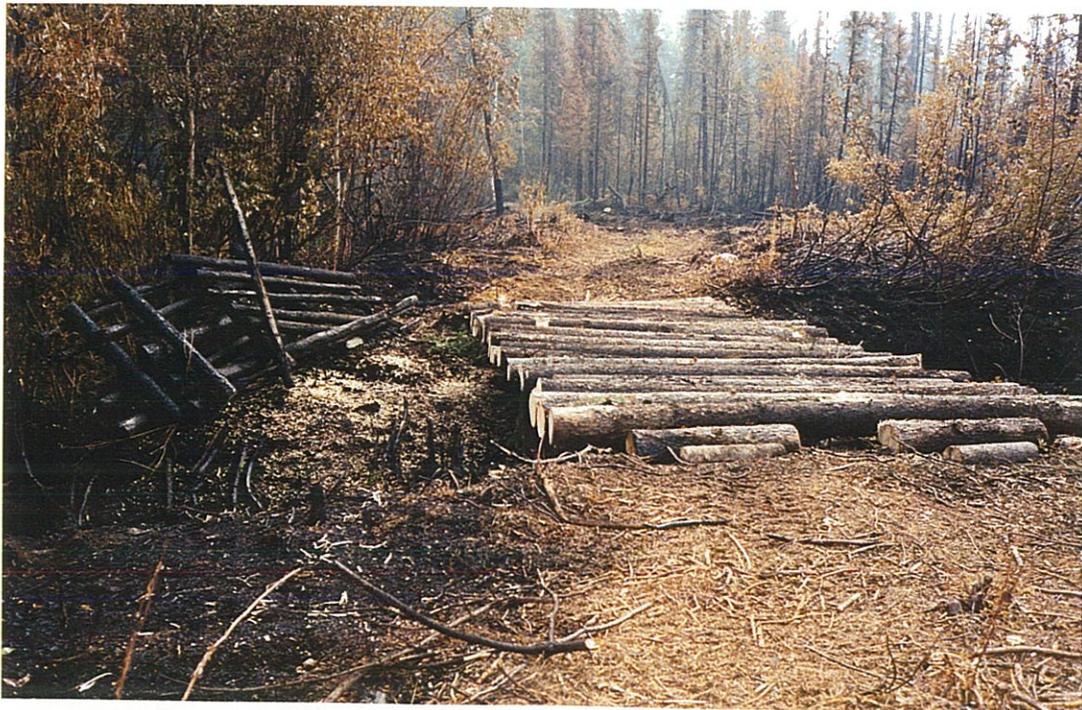
Photo 17

Above: Rebuilt ATV bridge

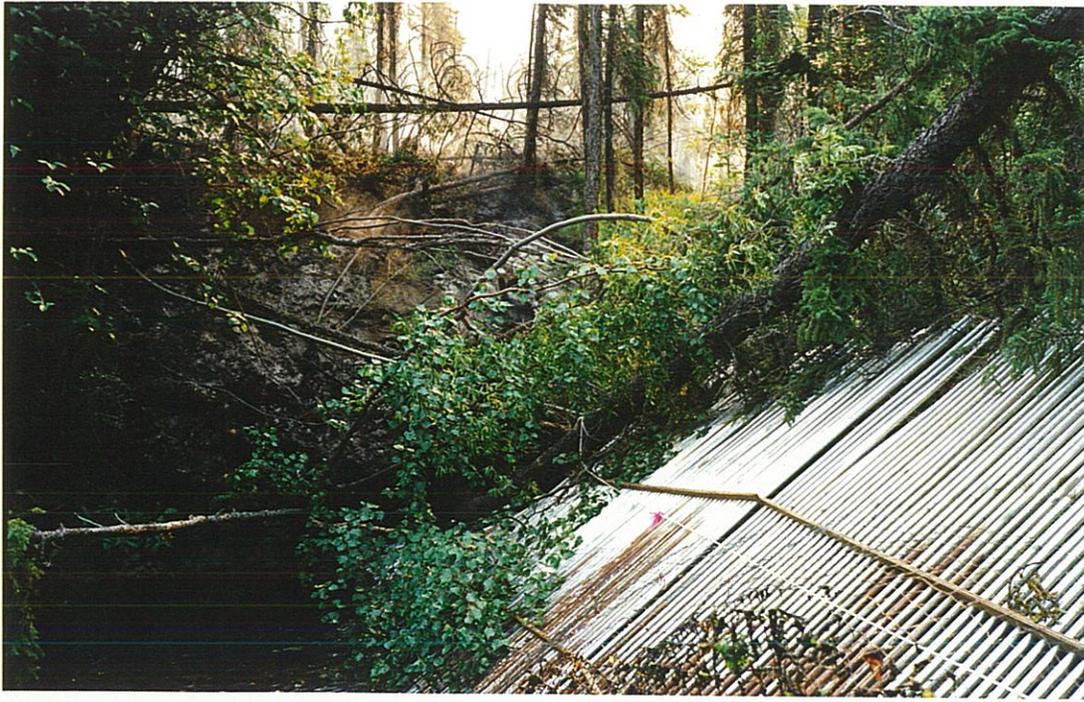
Photo 18

Above: Damage to weir from forest fires

15. Rebuilding ATV trail to weir site
16. Rebuilding ATV bridges after fires
17. Rebuild ATV bridge
18. Damage to weir from forest fires
19. Hot-spots on river bank below weir

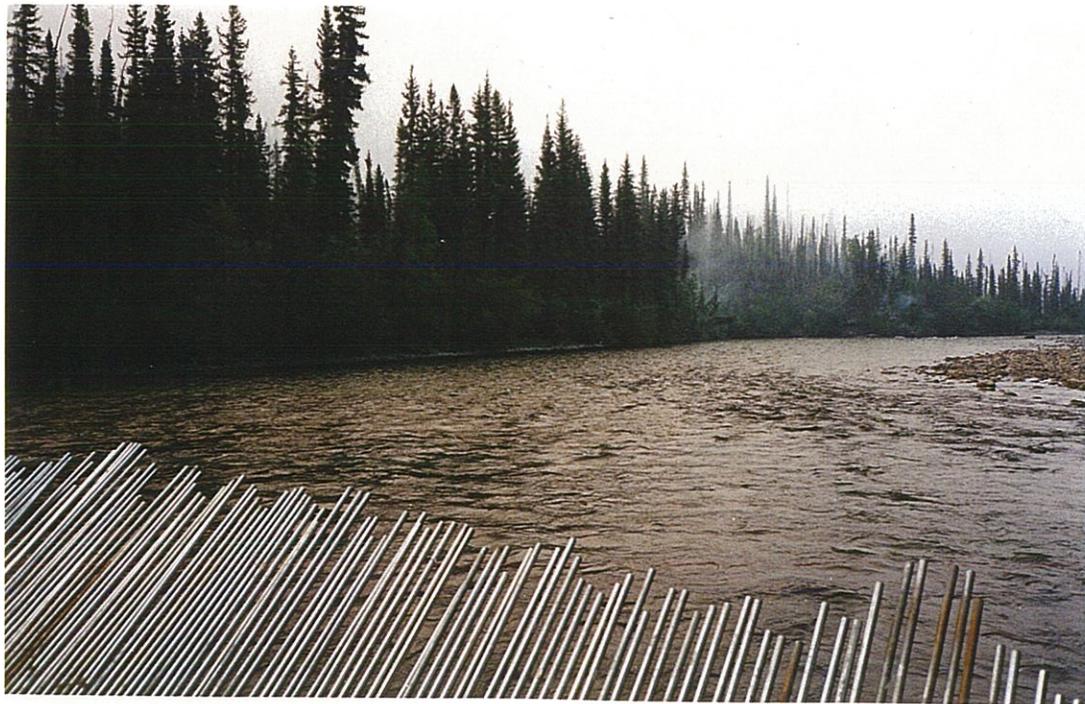
Photo 19

Above: Hot-spots on river bank below weir

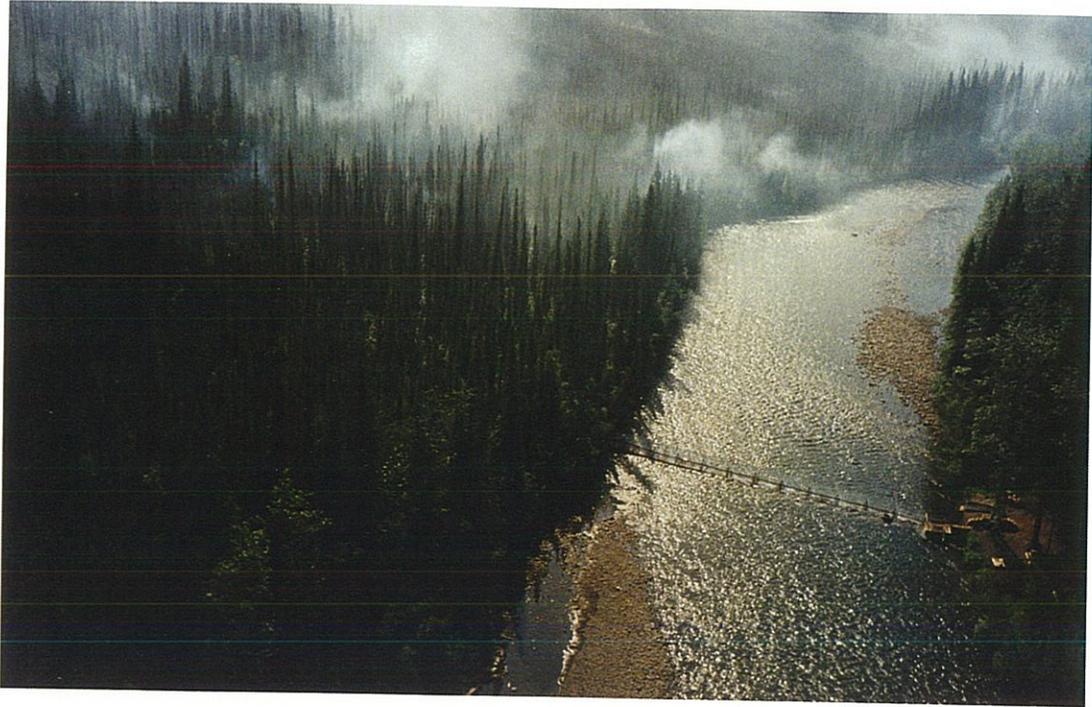
Photo 20

Above: Aerial photo of weir with forest fires looking downstream

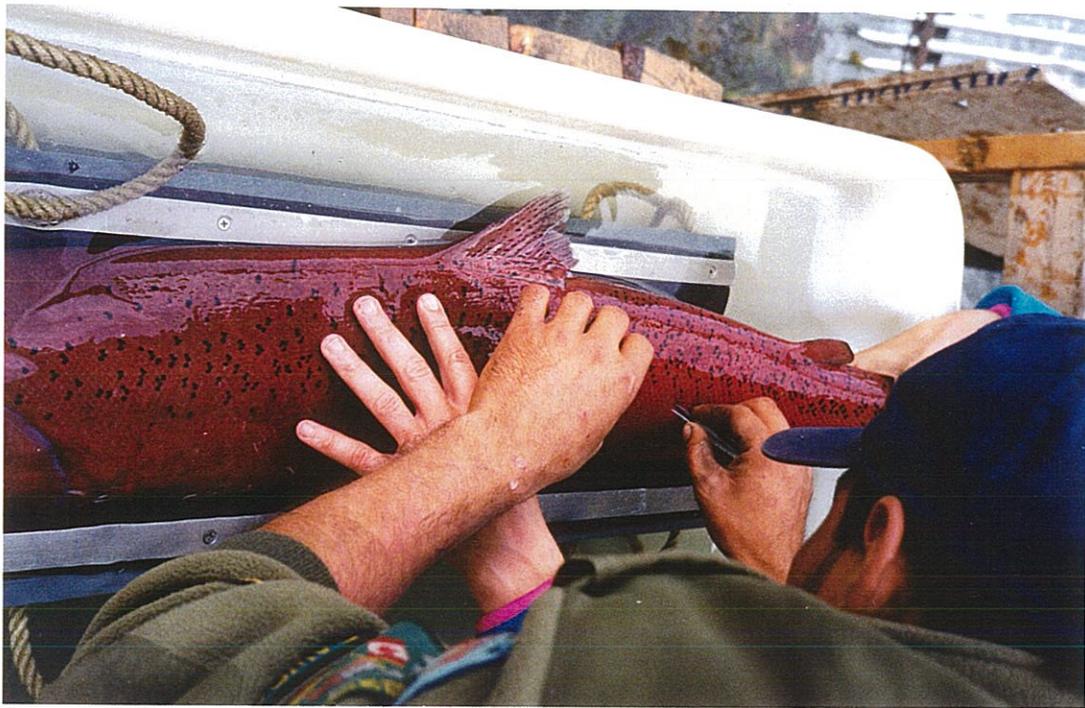
Photo 24

Above: Mike Taylor sampling a chinook salmon on the weir

Procedures were established that addressed the fact that all fish migrating through the counting fence were going to be sampled. Great care and respect was demonstrated during fish sampling (Photos 24). Fish entering the live box were captured by triggering the downstream gate, thus trapping them in the live pen. A rope trigger was set up to allow attendants to trip the gate remotely from the observation tower. A board was then placed over the front gate to restrict current and fish were dipnetted from the live box into the sampling tote. Time of capture (Table 2), fish length, sex, and general condition were all recorded. Scale samples and DNA samples were then taken from the fish (photo 24). Fish were released back into the live pen and the upstream gate opened (photo 25). Fish were left in the live pen and allowed to leave on their own recourse to continue their migration upstream. Any fish that stayed too long in the relatively swift current of the live pen was removed and placed into a fish tube. The tubes were then placed in slack water and the fish would leave the tubes upon recovery.

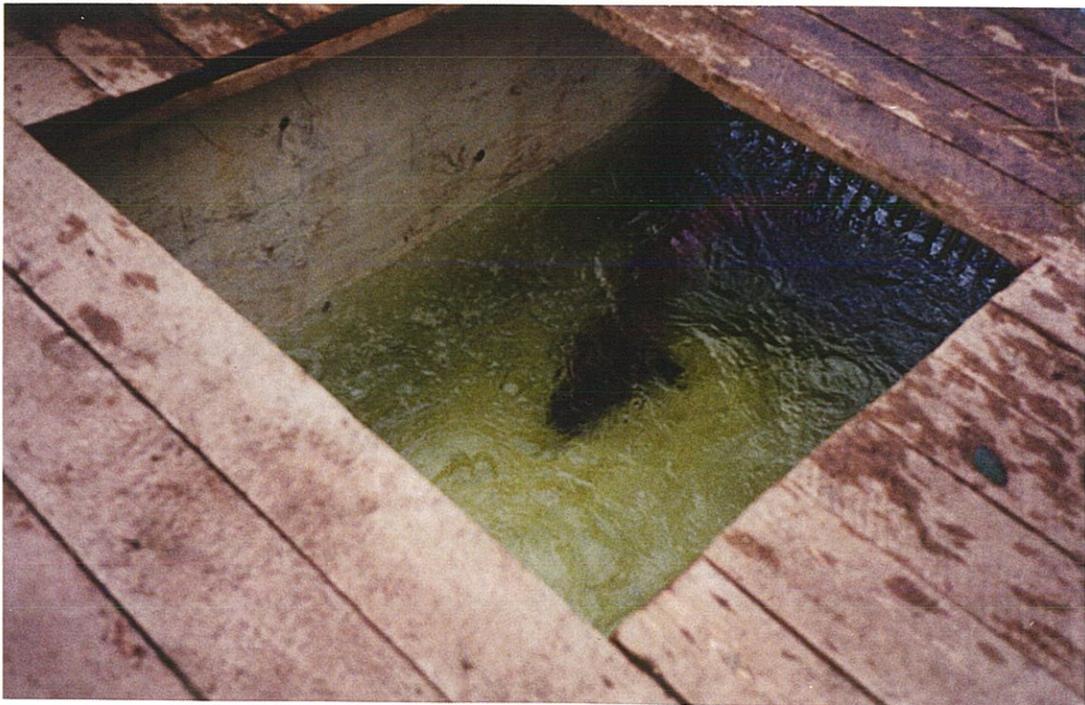
Photo 25

Above: Chinook salmon recovering after sampling in live pen

One notable observation was made by weir attendant Jay Farr. He found that if salmon were released into the live pen after sampling, and allowed to remain and leave on their own recourse, problems with fish hitting the upstream side of the weir were dramatically reduced. This observation, in comparison to older methods where fish were released above the live pen, benefitted the salmon by reducing unnecessary stress-related handling and almost eliminated the need for fish recovery tubes.
