**LOWER DONJEK RIVER
CHINOOK SALMON HABITAT and STOCK ASSESSMENT**

**final report to
YUKON RIVER PANEL
prepared by
Darrell K. Otto
for
WHITE RIVER FIRST NATION
December, 1998.**

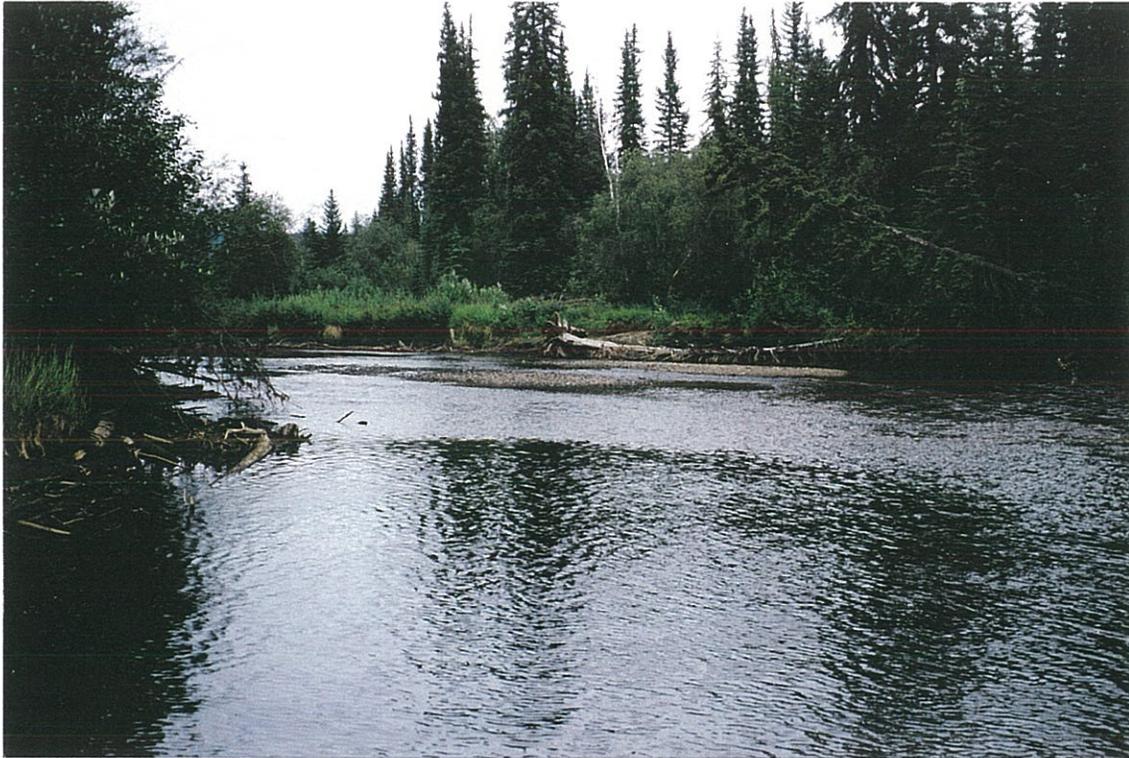
Figure 1: Lower reaches of Klotassin River, July 1998. Riparian vegetation is heavy and gravel bar exposed due to low water level.

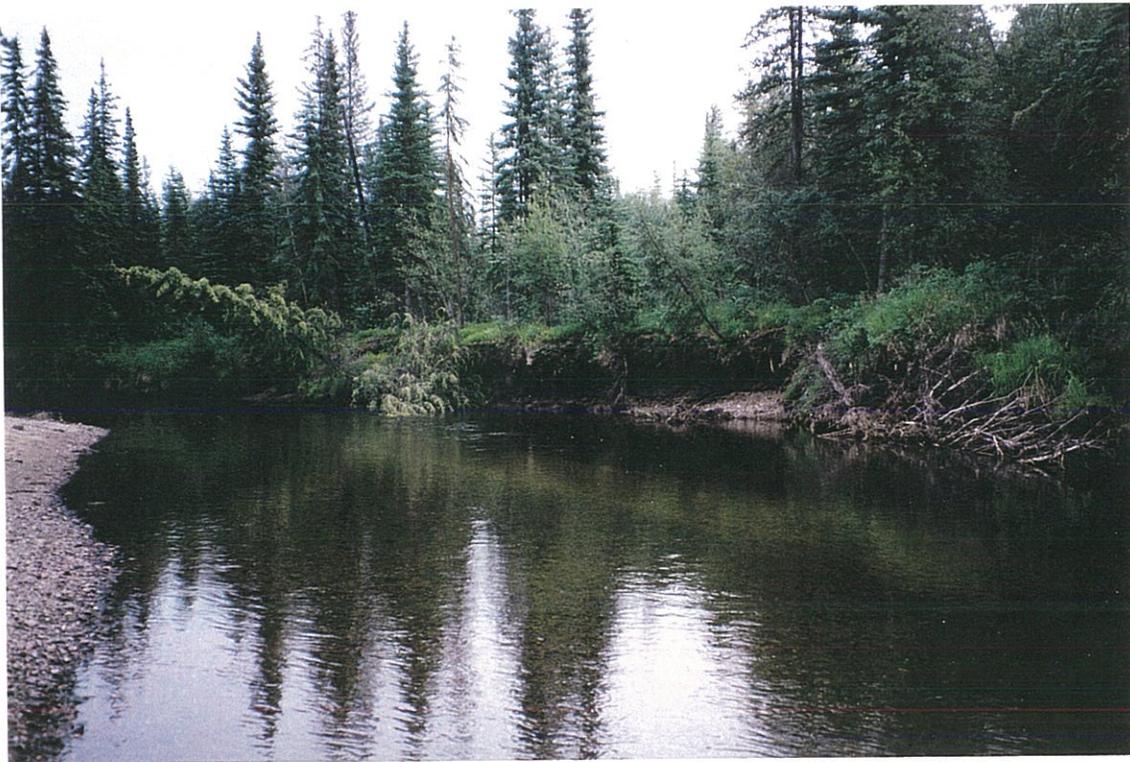
Figure 2: Lower Reaches of Klotassin River. Note gravel bar on inside radius of bend and eroding cutbank with overhanging vegetation on outer radius.

The Klotassin River is very meandering and exhibits a typical pattern of a gravel bar on the inside, and an unstable collapsing bank on the outer radius, of each bend (Figures 1 & 2). The river was generally quite shallow with a mixed substrate ranging from silt through to large cobbles. Areas of cobble/gravel which appeared to be suitable for spawning chinook salmon were common throughout the portions of the stream surveyed. The stream gradient in the lower reaches is low in general, and most of the lower sections of the river are glide zones with occasional riffle zones. Areas of clean gravel and/or cobbles occur, but are not extensive, in the reaches of the stream surveyed. Exceptionally tall white spruce trees line much of the rivers banks, and as the bank erodes on the outer radius of bends the trees which have fallen into the river produce areas which would appear to be good habitat for juvenile chinook salmon. Areas consisting of mixtures of willow, alder and some grasses are also found along the banks of this stream. On the basis of its physical characteristics the Klotassin River does appear to have potential as both a spawning and rearing stream for chinook salmon.

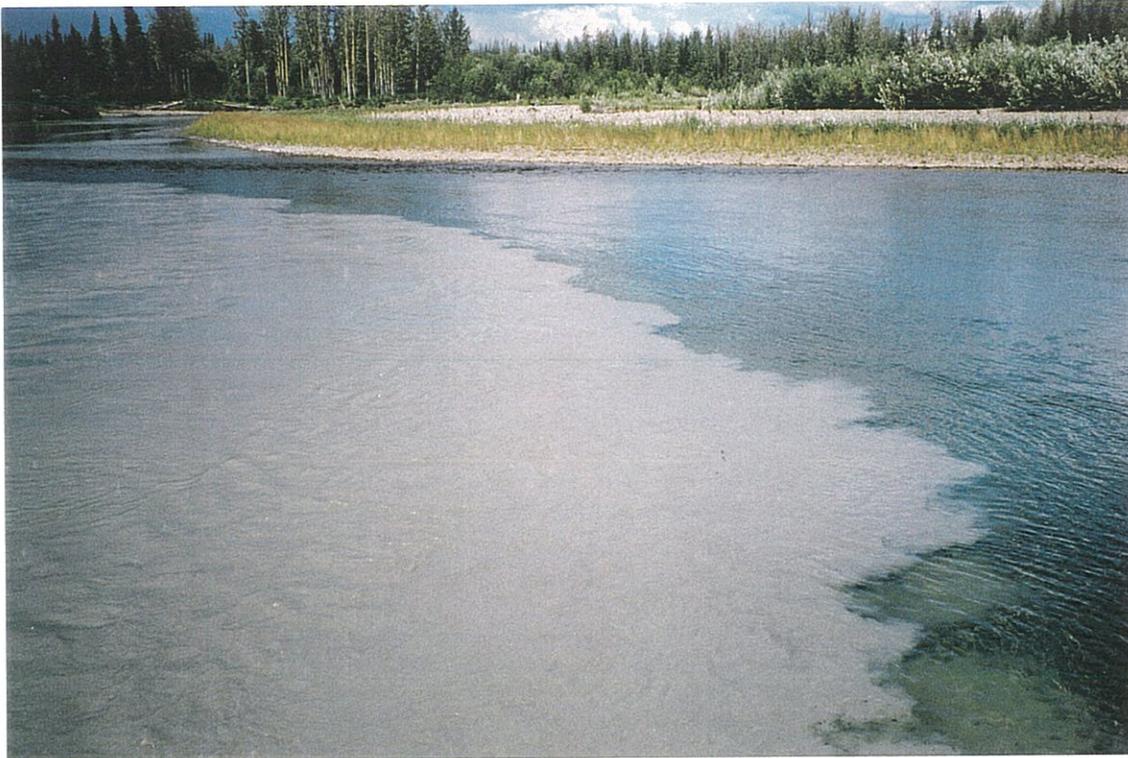
Figure 3: Confluence of North Fork of Nisling River with Donjek River. Entrance to Nisling River is obvious due to long plume of clear water.

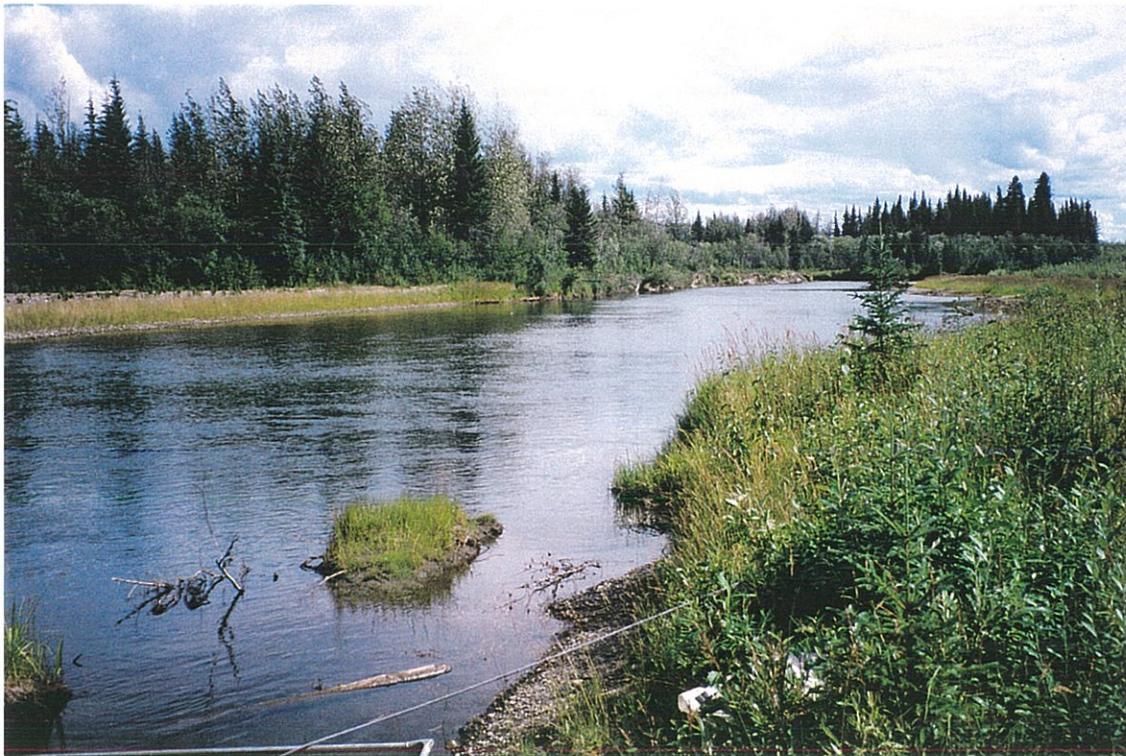
In comparison with the Klotassin River the Nisling River is wider and more open, has a greater volume, and exhibits significantly more unsedimented gravel and cobble substrate (Figure 4). The Nisling River has a steeper gradient in the lower reaches, which results in more riffle to glide, and riffle to pool stream characteristic changes; the higher stream velocity produces more extensive areas of clean gravel and cobbles. The Nisling River exhibits more stable streambanks with less slope, and is in general, less winding than the Klotassin River. Back channels are very common in the lower reaches of the river, and these, in conjunction with numerous log jams along the shore of the river and on the outer radius of bends, appear to provide extensive habitat for juvenile chinook salmon. Riparian vegetation along the Nisling River is in general, similar to that found along the Klotassin although the areas of mixed alder, willow and grasses are more common. The habitat characteristics of the Nisling River appear to indicate that its potential as a chinook salmon spawning and rearing stream is high.

Figure 4: Upstream view in lower reaches of Nisling River. This stream is less meandering and the banks have a more gradual slope and are more “open” than the Klotassin River.

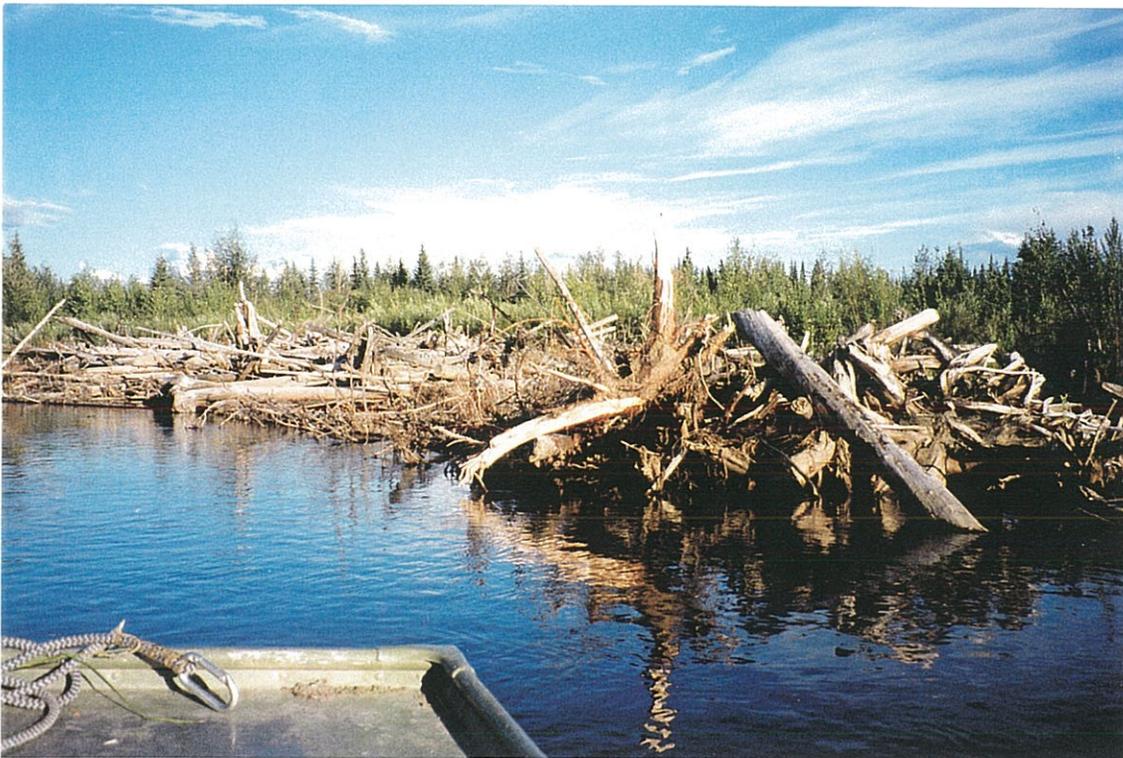
Figure 5: Large debris jam on streambank in lower reaches of Nisling River. These were very common along the north fork of the river, but the channel was navigable. The south fork was completely blocked by a large debris jam which extended for several kilometres.

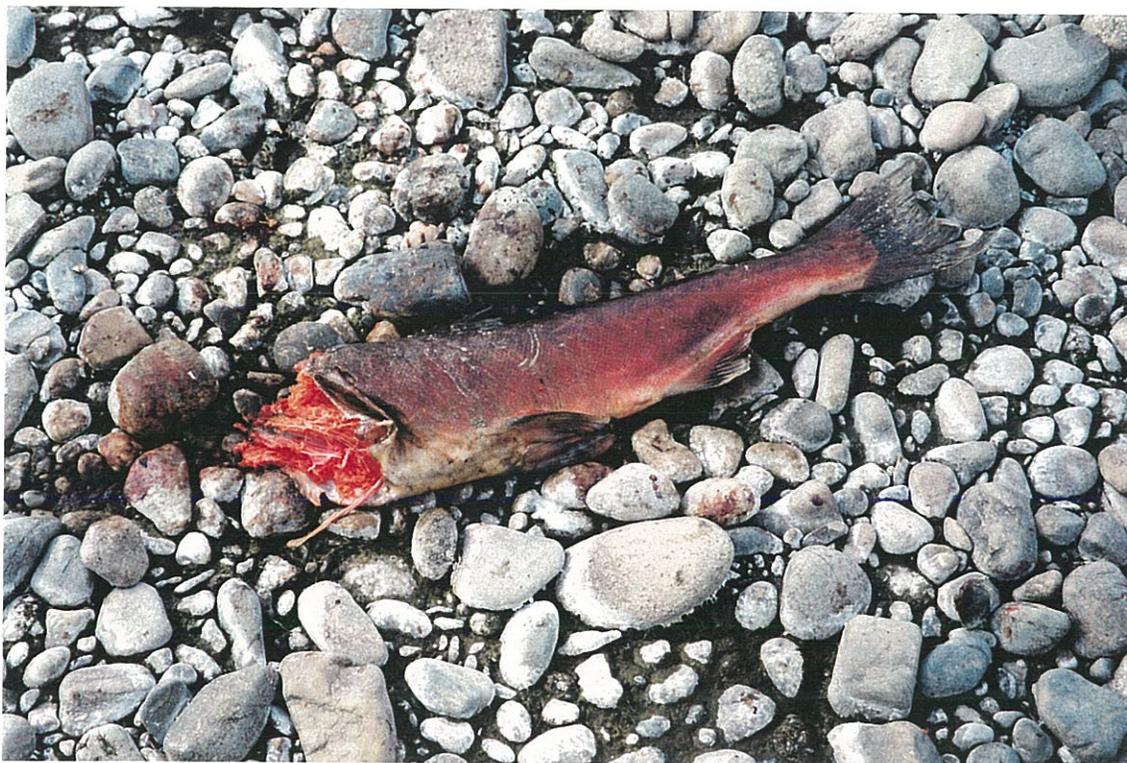
On July 13, during the survey of the Nisling River, a bald eagle was observed feeding on a gravel bar along the east bank of the river. As the boat approached, the eagle took flight, temporarily abandoning its meal. Further investigation revealed that the eagle's prey was a freshly killed male chinook salmon. The dark red colouration of the salmon indicated that it was approaching sexual maturity (Figure 6). This provides evidence that in the 1998 season, chinook spawners had begun moving into the Nisling River by the end of the second week in July. Bald eagles were observed regularly along the Nisling River during the boat survey, and were possibly congregating in preparation for the arrival of the spawning salmon. On July 14, during the return

Figure 6: Fresh carcass of a male chinook salmon, partially consumed by a bald eagle, found on July 13, 1998 in lower Nisling River. The presence of this maturing chinook salmon indicates that spawner migration into the Nisling River has begun.
