TA'AN KWÄCH'ÄN COUNCIL FOX CREEK CHINOOK SALMON RESTORATION PROJECT

CRE-25-16

FINAL REPORT 2016

Prepared for: The Yukon River Panel and the Pacific Salmon Commission

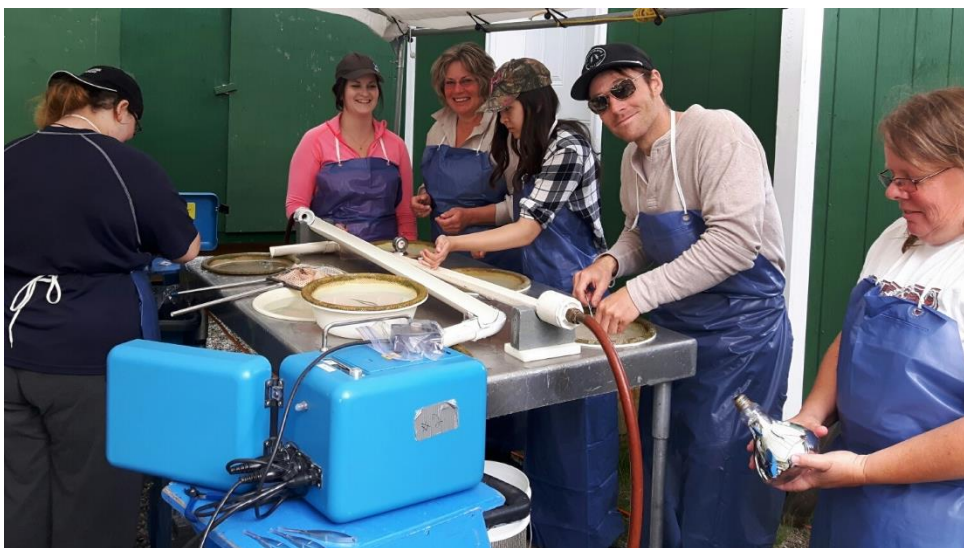
Figure 2 - TKC staff assisted in tagging fry at McIntyre Creek Incubation Facility. July 2016

TKC staff; Stan Clethroe, Clayton Kane, and Deborah Fulmer (who successfully completed the Yukon Fisheries and Field Assistant Program) and TKC summer student Jenna Duncan, assisted MCIF with throughout the year with operations, maintenance and annual fry tagging. MCIF staff cleaned trays daily, removed any discoloured (dead) eggs, monitored flows and water temperatures. During December 2015 and January 2016, the eyed-eggs hatched and developed into alevins. On March 19, 2016, Darrel Otto determined the fish were ready to be transferred to the troughs. In the troughs, they were fed daily and rates of flow, water levels and temperature were monitored. Approximately 45,000 fry were available for release in July 2016. Each Chinook salmon raised at the hatchery had a coded wire tag inserted and adipose fin clipped. TKC staff, Phil Emerson, Jenna Duncan and Deborah Fulmer assisted with the coded wire tagging and adipose clipping (Figure 2).

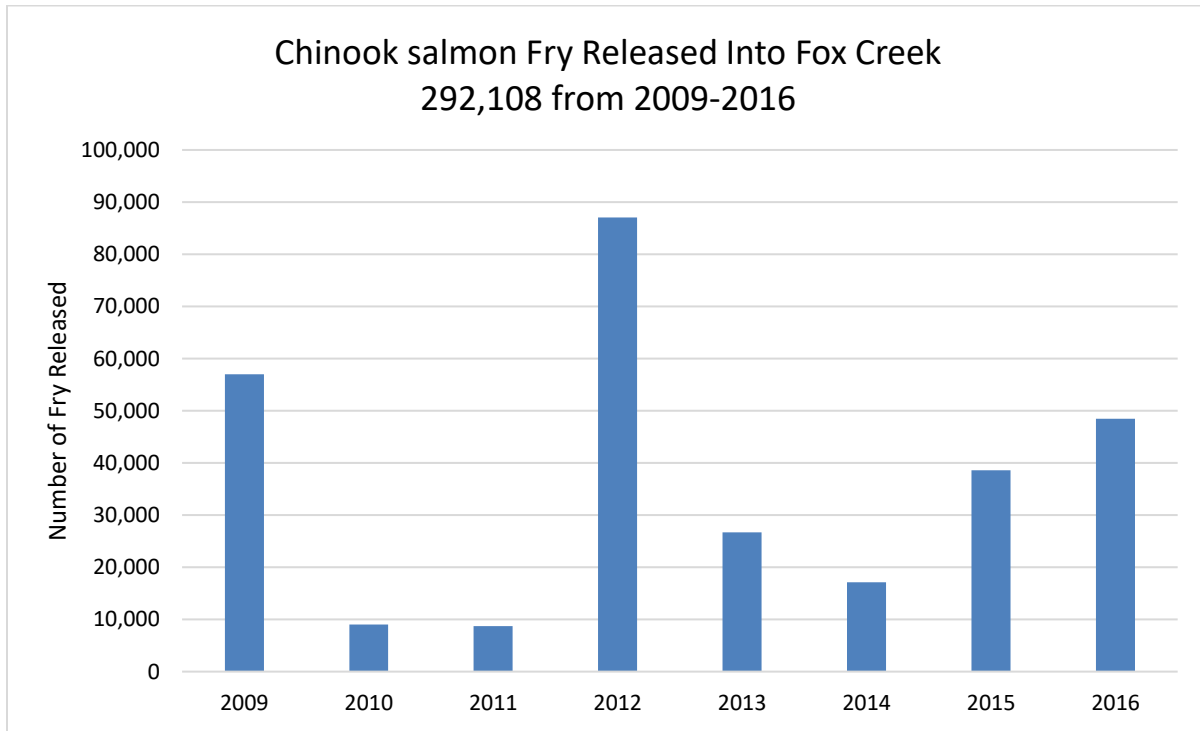
Figure 3: Chinook salmon Fry Released into Fox Creek 292,108 from 2009 - 2016

Fry releases into Fox Creek have taken place annually from 2009 to present with a total of 292,108 fry being released to date (Figure 3).

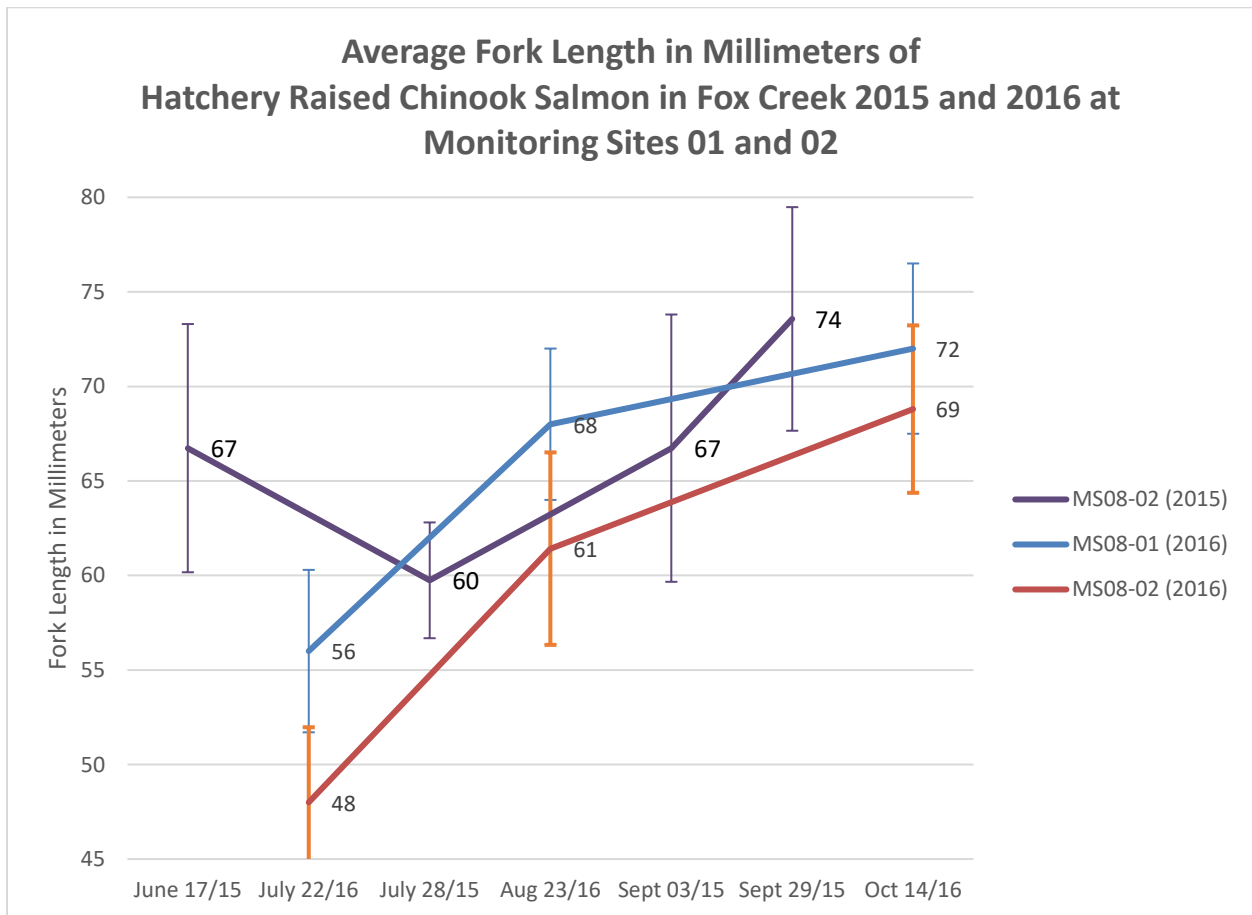
Figure 9: Average fork length (potential growth rate) of only the hatchery raised juvenile Chinook salmon at each site from the date of release to the end of the field season for MS08-01 and MS08-02 in 2016 and MS08-02 only in 2015.

In 2015 15,100 fry were released from the Whitehorse Rapids Hatchery on June 8th and 23,477 from McIntyre MCIF July 12th. Because the water temperature is higher at Whitehorse Rapids the fish grow faster and the average length in June was 55.5mm. The average length at time of release from McIntyre hatchery in July was 53.6. The longer average fork length on June 17, 2015 in Figure 9 could be reflecting the larger fry from WRFH.

In 2016 approximately 45,000 fish were released on July 18th and 18th from the McIntyre Hatchery. Approximately 35,000 were released at MS08-02 and 10,000 at MS08-01 The average fork length was 52mm at the time of release. The density of fish in the stream and competition for nutrients was potentially higher at MS08-02 and this could be reflected in the average fork length being smaller at this site in 2016 in Figure 9.

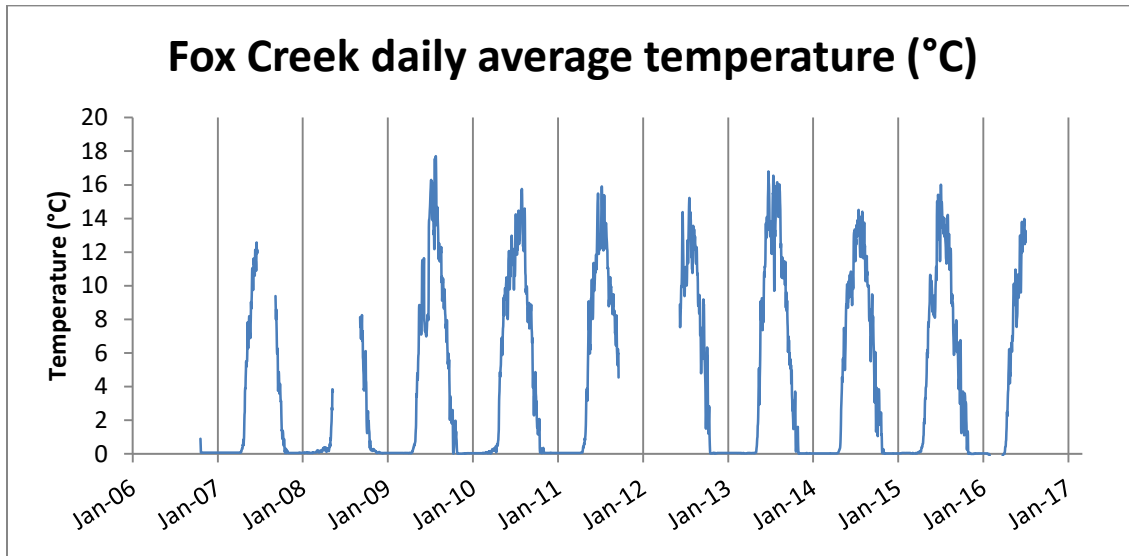
Figure 11: Fox Creek Daily Average Temperature (°C) from 2006 to 2017

From 2006 to present TKC, with support from Al von Finster, TKC has been very diligent at monitoring surface water temperature in Fox Creek using in-stream Tidbit temperature data loggers. This temperature monitoring is part of a larger project on creek, groundwater and river thermal regimes throughout Yukon River watershed in relation to climate change and salmon habitat.

In 2016 TKC hired University of Alberta PhD student Ellorie McKnight under Natural Sciences and Engineering Research Council (NSERC)'s; Collaborative Research and Training Experience (CREATE) program. Ellorie was tasked to organize, synthesize, and analyse TKC's long term temperature data. Her results are displayed below in Figure 11 and 12. The data is indicating an increase in average monthly temperatures in April and May in recent years.

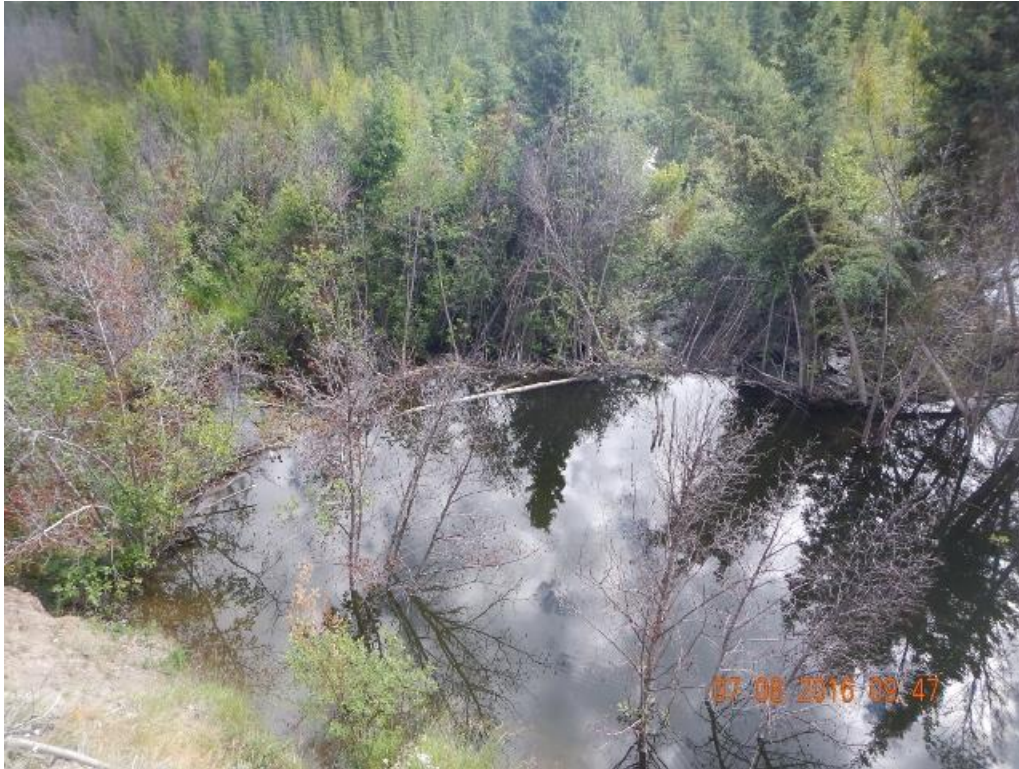
Figure 13: Large Beaver Dam (BD316) Barrier on Fox Creek 2016

Although TKC held a beaver trapping workshop in April 2015 where 5 beaver were trapped, the beaver population appeared to increase as evidenced by the number of dams. The increase in beaver dam activity is displayed the beaver dam map attached in Appendix A. In 2015 (yellow font) there were three active beaver dams (BD115, BD215 and BD315) impeding upstream access to returning adults. This 2016 season there were 12 new dams impeding access (BD116 through DB1216) and BD215 from last season was still active.

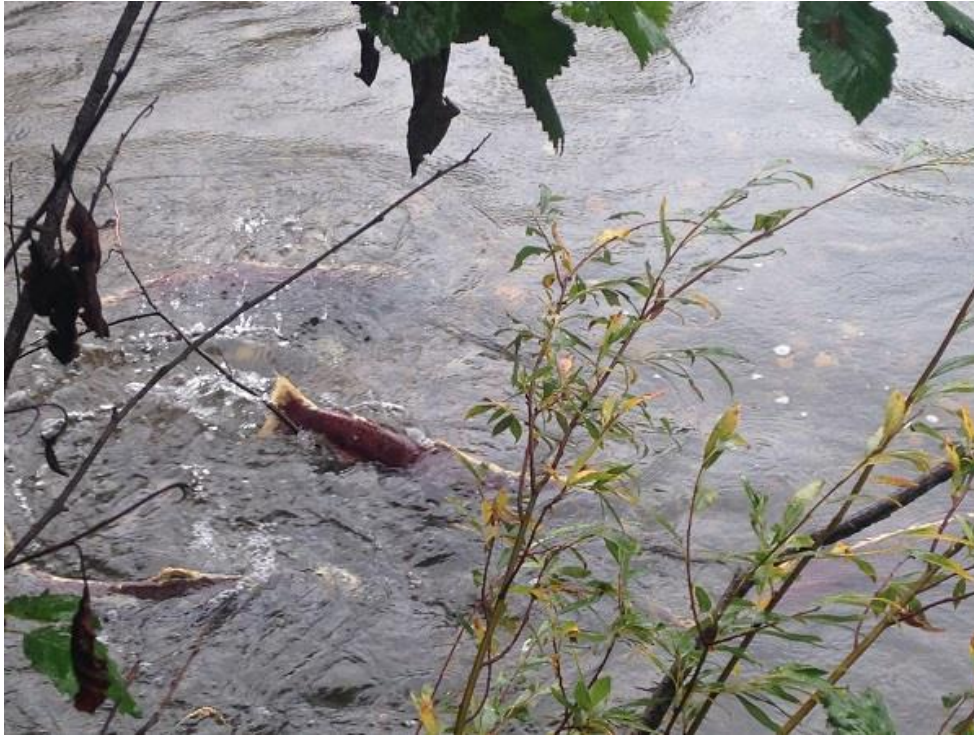
Figure 14: Spawning Salmon at Salmon Siting (SS)416 Just Downstream of BD215

Areas of Chinook salmon spawning behaviour was observed, recorded, photographed and geo-referenced. Temperature data loggers, known as artificial redds, were again installed this season to determine the success of these redd sites. TKC will return mid-June 2017 to retrieve and analyse these loggers and monitor any 0+ fry that may emerge from the substrate.

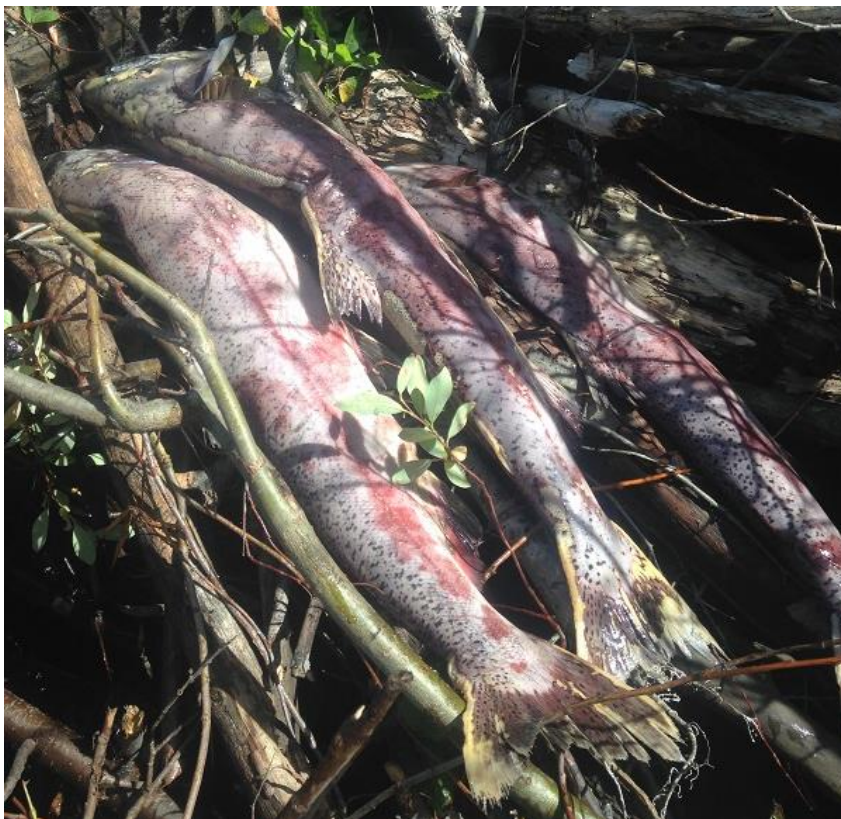
Figure 15: Three Male Carcasses Found in Beaver Dam (BD215)

Biological samples were taken from 4 carcasses. Three were males and one spawned female and all were near of beaver dam barrier BD215. Staff collected scale samples; measured fork and post orbital hypural length, then collected and tagged heads. The heads were submitted to DFO for further analysis and these results will be provided to TKC.

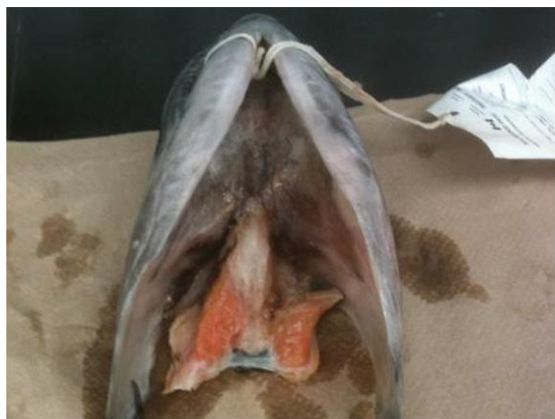
Figure 1. Head with excess flesh and gills

In some cases during transport heads may thaw so it is important that all heads shipped to the Whitehorse office should have gills and any excess flesh removed to help slow the rotting process.
