TA'AN KWÄCH'ÄN COUNCIL FOX CREEK CHINOOK SALMON RESTORATION PROJECT

CRE-25-17

FINAL REPORT 2017

Prepared for: The Yukon River Panel and the Pacific Salmon Commission

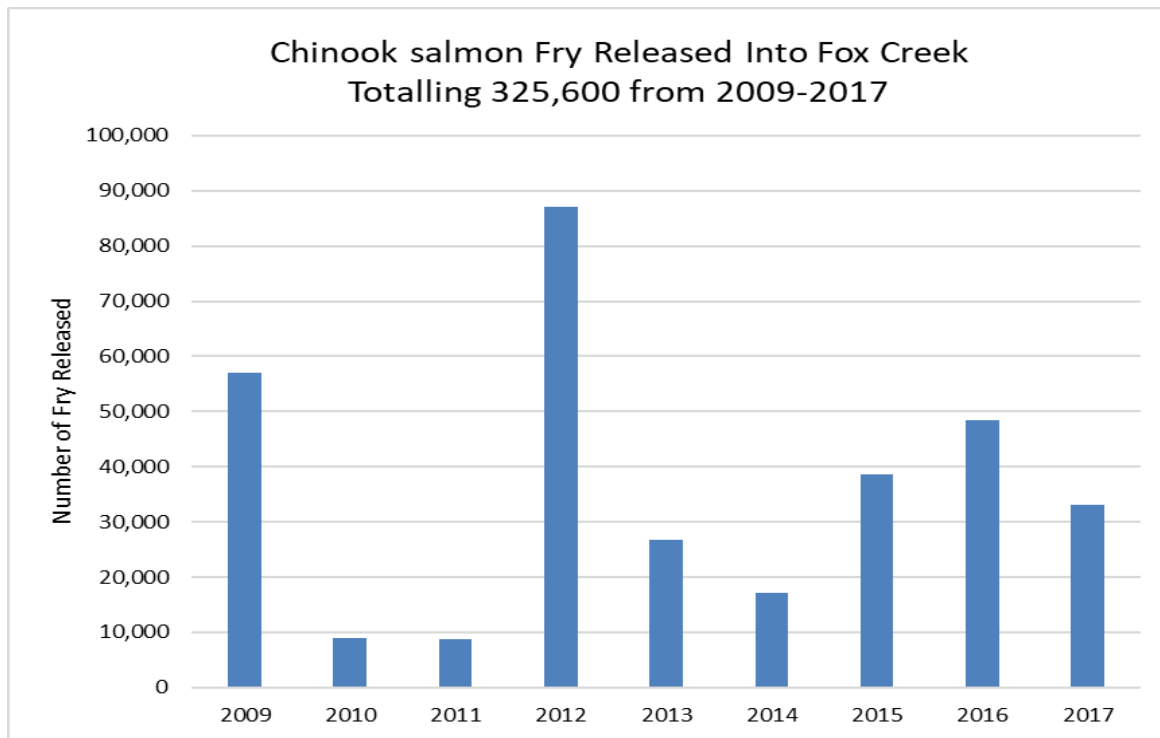
Figure 3: Chinook salmon Fry Released into Fox Creek from 2009 - 2017

Fry releases into Fox Creek have taken place annually from 2009 to present with a total of 235,600 fry being released to date (Figure 3).

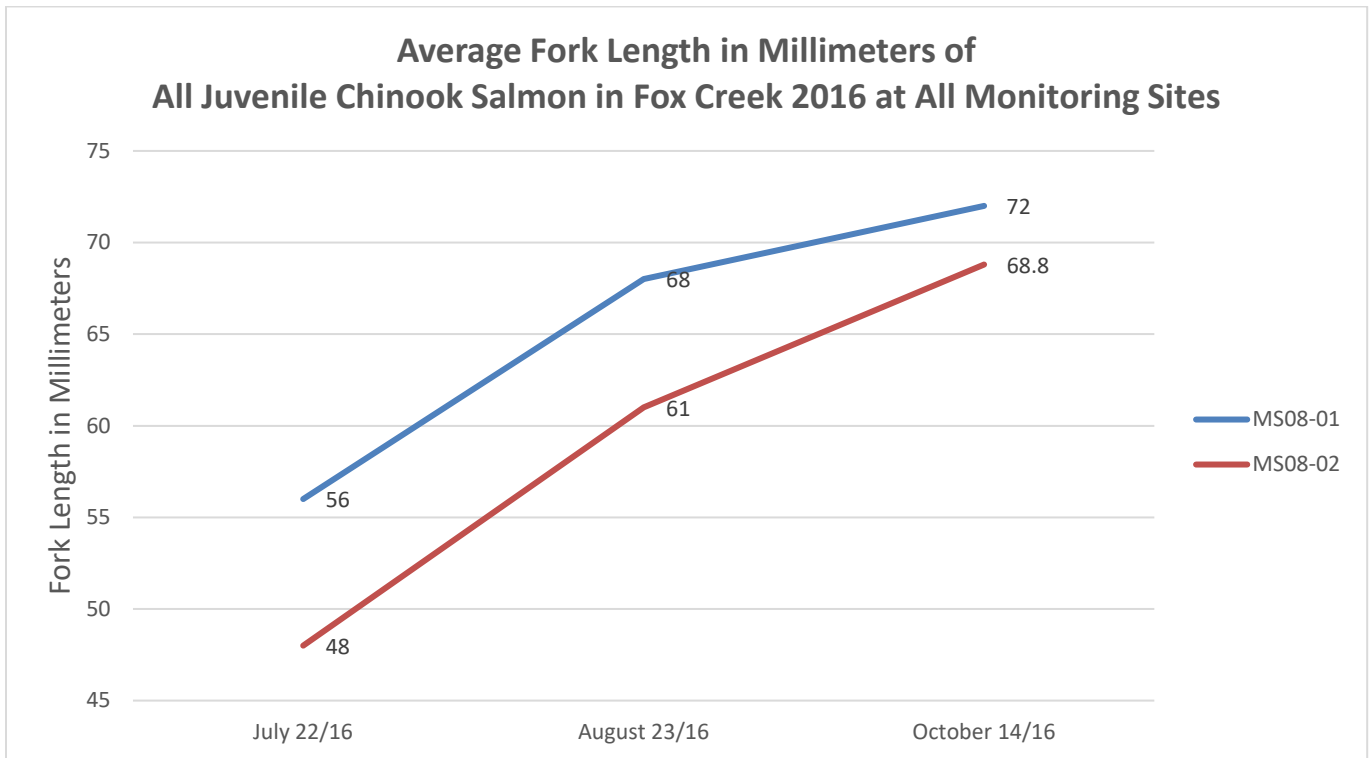
Figure 7 - In 2016, 35,000 Released at Site 2 and 10,000 at Site 1

On July 16, 2017 approximately 22,000 age 0+ salmon from the McIntyre Hatchery were released at MS08-02 and on July 21, 2017 approximately 11,000 were released at MS08-01. The latter group was composed of fish which had grown more slowly at the McIntyre Hatchery and needed more time to grow to a size where tags could be applied. Average Fork Lengths (FL) of juveniles captured in post-release sampling on July 26 reflect this: the average FL of age 0+ juveniles captured at MS08-01 was 3.84 mm less than those captured at MS08-02. However, by September 14 the average length of age 0+ juveniles captured at MS08-01 was 0.9 mm longer than at MS08-02, and by October 18 they averaged 4.3 mm longer. Growth per day, expressed as average increase in FL divided by number of days between sampling periods provides a good measure of growth that is, for juvenile salmon, independent of initial differences in length. In 2017 age 0+ juveniles at MS08-01 grew at an average of 0.2 mm/day between July 21 and October 18 and those at MS08-02 grew at an average of 0.12 mm/day. Growth rates calculated between July 22 and October 14, 2016 were identical to those in 2017. The lower growth rates calculated for juveniles released at MS08-02 probably reflect the greater number of fish released there in 2016 and 2017, and the resulting increased density of juveniles. These findings will guide our 2018 release strategy. See Figures 6 and 7.

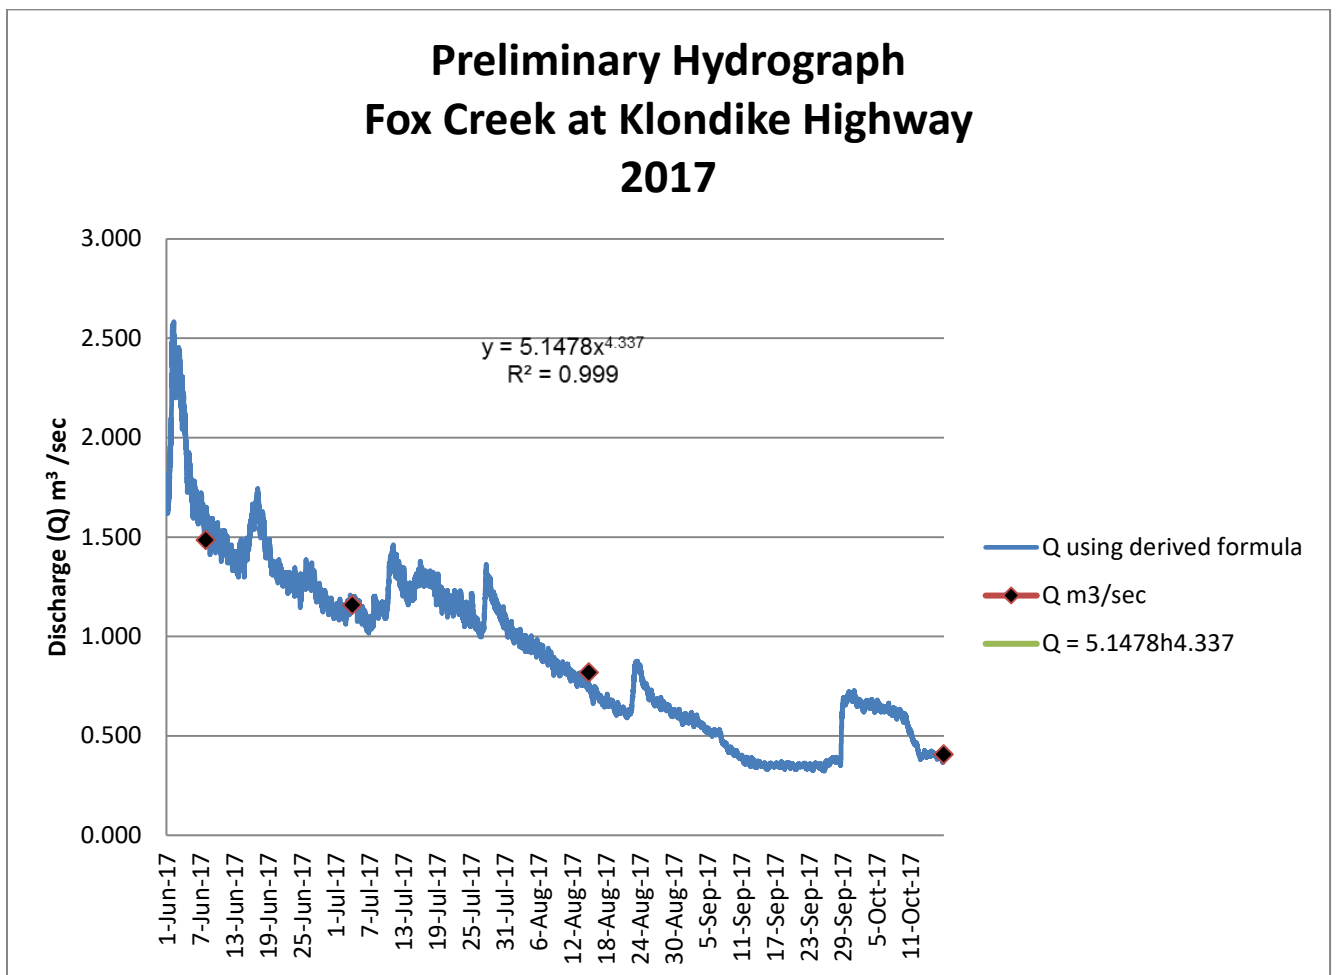
Figure 9 - Preliminary Hydrograph Fox Creek Hydrometric Station 2017

The installation took place on June 8th, 2017 and we conducted tandem discharge measurements with Laberge for comparison. We met again with Laberge on August 15th and October 17th to download the data loggers, conduct discharge measurements, and record staff gauge readings. Figures 9 and 10 below display preliminary Hydrograph and Rating Curve results.

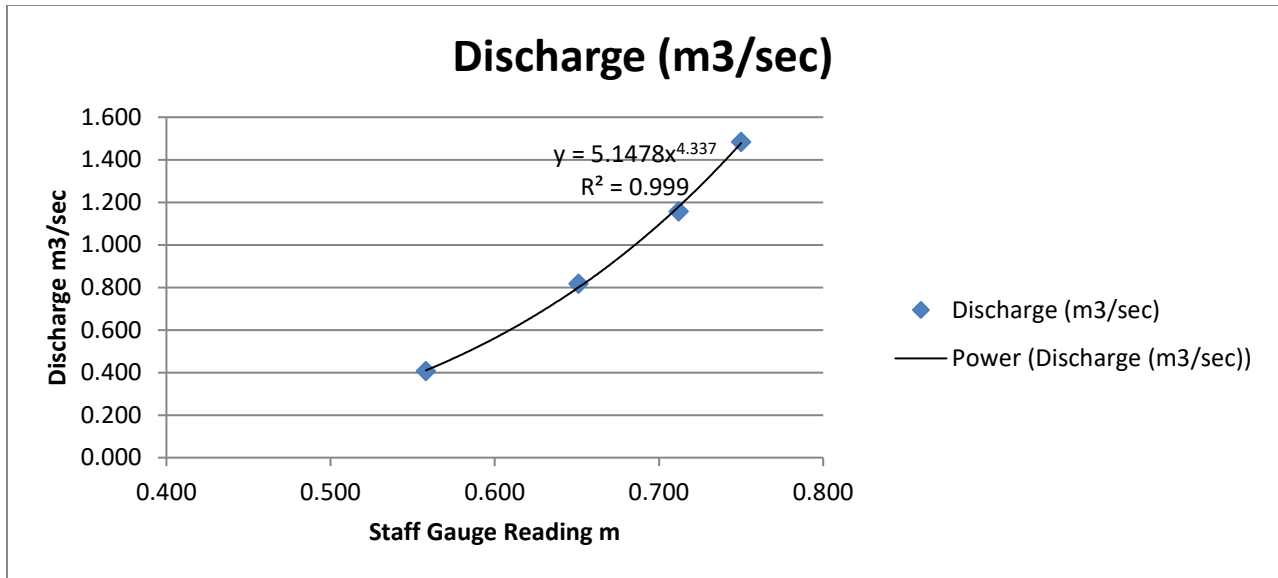
Figure 10 - Preliminary Rating Curve at Fox Creek Hydrometric Station 2017

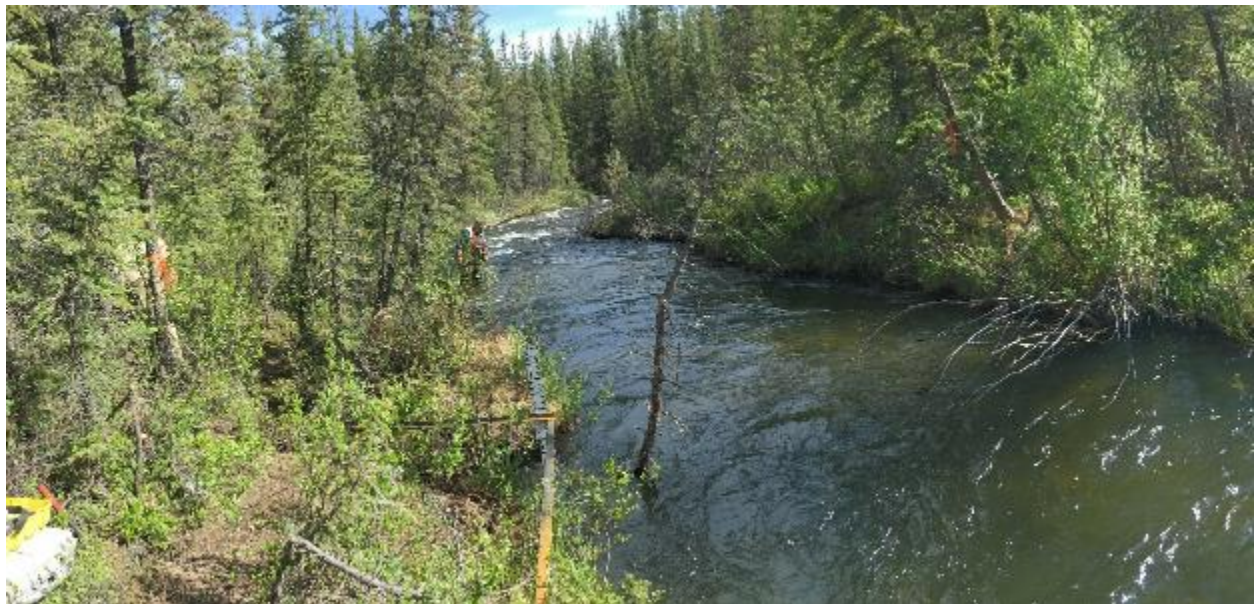
Figure 11 – Fox Creek Hydrometric Station after installation. June 8, 2017

As part of our Phase II Fox Creek Chinook Salmon Restoration Plan; TKC committed to install a hydrometric station, including a staff gauge in the 2017 operating year. The goal of the hydrometric station is to develop a rating curve over time. We contracted Laberge Environmental Services who worked with TKC staff members to install the station and record results throughout the 2017 field season.

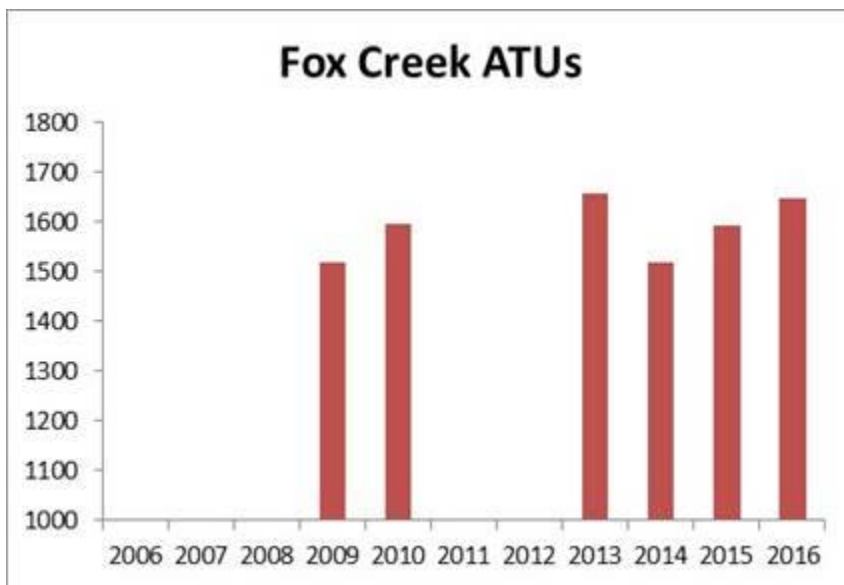
Figure 14: Fox Creek Annual Accumulated Thermal Units (ATU's) 2009 to 2016

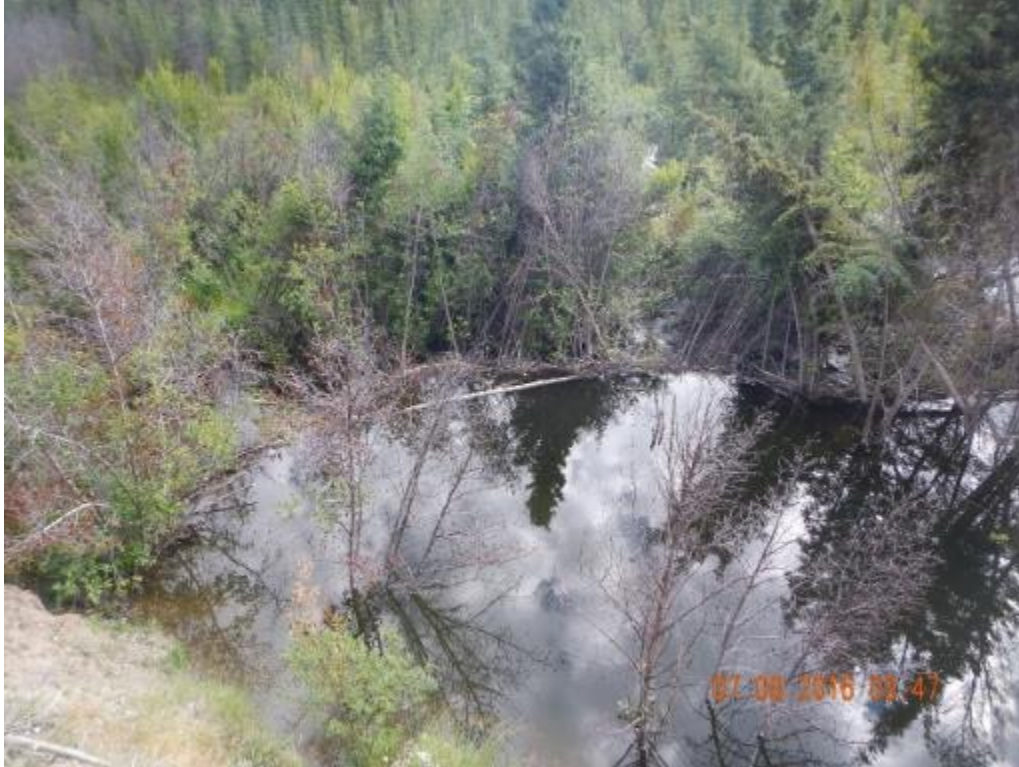
Figure 15: Large Beaver Dam (BD315) Barrier on Fox Creek 2017. Photo taken July 2016

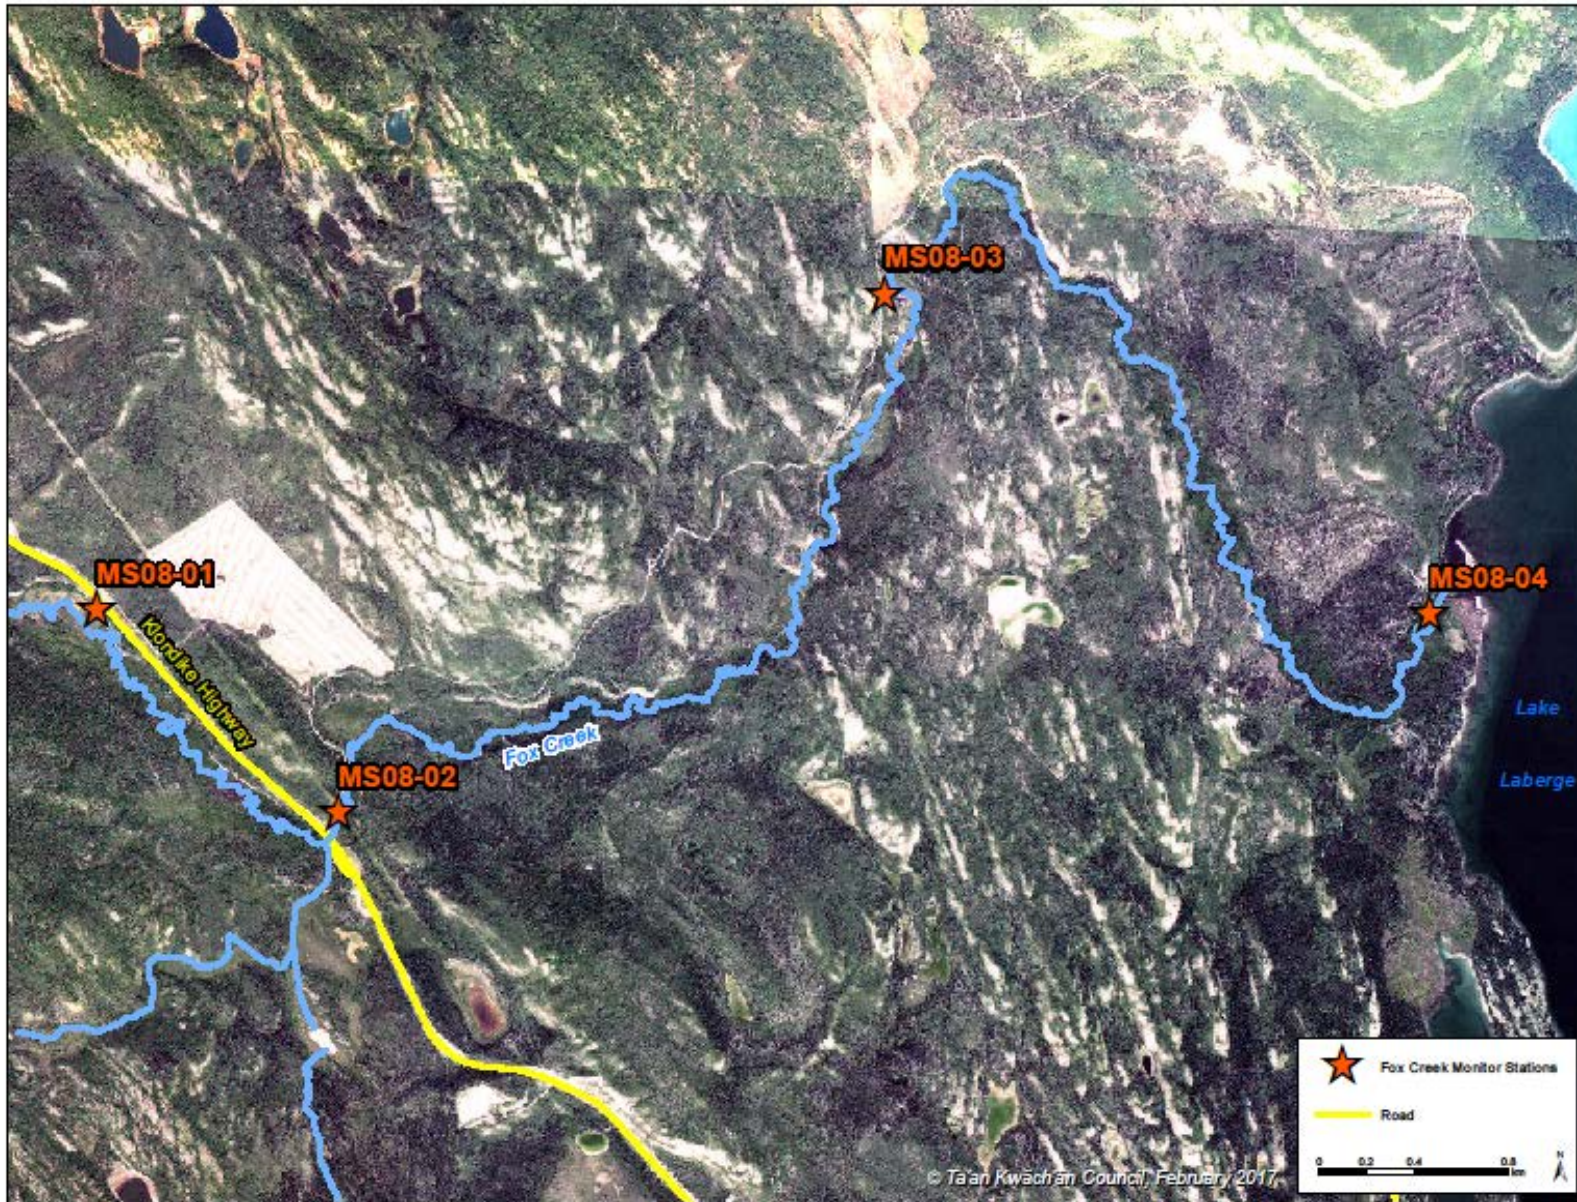
Figure 18: Fox Creek Juvenile Chinook Salmon Monitoring Stations

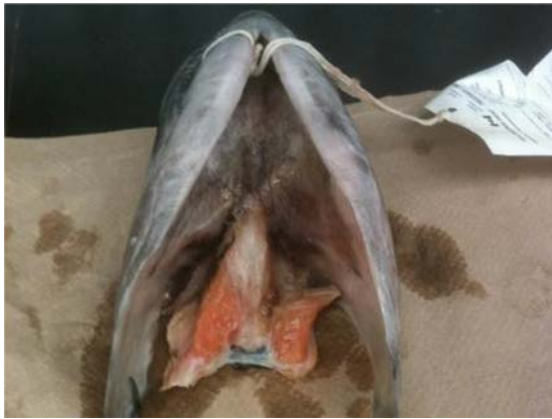
1. Head with excess flesh and gills removed

In some cases, during transport heads may thaw so it is important that all heads shipped to the Whitehorse office should have gills and any excess flesh removed to help slow the rotting process.

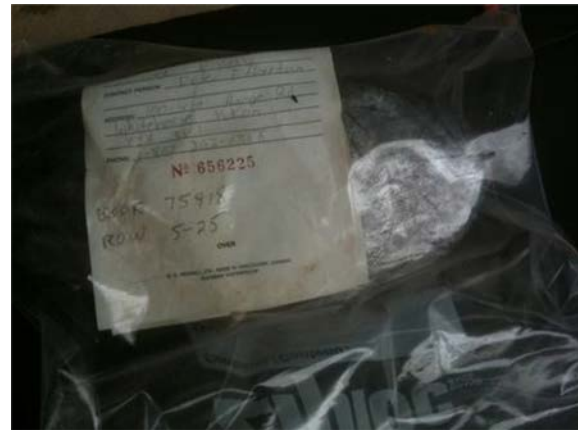
Figure 2. Properly packaged head

A jaw tag should be filled out (if applicable) using a pencil and attached to the jaw. In some cases, a jaw tag will be supplied to you that does not have a spot to fill out the required information. This makes it very important to ensure the jaw tag number is referenced in the dataset. The heads are stored in a communal freezer until shipped for analysis and if not labelled properly it will become hard (if not impossible) to identify them. If you do not have a jaw tag handy write down the required information on a piece of waterproof paper and slip it in with the head and tag.
