BLIND CREEK CHINOOK SALMON ENUMERATION WEIR, 2017

Prepared for: The Yukon River Panel  
Restoration and Enhancement Fund  
CRE-37-17

Prepared by: Jane Wilson

March, 2018

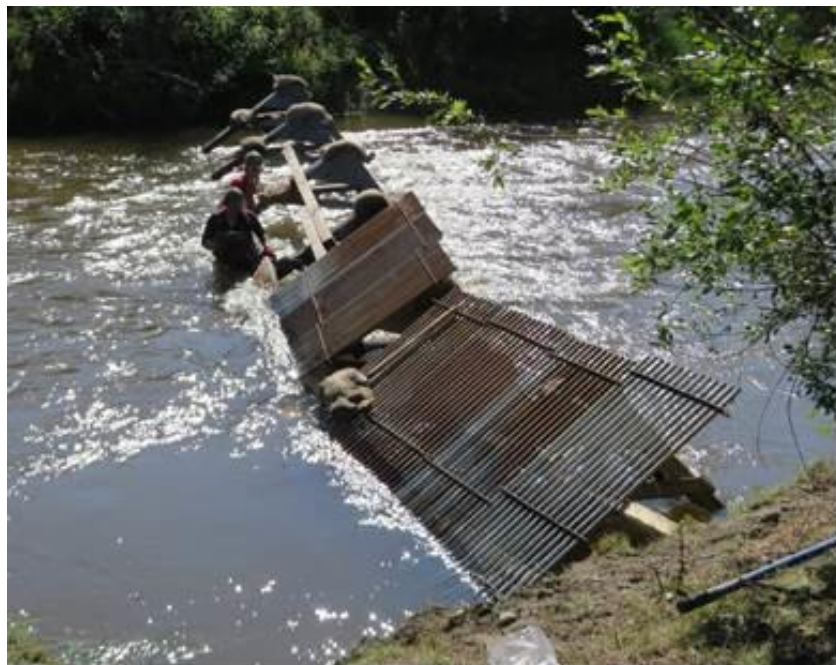
Materials used for construction of the weir were stored on site from the previous season's operation. The fence was constructed of conduit panels supported by tripods placed in a 'V' configuration to direct fish moving close to the bank towards the holding pen (Figure's 2 & 3). The holding pen was placed in the main current and at the upstream apex of the fence location. This pen consisted of conduit panels connected together to form an enclosure measuring 2m (L) X 0.7 m (W) X 1.0 m (H). Two triangular shaped conduit panels, each 2 metres long, were used to connect the pen to the fence and create a staging area for fish moving into the pen. Sand bags were placed along the bottom upstream side of the weir to prevent scouring of the creek substrate and undermining of the structure. A platform was placed alongside the holding pen to facilitate enumeration and biological sampling.

Figure 2. Weir under construction, July 24.

Weir construction was initiated on July 14 with the placement of a segment of the fence next to the right bank. Because of rising water conditions and strong midstream flows the entire

structure could not be completed at this time. Complete installation of the weir was delayed until July 24, after the water level had subsided. The weir was placed in the same area used for the past 14 years, approximately 1 km upstream of the creek mouth and 30 m downstream of the first bridge crossing.

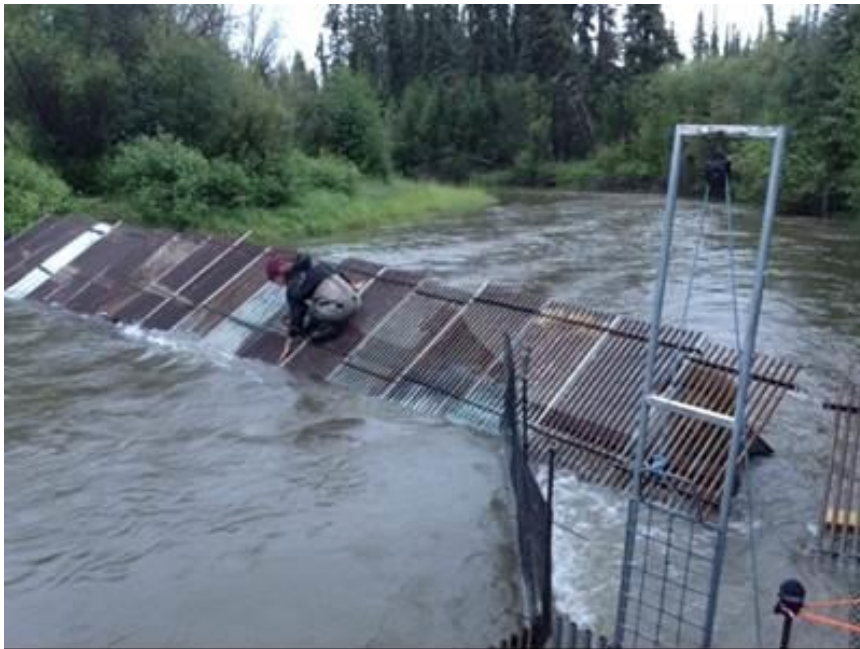
Figure 3. Weir in place, July 25.

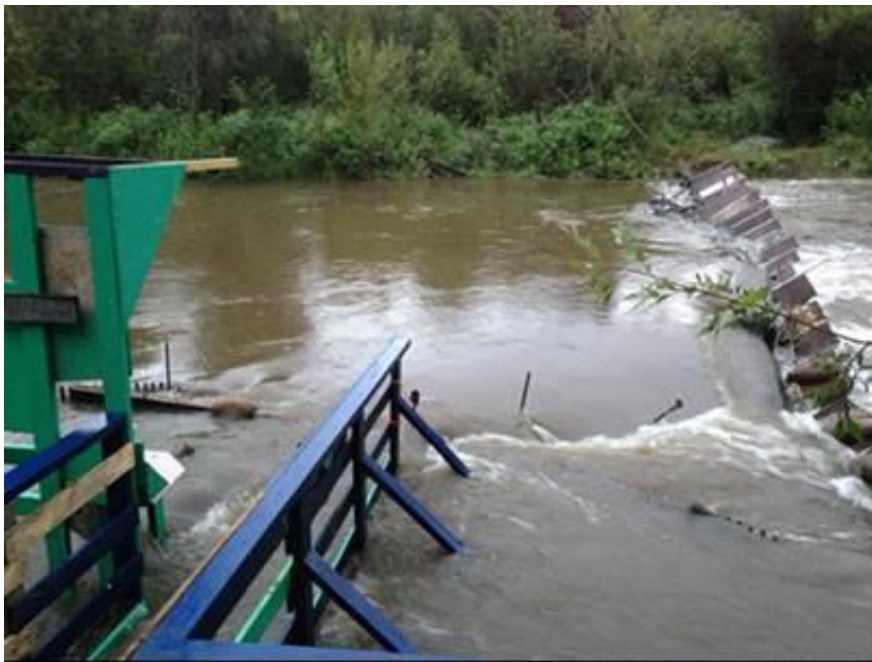
The weir was operational from July 24 to July 27. After heavy rainfall in the drainage the water level increased steadily reaching extreme flood conditions beginning July 28 (Figure 4). With rising water levels and increased turbidity weir operations were suspended and un-impeded fish passage was provided by the removal of the pen gates and weir panels next to each bank. Debris was removed from the fence structure until it became unsafe to do so. Water levels continued to rise with the eventual collapse of the weir structure on July 29 (Figure 5). The 2017 weir project was terminated at this time and the camp was dismantled August 1. The remaining weir material was removed from the creek on August 11 after water levels had receded.

Figure 3. Flood conditions, July 28.

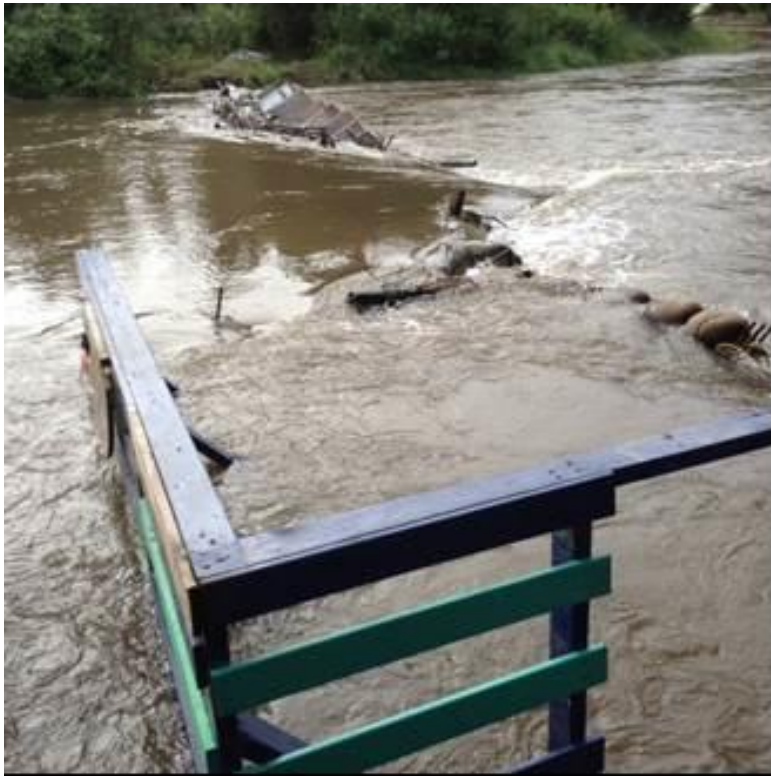
Figure 4. Collapse of fence structure, July 29.

The 2017 Blind Creek weir project objectives were not met due to the early collapse of the weir structure during extreme flood conditions. The majority of the weir panels are reusable; however several of the tripods were destroyed and will need to be replaced in the 2018 season. The 2017 project was the first time in 14 years of operation that the weir project has failed due to high water.

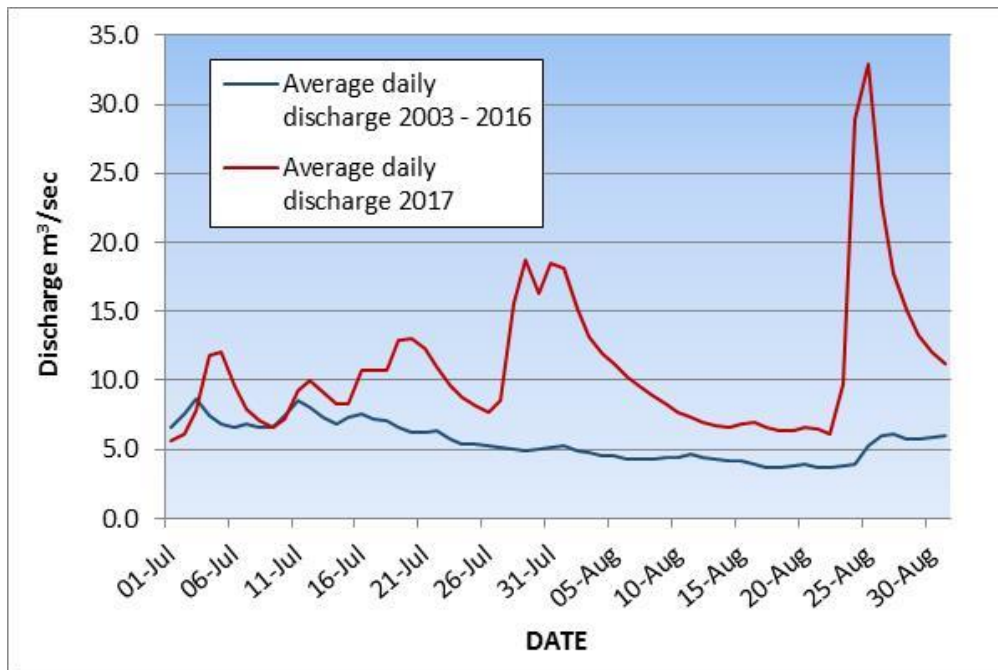
Daily discharge in Blind Creek during the Chinook run was above the average observed in previous years of weir operation (2003 – 2016) (Figure 5). Heavy rainfall in the drainage before and during the Chinook run in Blind Creek resulted in very high water levels and extremely murky water conditions. The mean, maximum and minimum discharge in July and August for the period 1992 to 2017 is presented in Appendix 4. Daily weather and water conditions recorded by weir attendants in July are presented in Appendix 5.

Figure 5. Mean daily discharge in Blind Creek, 2017 and 2003 – 2016. (data from: Environment Yukon, Water Resources Branch).
