**Klondike Area Central  
Incubation/Outplanting Facility**

Chandindu River Salmon Enumeration Weir  
Brood Stock Feasibility 1999

June 2, 2000

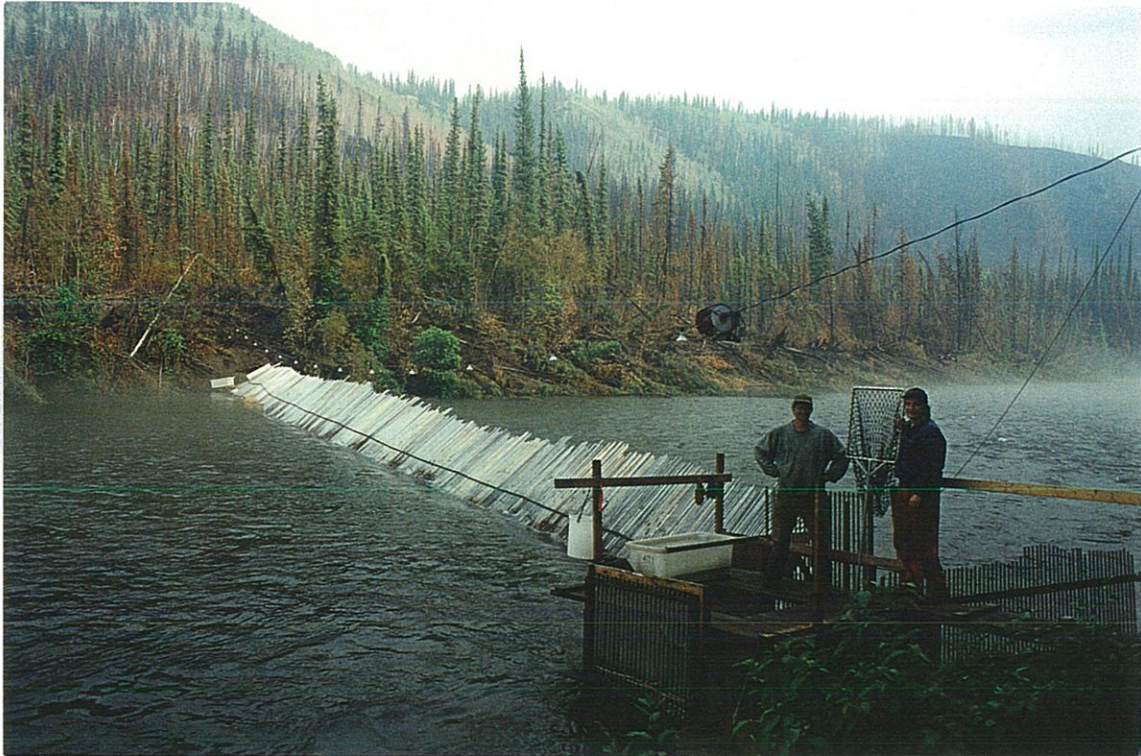
Above: Chandindu River Salmon Enumeration Weir 1999 (photo by Jody Cox)

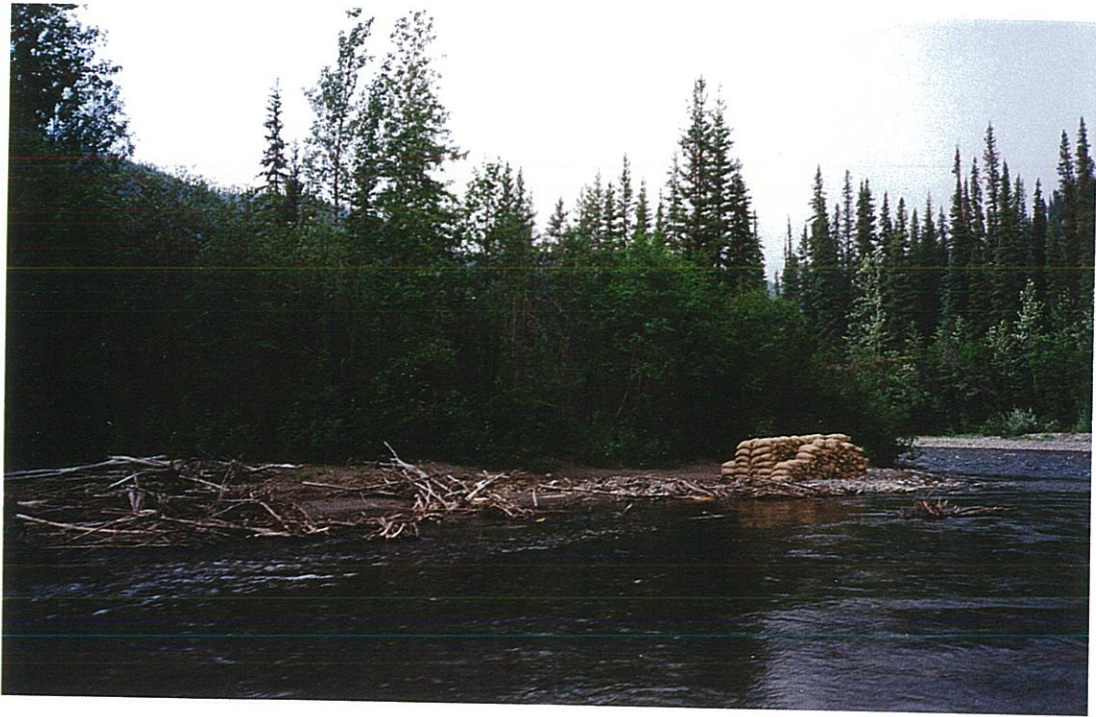
Photo 2

Above: Filling 400 Sandbags for the weir

Initially, the wall tent camp was erected, 400 sandbags were filled and moved on site, and the weir was installed from June 25th to June 30th (photos 2&3). The original start-up goal for weir operations was July 1st. This date had to be reconsidered after forest fires in the area, particularly Dawson District Fire No.11 (DA-011), flared up and became unmanageable.

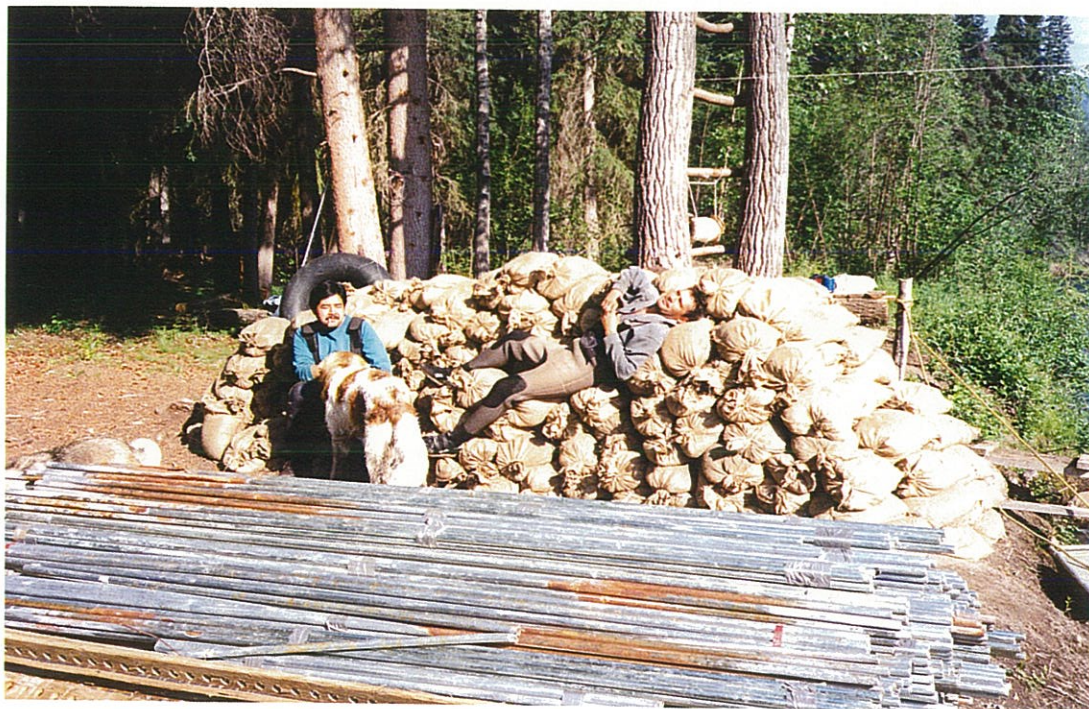
Photo 3

Above: The crew takes a break after getting the sandbags on site

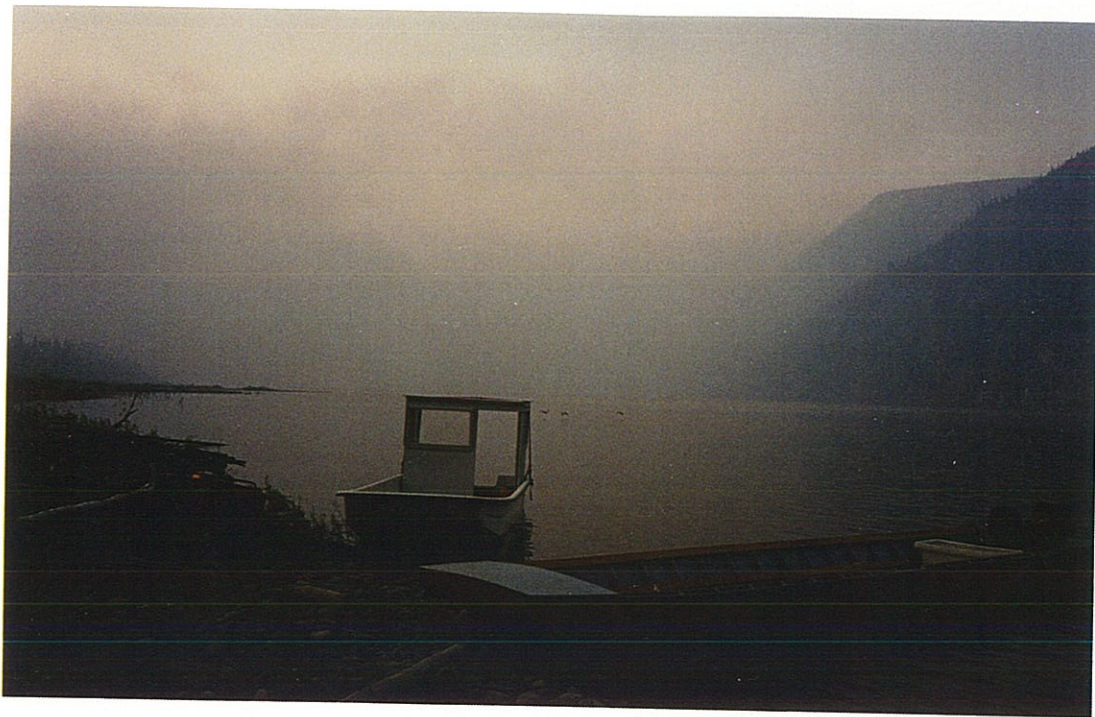
Photo 6

Above: Boats at landing readied for camp evacuation

It was decided on June 30th that the camp should be removed from the weir site and placed at the mouth of the Chandindu River due to the fire activity and extremely poor weather conditions which were aggravating the situation. A temporary camp was then set-up at the landing and trips to the weir were made twice daily to remove the extensive debris that was accumulating on it. Weir materials were stored underwater to protect them from fire damage. Large freighting boats were parked at the landing and readied for a quick evacuation (photo 6).

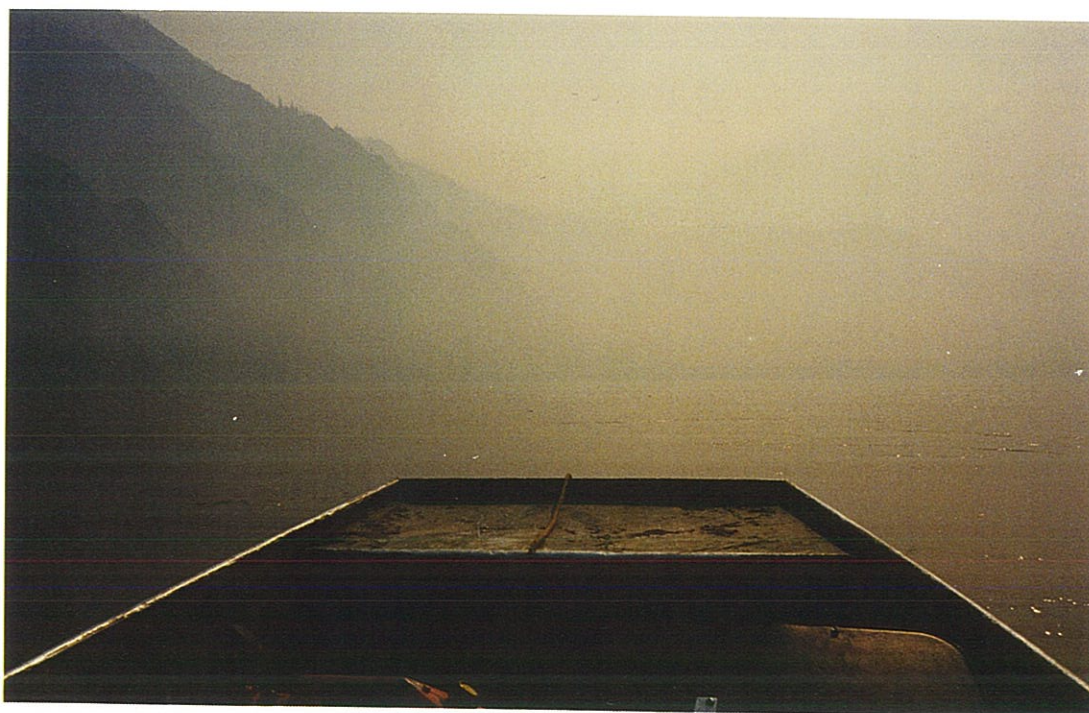
Photo 7

Above: Poor visibility on Yukon River during forest fires

Initial trips to the Chandindu River on the 16th of June were made difficult by poor visibility due to extreme smoke in the area from forest fires (photo 7). Concerns were raised at this time; particularly that the area of the Chandindu River valley near the weir might be threatened by Dawson District Forest Fire #11. Consultation with DIAND commenced and contingency plans were made. It was decided that a temporary camp should be erected at the Chandindu River landing and that camp materials, supplies and all fuel be stored there in the event that the forest fire became more of a threat.

By July 7th, Fire DA-011 had grown from 775 hectares to 12,000 hectares. At this time, the entire camp had been removed, but the weir remained in the river (photos 19-22). Trips from Dawson to the weir were made daily to clear accumulating debris. The cached equipment was checked on these trip as well. Smoke in the area was so thick at times that these daily trips were dangerous and sometimes impossible (photo 7).

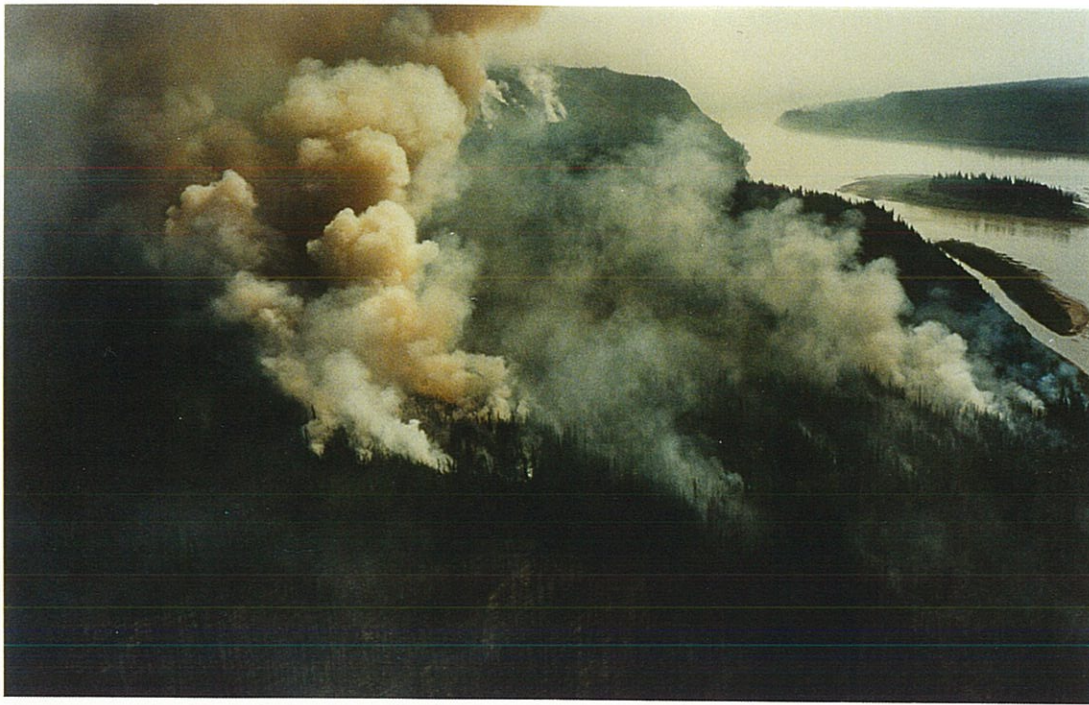
Photo 8

Above: Forest fires flaring up at the mouth of the Chandindu River

In the early morning hours of July 1st, Fire DA-011 grew dramatically (photos 8-13&23), burned the entire left bank of the lower Chandindu River and crossed over to the right bank approximately 1km above the weir site. The fire continued burning toward the mouth of the Chandindu River until it made its way to the Yukon River valley. By the end of the day the fire had burned all the way to the Fifteenmile River (Map 2).

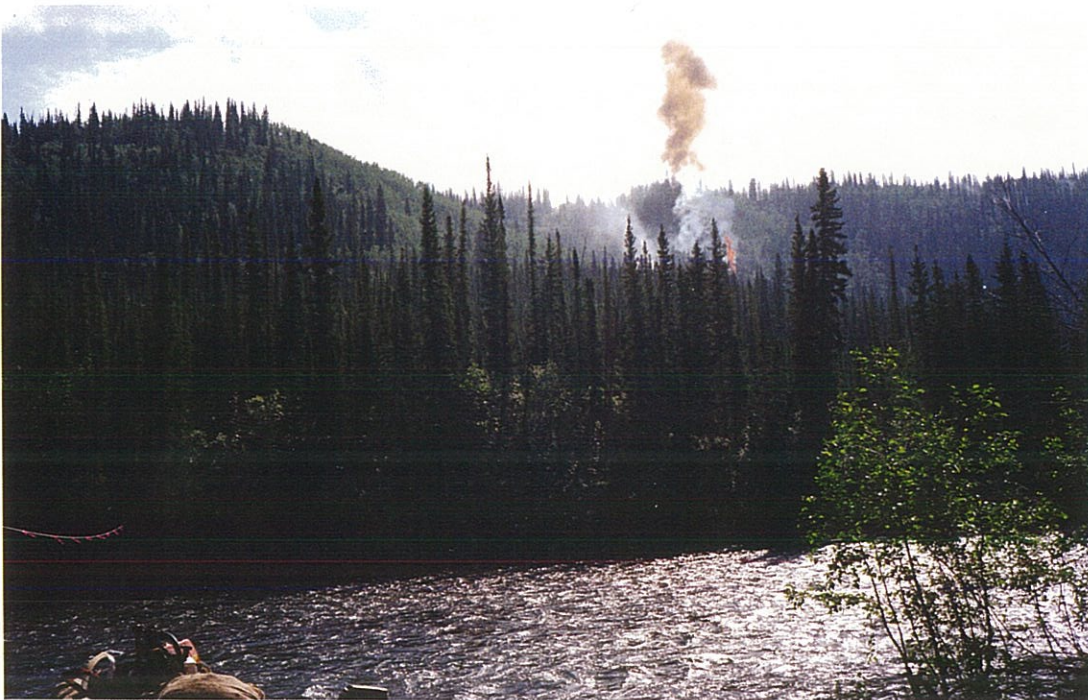
Photo 9

Above: Forest fire hot-spots across the river from the weir camp site

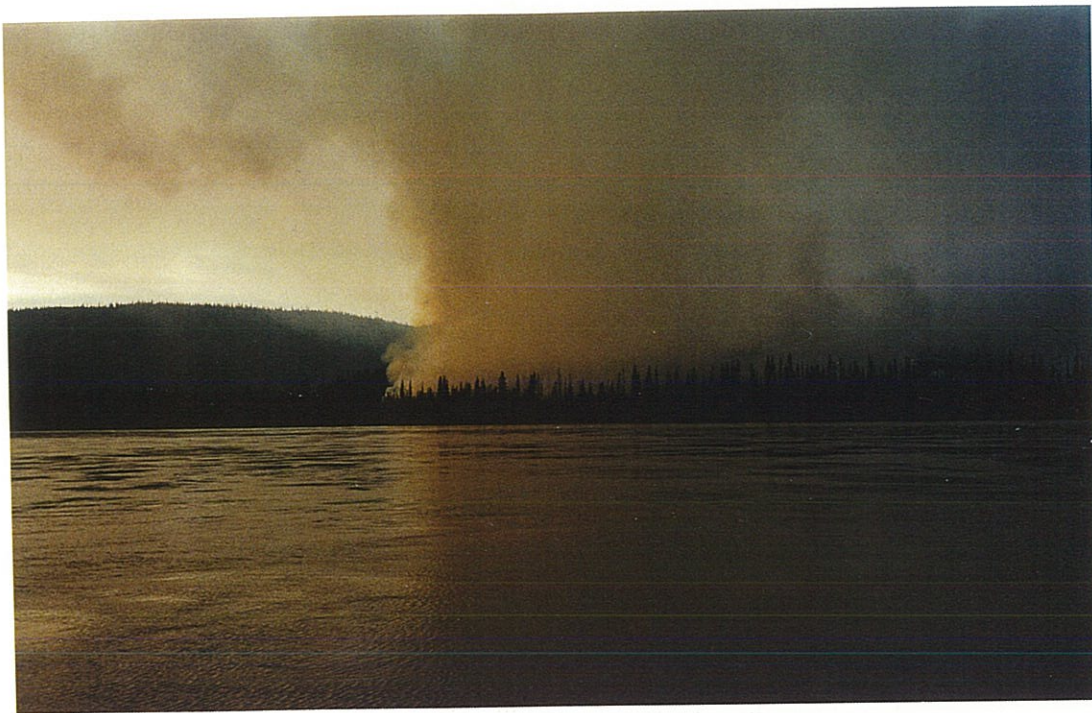
Photo 11

Above: Fires at the mouth of the Chandindu River

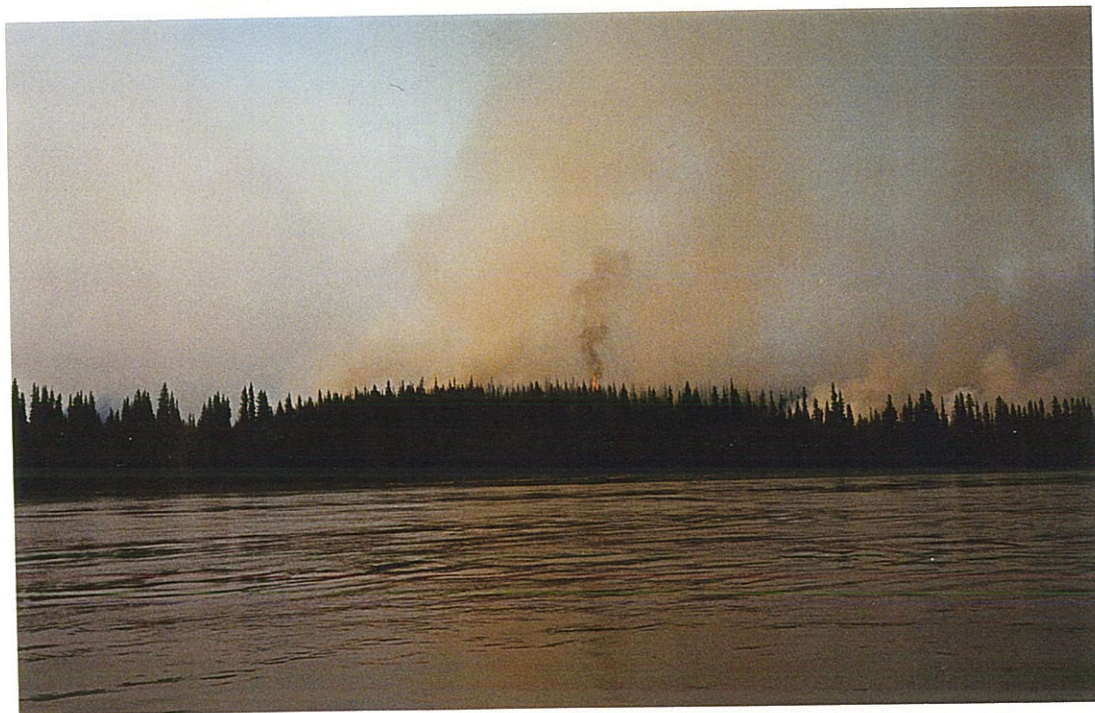
Photo 12

Above: Crowning forest fire at the mouth of the Chandindu River

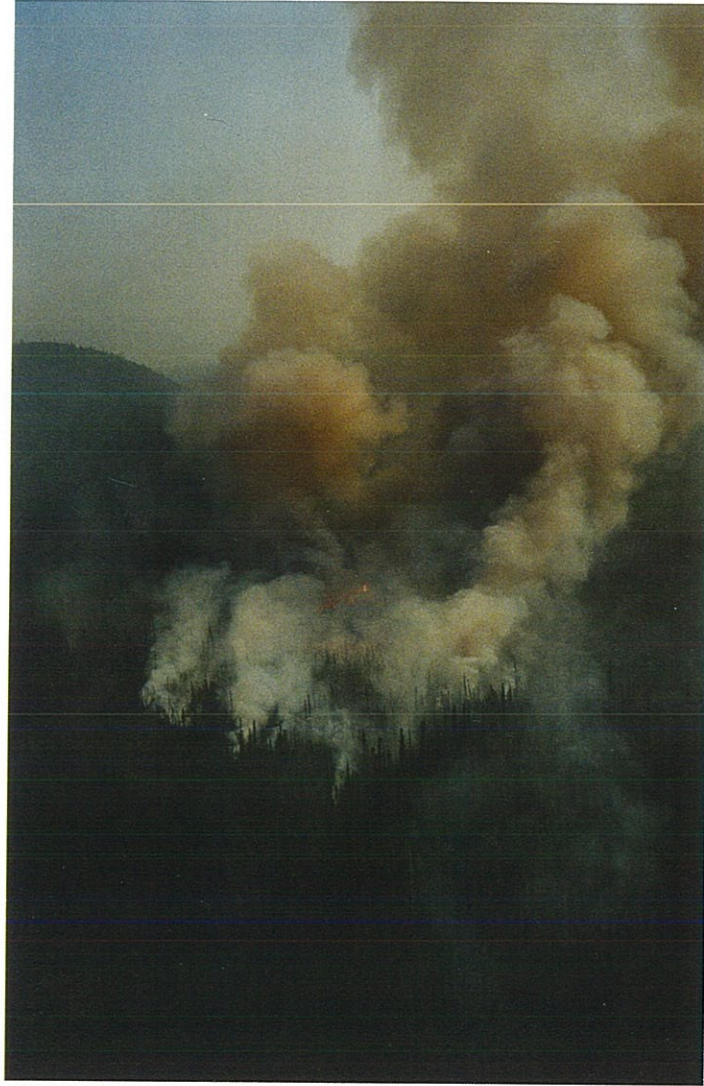
Photo 13

Above: Fire flaring up on hill by the weir site
