BLIND CREEK CHINOOK SALMON ENUMERATION WEIR, 2005

CRE-37-05

Prepared for the Yukon River Panel

March 2006

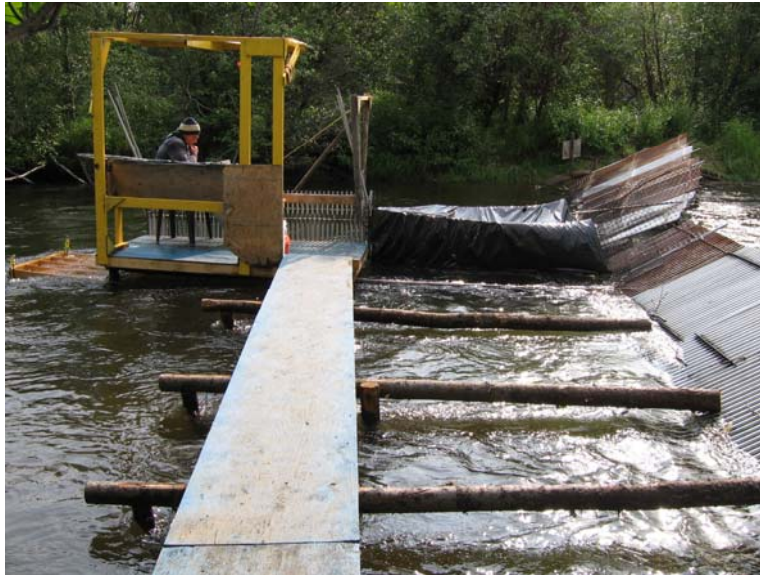
Figure 2. Weir and sampling station viewed from the north bank.

Construction of the weir began by the assembly of a counting chamber in the middle of the stream. This consisted of pre-fabricated panels of electrical conduit connected together to form an enclosure measuring 2 m (L) X 0.7 m (W) X 1.0 m (H). Wooden tripods were then placed downstream of the counting chamber in a 'V' configuration to direct fish moving close to the bank towards the counting chamber. Once in place, the tripods were joined together by wooden stringers to support the fencing panels. These panels consisted of 12, 3 meter long electrical conduit pieces that were strung vertically through four horizontal steel plates drilled with holes and welded to prevent movement. Panels were laid side by side against the weir supports and connected by inserting a loose conduit through an empty hole drilled at each end of the steel plates. The counting chamber was connected to the weir structure using two, 2 meter long conduit panels that were tapered to fit the weir panels. These were placed at each downstream corner of the pen and angled towards the weir to form a V-shaped staging area for fish moving into the counting chamber. A sheet of black poly was draped over the staging area to prevent disturbing fish.

After the panels were in place, sand bags were placed along the bottom upstream side of the weir to prevent scouring of the creek substrate and undermining of the structure. A white 'flashboard' was secured to the bottom of the counting chamber to improve visibility of salmon passing through. A platform was placed alongside the counting chamber for enumerating and sampling fish and accessed from the bank via a wooden walkway. See photograph in Figure 2 showing view of weir and sampling station.

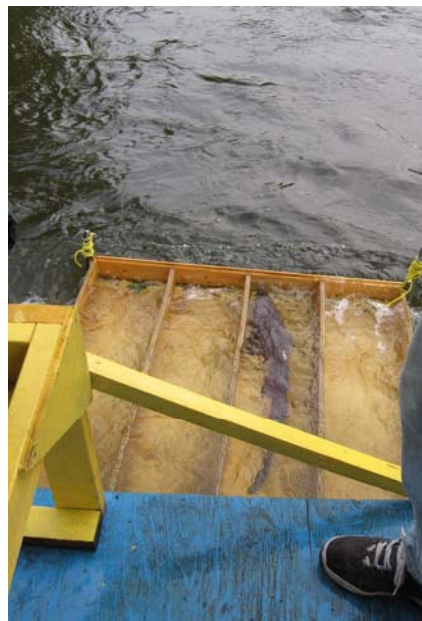
Figure 3. Chinook salmon resting in recovery chamber after sampling.

A container to hold fish for recovery from handling stress was placed immediately upstream of the sampling platform (Figure 3). This was constructed of plywood and consisted of four shallow chambers to support individual fish. The container was submerged just beneath the

surface level to allow some water to flow over the chambers. Once the fish regained its strength it could then swim over the top and continue upstream.

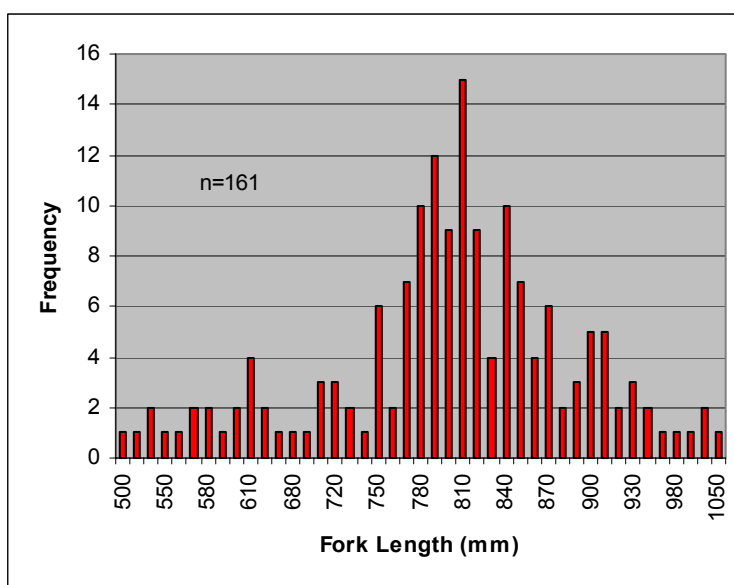
Figure 4. Length frequency of Blind Creek chinook sampled in 2005.

A total of 161 chinook was sampled for length, age and sex data (see Appendix 2). Tissue samples for DNA analysis were taken from 53 of the chinook sampled. Of the total sampled, 78 were female and 83 were males (including 18 jacks <630 mm (FL)). The median fork length for females was 820 mm and the range from 710 mm to 1020 mm. For adult males (>630 mm), the median fork length was 81 mm and the range from 640 mm to 1050 mm. Fork length frequencies of chinook sampled are shown in Figure 4. Age analysis of scale samples was not completed at the time of writing this report.

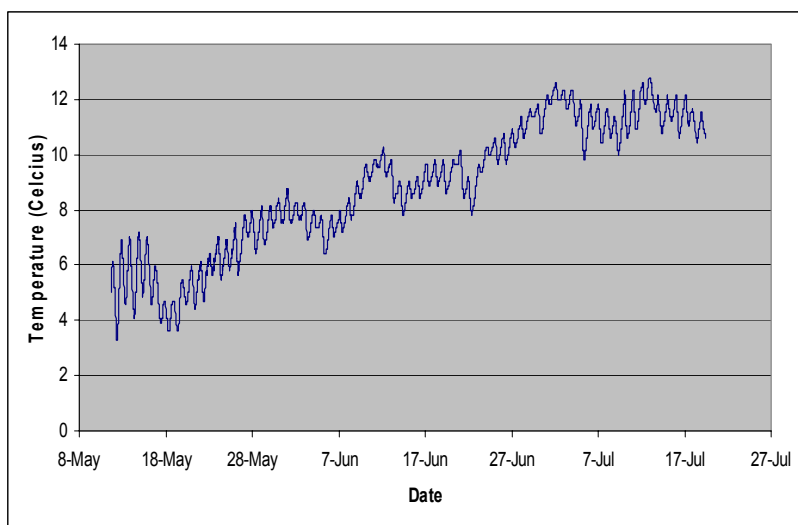
Figure 5. Water Temperatures in Blind Creek, May 11-July 19, 2005 (Water Survey of Canada Data).

Water temperatures recorded by Water Survey of Canada between May 11 and July 19 are illustrated in Figure 4. The maximum water temperature during this period was 12.8°C on July 13. Early morning temperatures recorded between July 15 and August 15, using a thermometer, ranged from 9°C to 12°C (see Appendix 3).
