2009 Klondike River DIDSON Sonar

CRE-16-09

Prepared For: The Yukon River Panel

March 2010

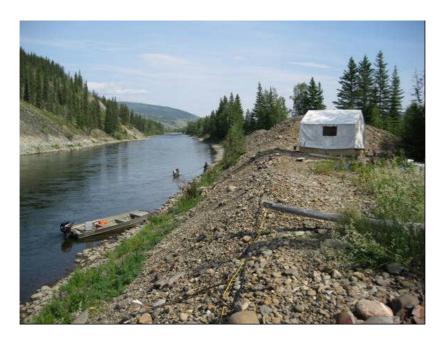
Figure 3. Klondike River sonar station camp, looking upstream.

Construction of the camp and sonar station was initiated on July 5. All supplies and equipment were transported by truck from Whitehorse to Dawson City. The camp was located 15 m from the south bank of the river and comprised of a single wall tent which served as living quarters and computer station. (Figure 3).

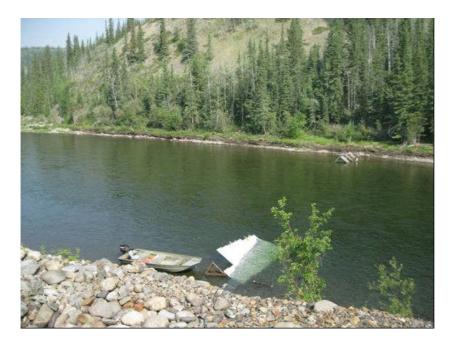
Figure 4. Partial weir structures in place at the Klondike River sonar station, 2009.

Construction of partial weirs on either side of the river to divert shoreline migrating Chinook salmon into the mid section of the river was initiated on July 6 and completed by July 7. The weir materials were moved and installed using a jet boat. Prefabricated panels of electrical conduit were placed on the tripod structures to create the diversion fence in the deeper sections of the river (Figure 4). Light activated flashing beacon lights were secured to each diversion fence to mark the in-stream extent of weirs. A warning sign was also posted 200 m upstream of the station to alert boaters of the partial obstruction in accordance with Transport Canada, Navigable Waters Protection requirements.

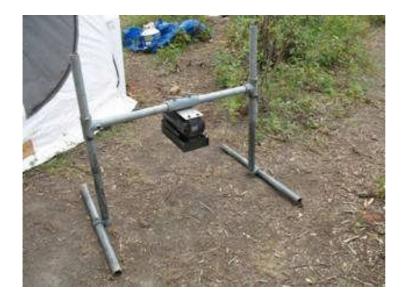
Figure 5. Sonar transducer unit and mounting stand.

The set up and configuration of the DIDSON sonar unit was similar to that used for the Big Salmon River project (Mercer and Wilson 2009). The unit was mounted on an adjustable stand constructed of 2-inch, schedule 80 steel pipe. The stand consisted of two T-shaped legs 120 cm in height connected by a 90 cm crossbar (Figure 5). The sonar unit was bolted to a steel plate suspended from the cross bar that was connected to the stand with adjustable fittings (Kee Klamps™). The adjustable clamps allowed the sonar unit to be raised or lowered according to fluctuating water levels as well as enabling rotation of the transducer lens to adjust the beam direction.

The mounted sonar unit and stand was placed next to the south bank immediately upstream of the diversion fence in approximately 0.8 m of water (Figure 5). The "feet" of the stand were secured to the stream bottom using sandbags. A 6 mm stainless steel safety cable was affixed to the sonar unit and fastened to a buried anchor onshore.

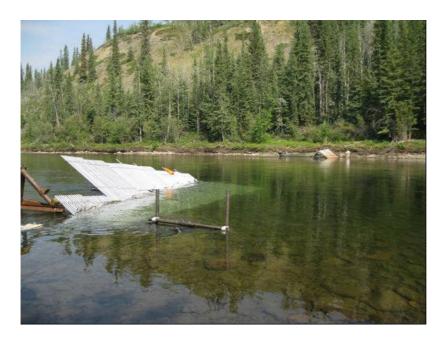
Figure 6. DIDSON sonar in position at the Klondike River sonar site, 2009.

The DIDSON sonar produces an ensonified field 29° wide in the horizontal plane and with the concentrator lens, 8° deep in the vertical plane. The DIDSON transducer lens was positioned to a depth of approximately 12 cm below the surface of the river and angled downward approximately 3° from horizontal, which resulted in the ensonified field of view remaining parallel to the surface of the river (Figure 6).
