**CHINOOK SALMON HABITAT ASSESSMENT AND RESTORATION
ENHANCEMENT POSSIBILITIES FOR SELECTED TRIBUTARIES OF THE
PELLY RIVER IN THE VICINITY OF PELLY CROSSING, 1998.**
(Needlerock, Mica, Willow and Grayling Creeks)

The Yukon River Panel

Jane Wilson & Associates

December, 1999

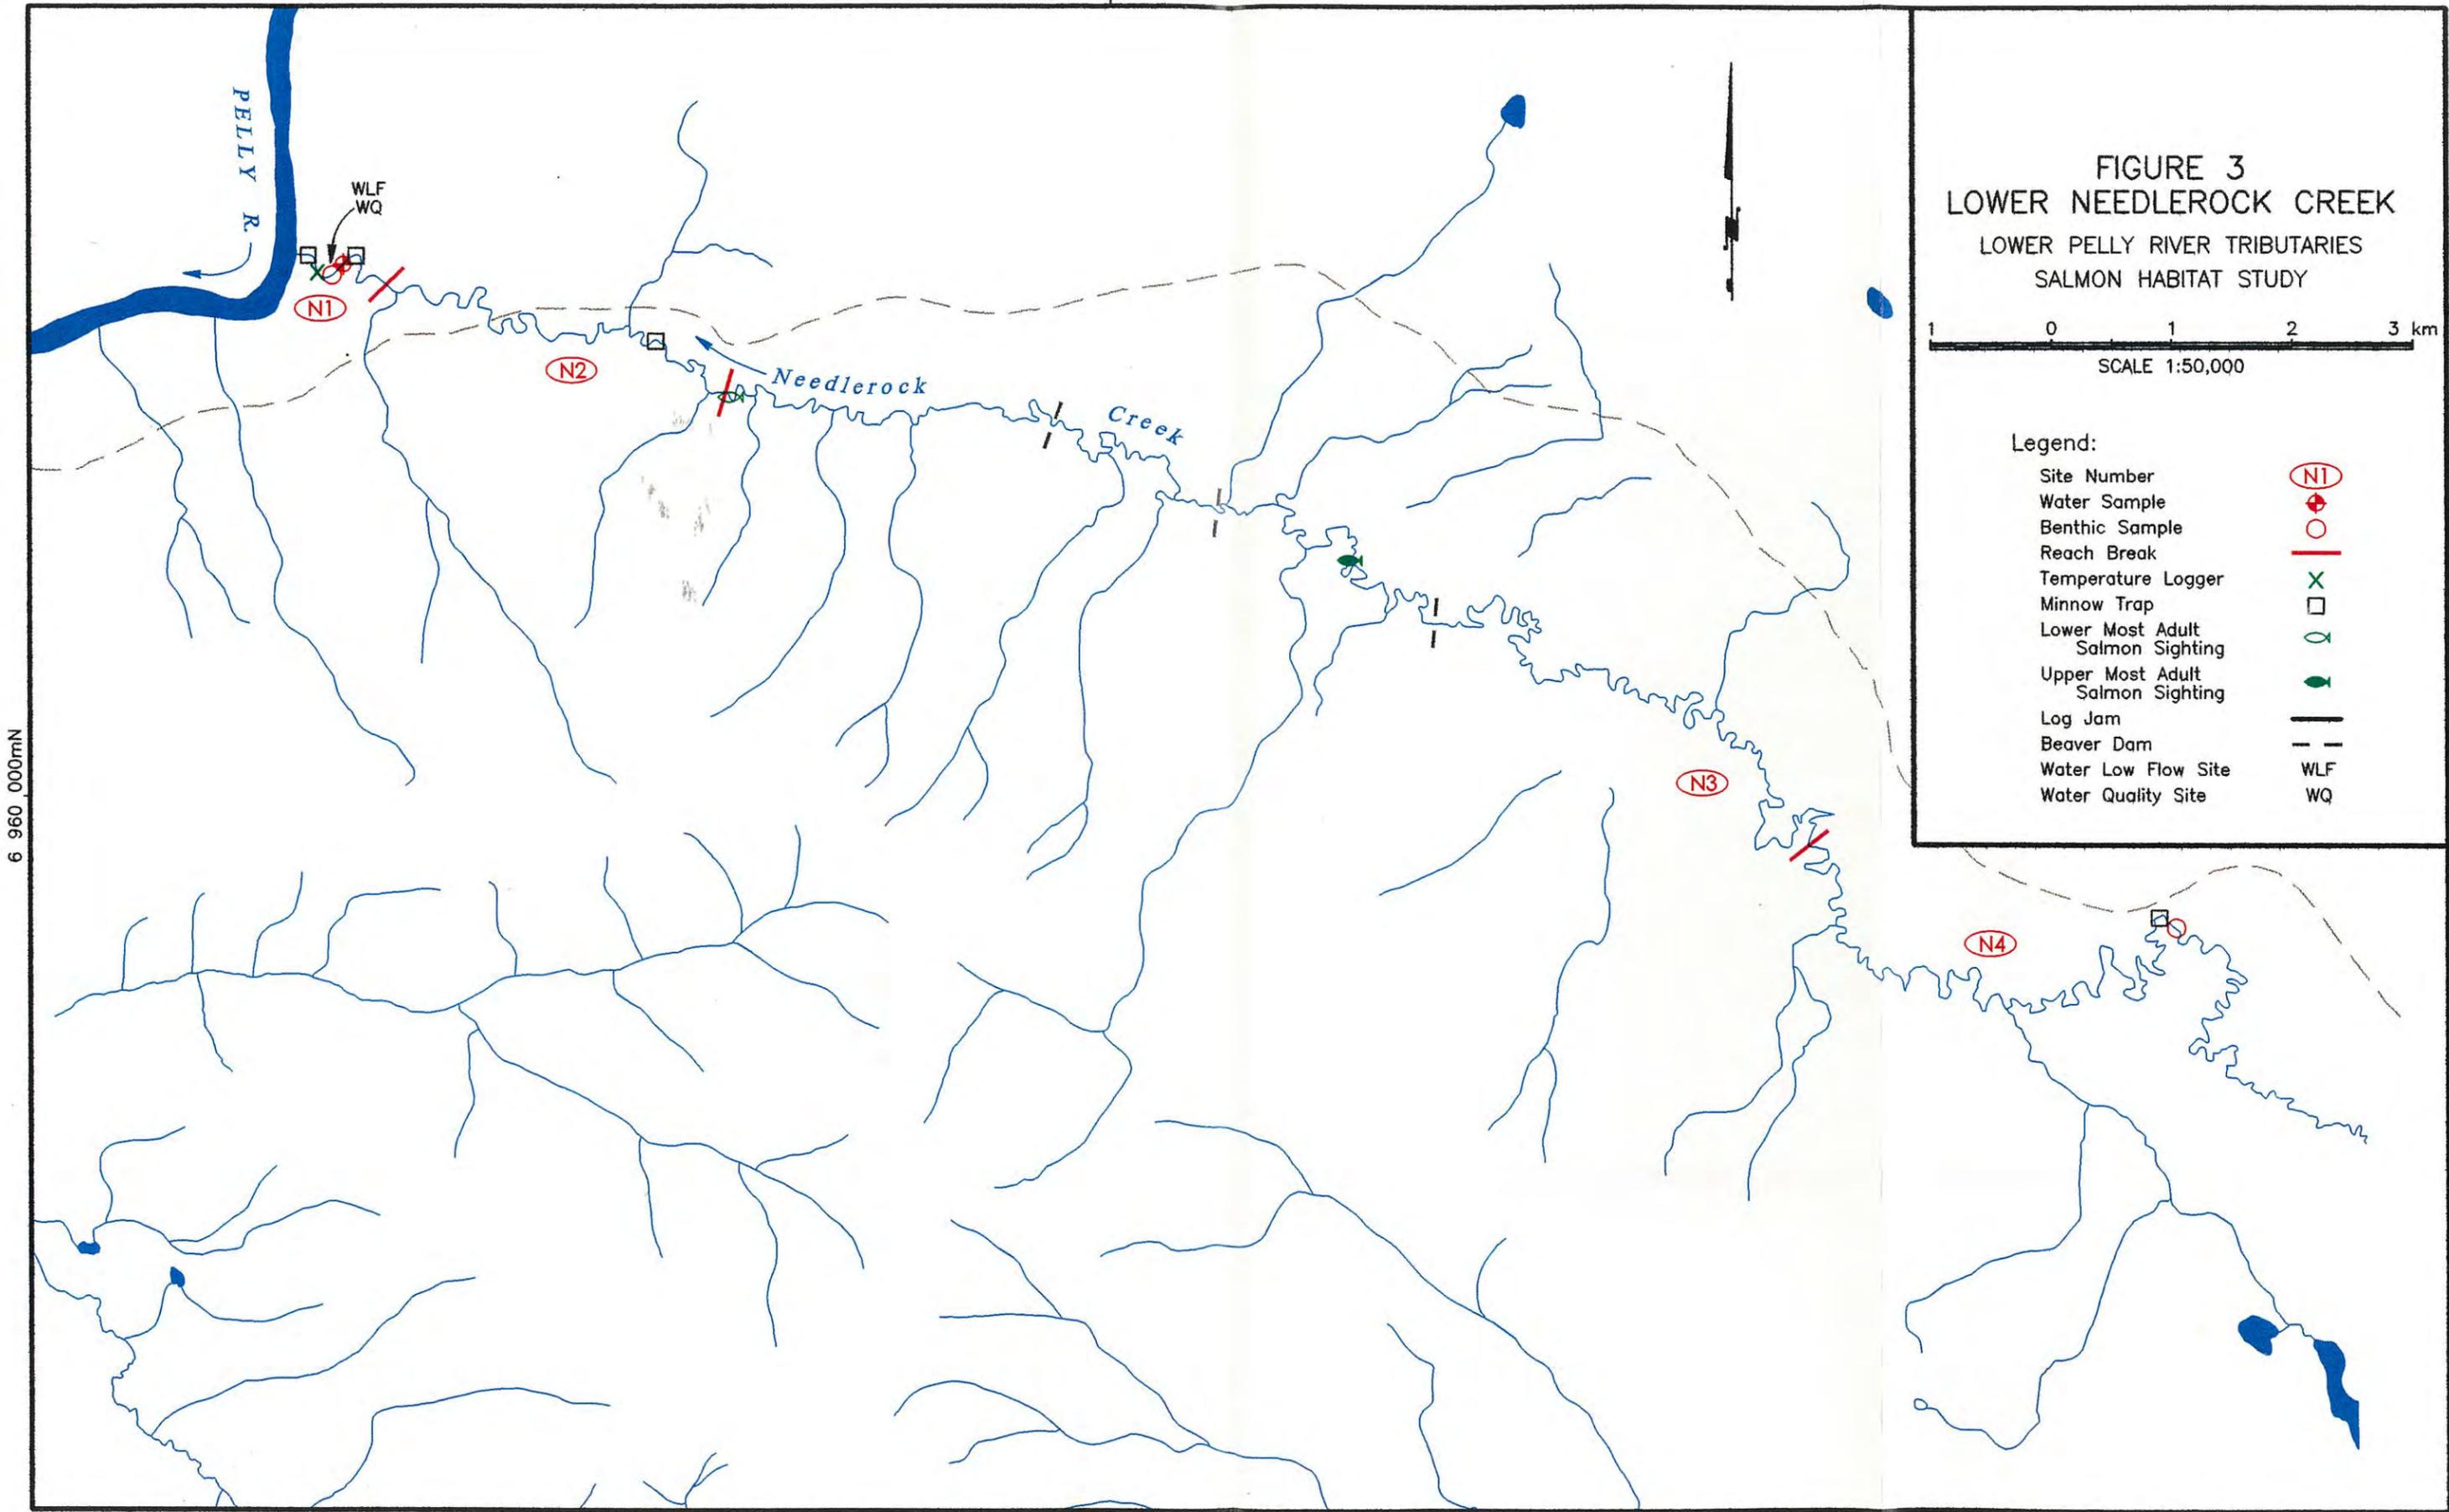
FIGURE 3
LOWER NEEDLEROCK CREEK
 LOWER PELLY RIVER TRIBUTARIES
 SALMON HABITAT STUDY

A total of 26 adult chinook salmon and three carcasses was observed in Needlerock Creek during an aerial survey conducted on August 26, 1998; all within a 6 km (straight line) stretch above the winter road crossing (Fig. 3). During the ground survey, eight adult chinook were observed migrating upstream at the winter road crossing. A few small beaver dams were observed in this area, however they did not impede migration. No adult chinook were observed above a beaver dam located at GPS 6246952N 13602400W, however it is uncertain if it was a barrier to migration. In the area above this dam, fewer large spruce stands were noted adjacent to the creek and willow/alder shrubs generally predominated.

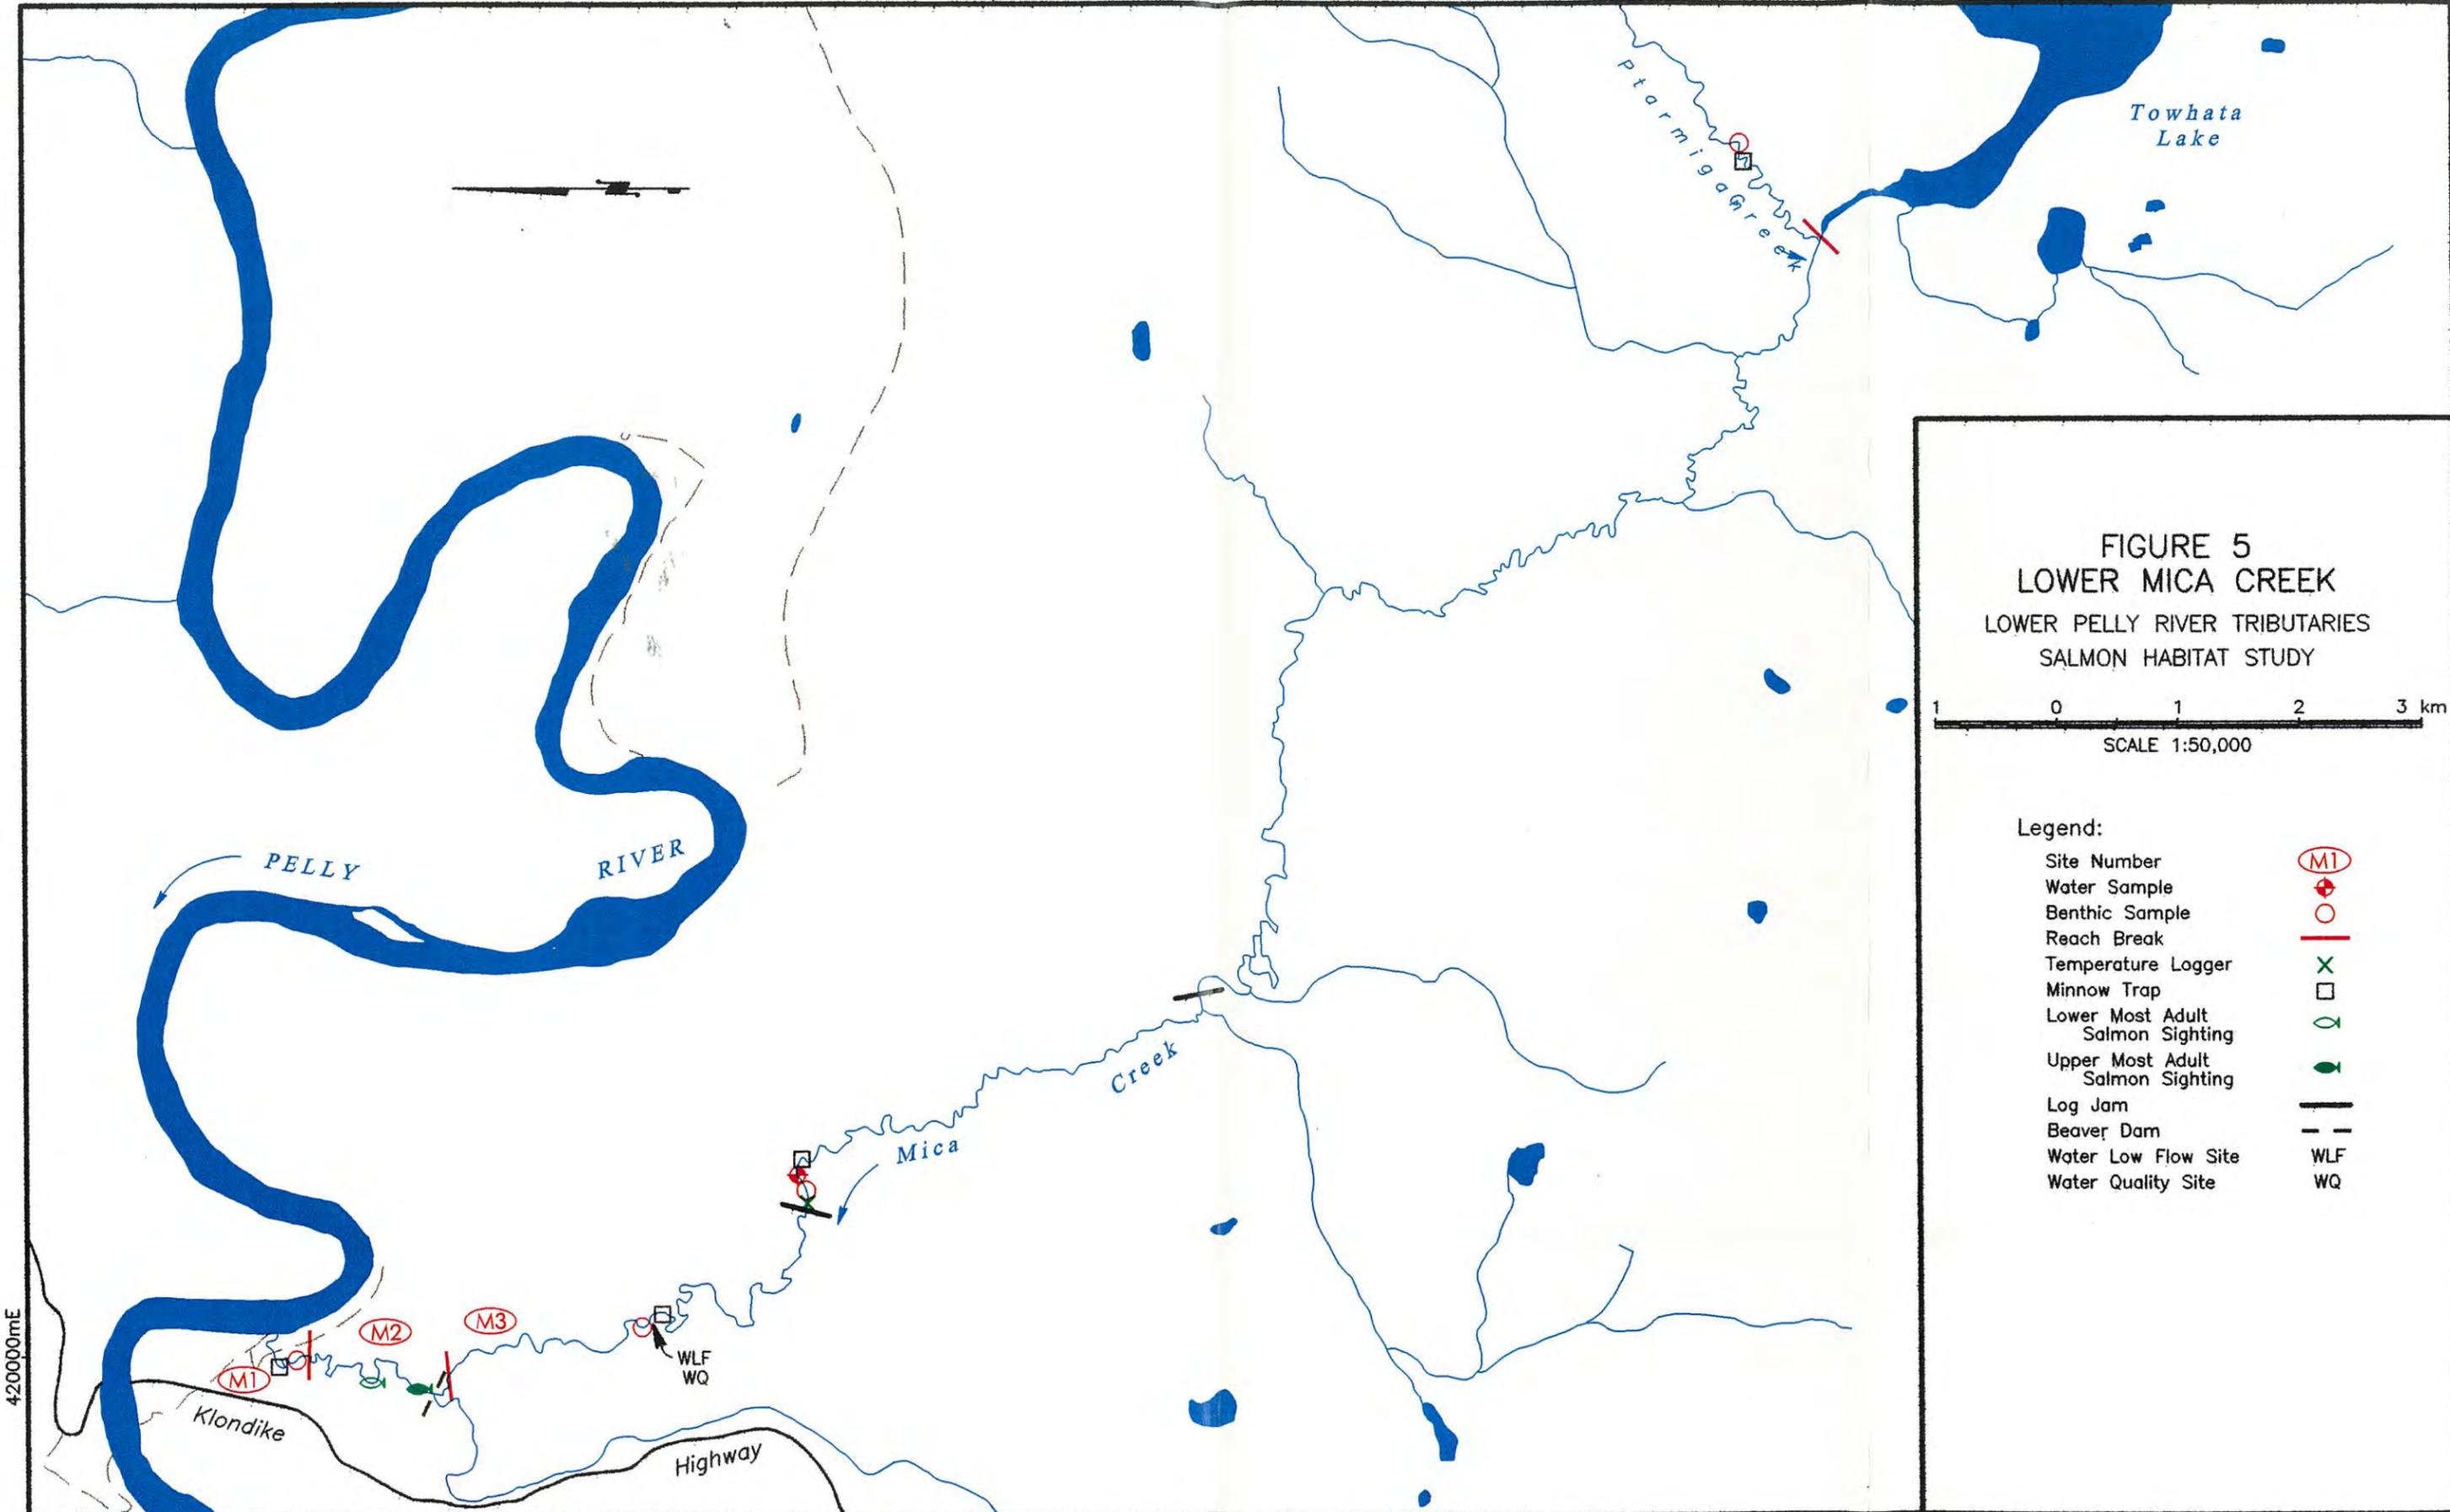
FIGURE 5
LOWER MICA CREEK
 LOWER PELLY RIVER TRIBUTARIES
 SALMON HABITAT STUDY

A total of 17 adult chinook salmon was observed in Mica Creek during an aerial survey conducted on August 26, 1998; all observed within a short distance below a beaver dam located approximately 1 km upstream of the mouth (Fig. 5).

Two very large logjams were observed below Towhata Lake, during the aerial survey (Fig. 5). In the past these logjams have not obstructed migration of chinook salmon, however they could be cut through to allow easier passage for chinook spawning migrating to sites upstream. Care must be taken in the removal of any part of a logjam as large releases of water and displacement of logs could cause damage to the habitat downstream. The Department of Fisheries and Oceans should be consulted before a logjam removal project is initiated.

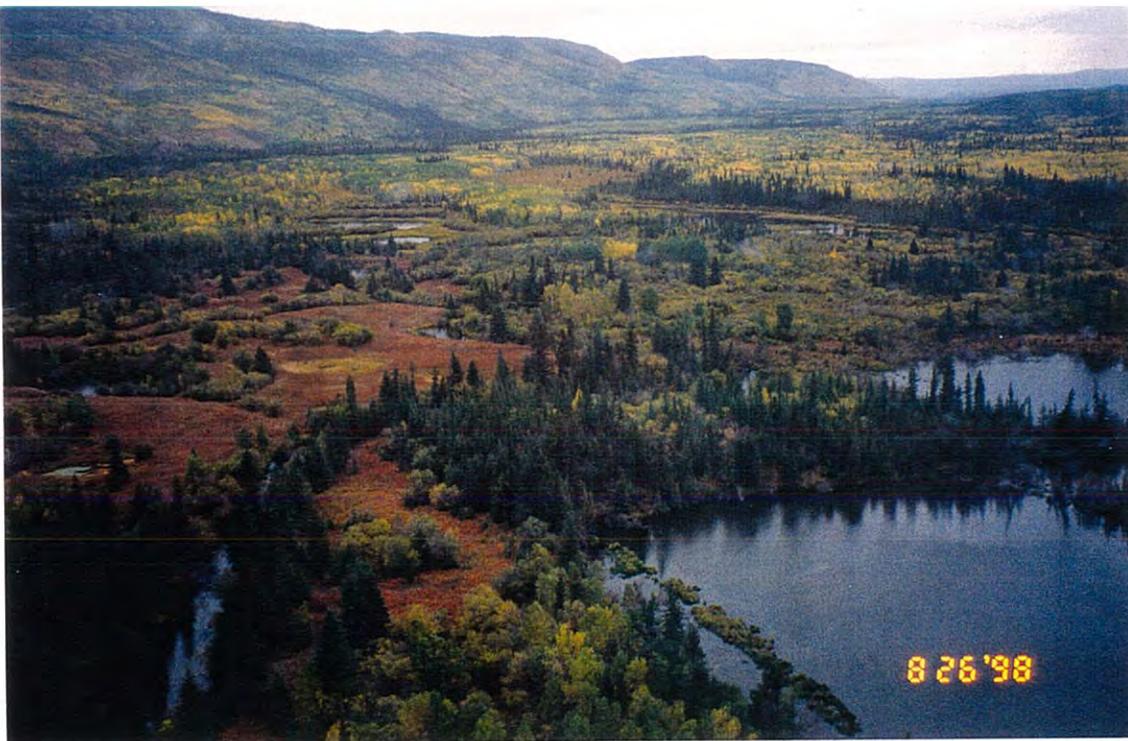
Photo 10. View of low flat valley above Towhata Lake. Mica Creek enters Towhata Lake upper right of photo.

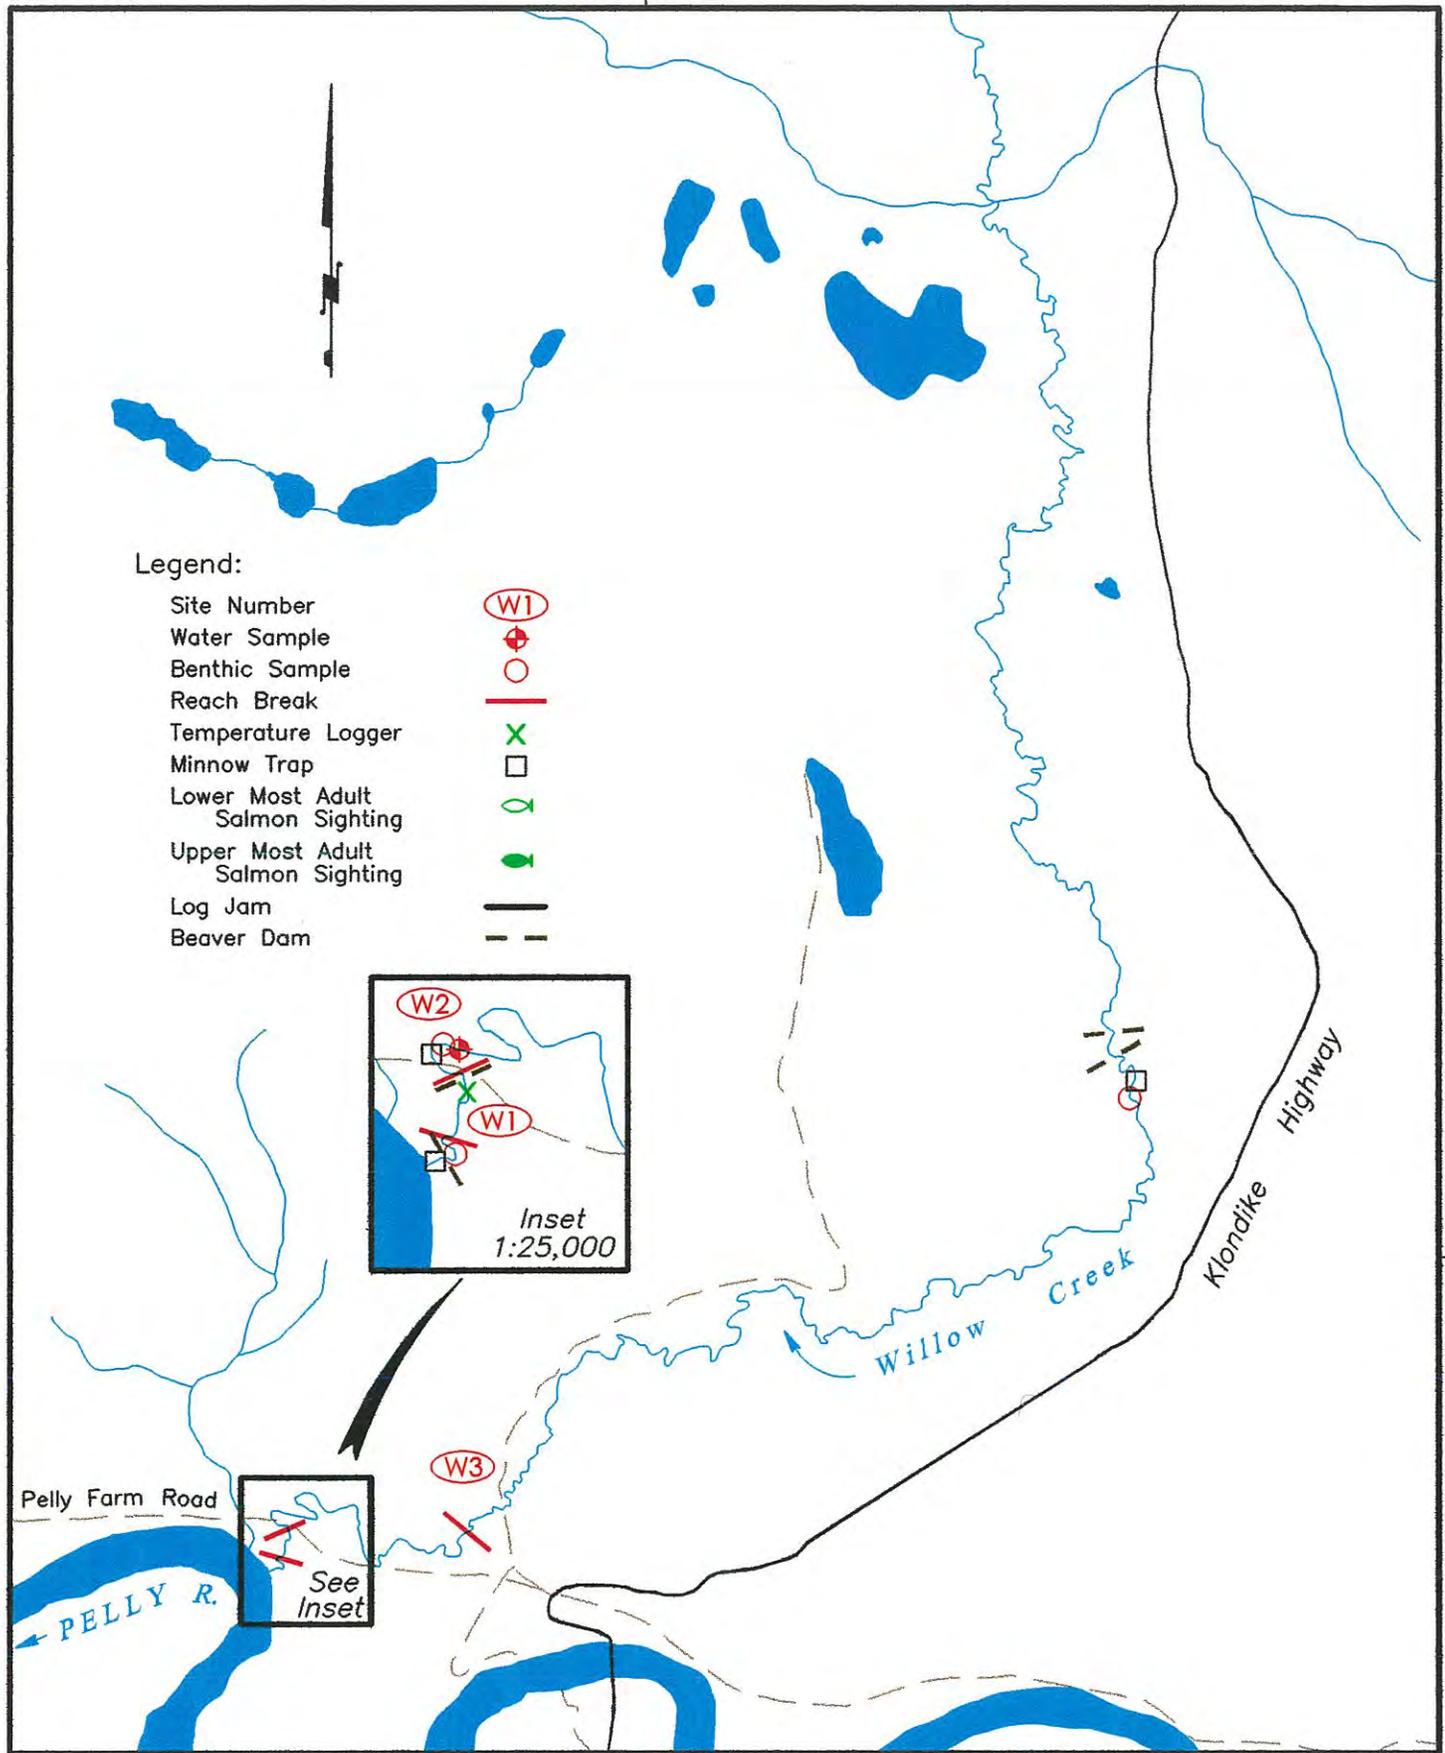
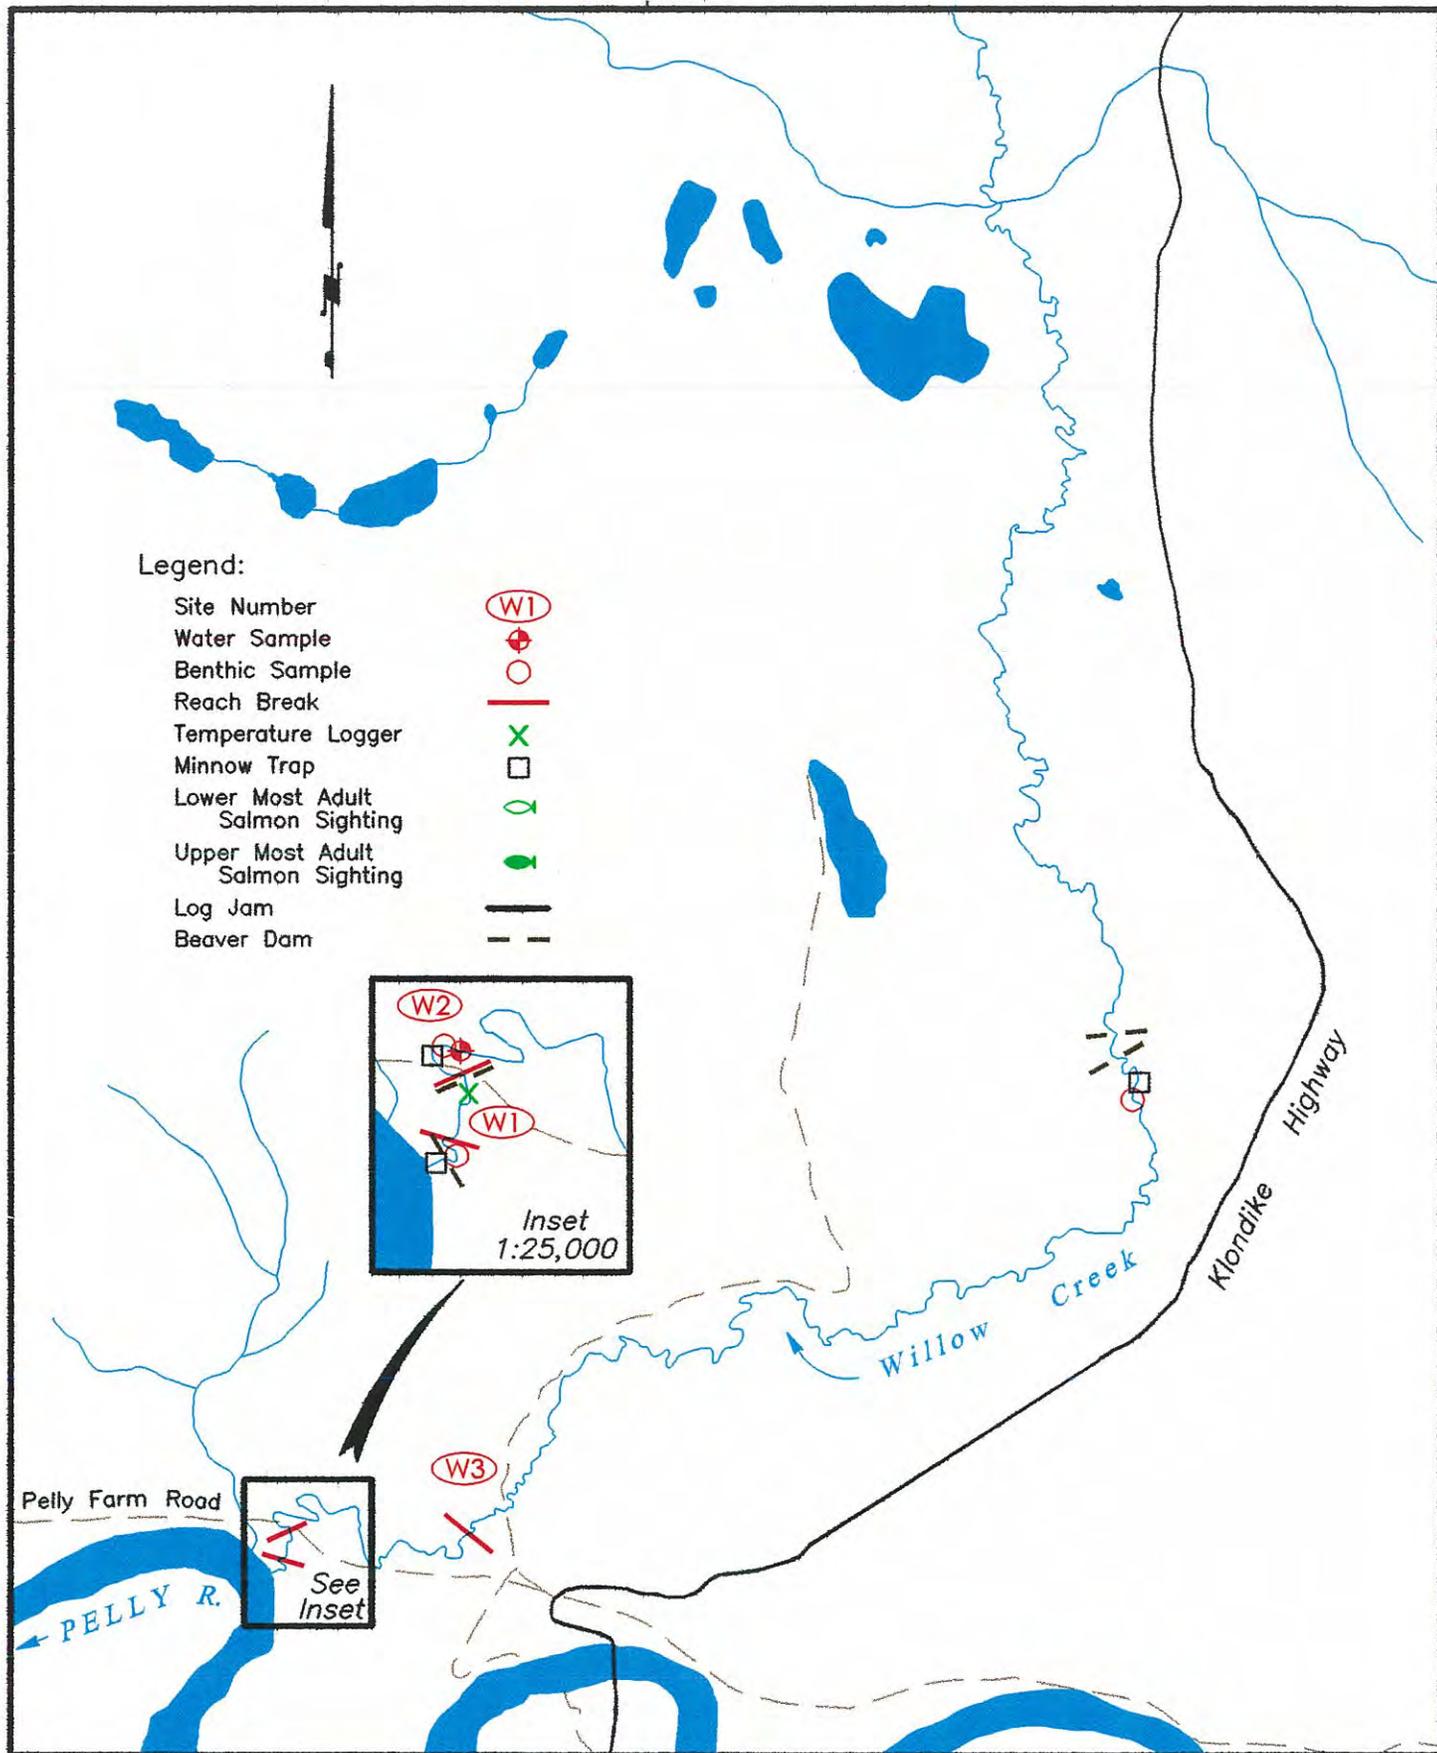
FIGURE 6 : WILLOW CREEK
LOWER PELLY RIVER TRIBUTARIES SALMON HABITAT STUDY

Three sites were investigated on the lower reaches of Willow Creek (Fig 6). Two of the sites were within close proximity to the bridge crossing on the Pelly Farm Road. An upstream site was accessed from a fire control road which extends from the Klondike Highway approximately 7 km from the village of Pelly Crossing.

The numerous beaver dams throughout Willow Creek have changed the morphology of the creek and created obstructions to upstream migration. The extent of beaver activity and the ample supply of successional growth aspen and other deciduous species which have grown since a fire in the 60's, would make a beaver control program at this time ineffectual unless an intense trapping or beaver reduction program were initiated. With the low prices of beaver pelts, there may be little monetary incentive for such a program.
