# **Yukon River Restoration and Enhancement Fund**

**CRE 28 02**

## **Mica Creek Salmon Habitat Restoration**

**September 29, 2003**

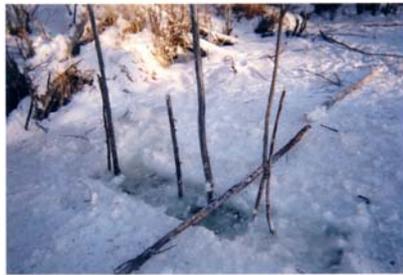
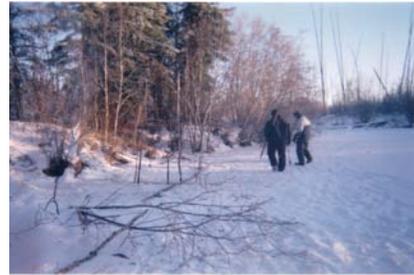
**Figure.D**

**These pictures show the depth of ice, the placement of the hole cut in relation to the bank and how the trap is set in the water and held.**
