CRE - 86 - 02

RESTORATION OF PLACER MINED STREAMS: IDENTIFICATION OF STRATEGIES TO EXPEDITE RECOVERY

Prepared by:
M. MILES & ASSOCIATES LTD.
645 Island Road
Victoria, B.C.
V8S 2T7
Phone: 250-595-0653
email: mmaa@coastnet.com

MAY 2003

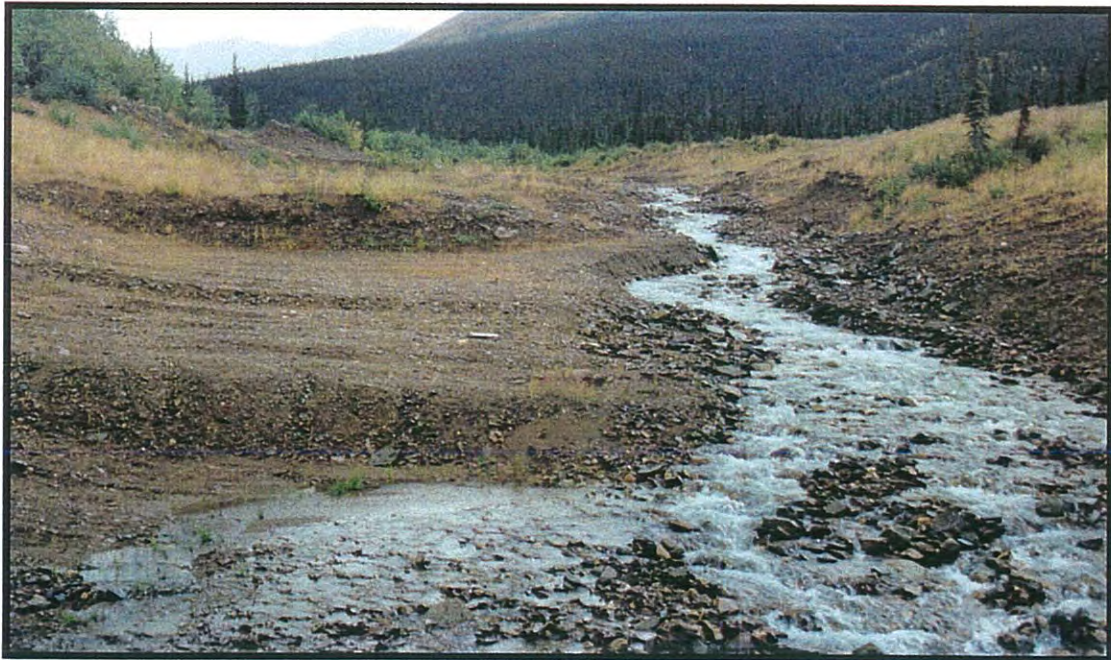
MM 02 - 70 - 25A

Plate 4.1.2: Looking downstream on Left Clear Creek at SiteC4Nels, showing valley bottom clearing and overburden on spoil piles along the base of the valley walls.

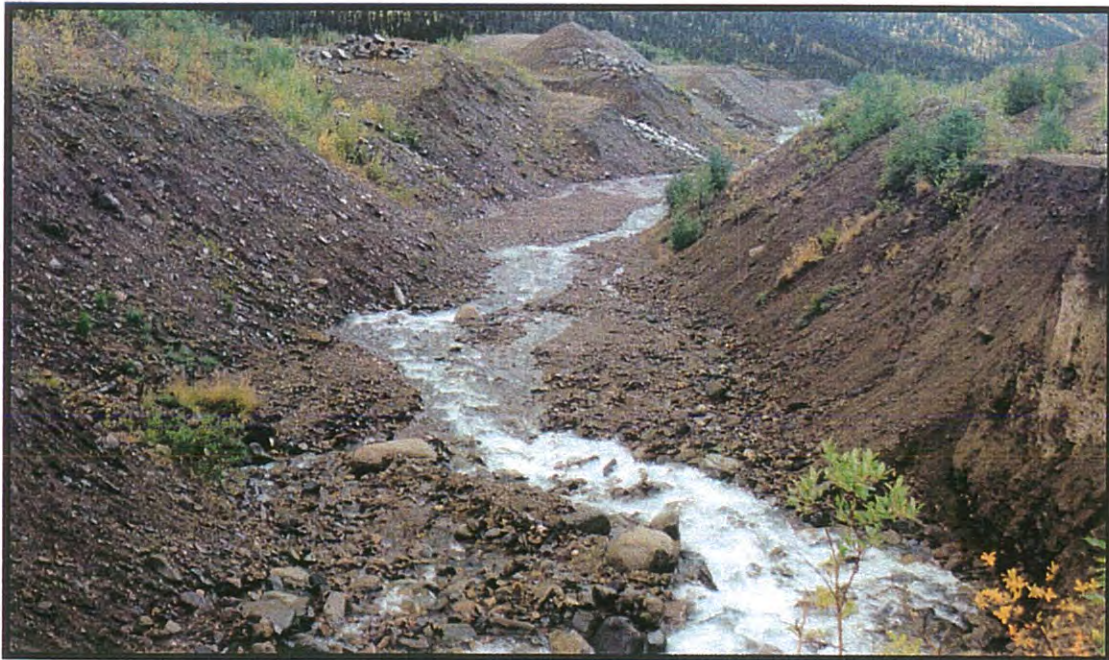
MM 02 - 70 - 27A

Plate 4.1.3: Looking upstream showing the wide shallow channel which has formed along cleared sections of Left Clear Creek.

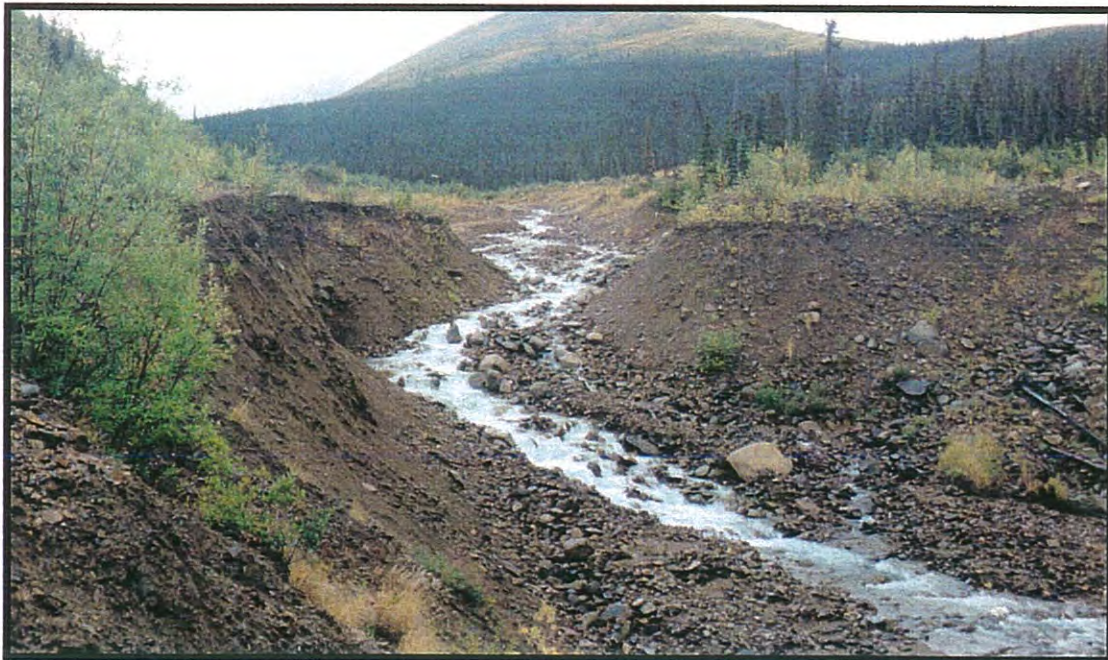
MM 02 - 70 - 26A

Plate 4.1.4: Looking downstream on Left Clear Creek showing how eroding spoil piles confine the channel.

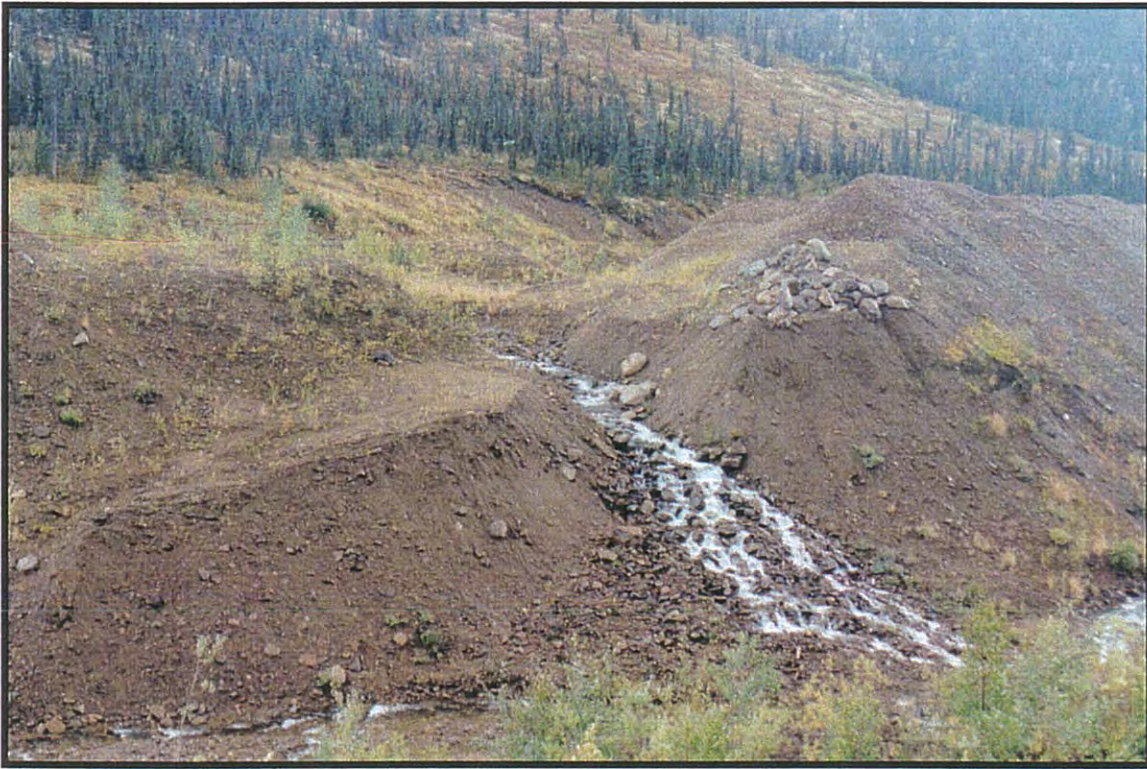
MM 02 - 70 - 29A

Plate 4.1.5: Looking upstream on Left Clear Creek showing how the channel is downcutting into a placer excavation.

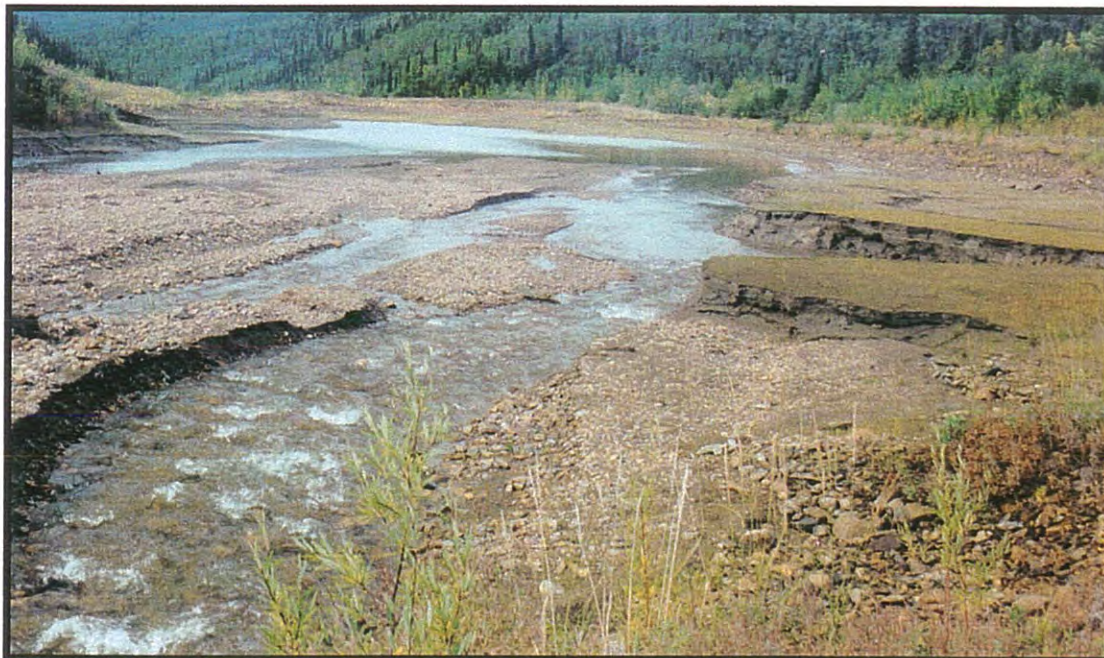
MM 02 - 70 - 30A

Plate 4.1.6: Small tributary channels are commonly downcutting through spoil piles to the lowered mainstem channel.

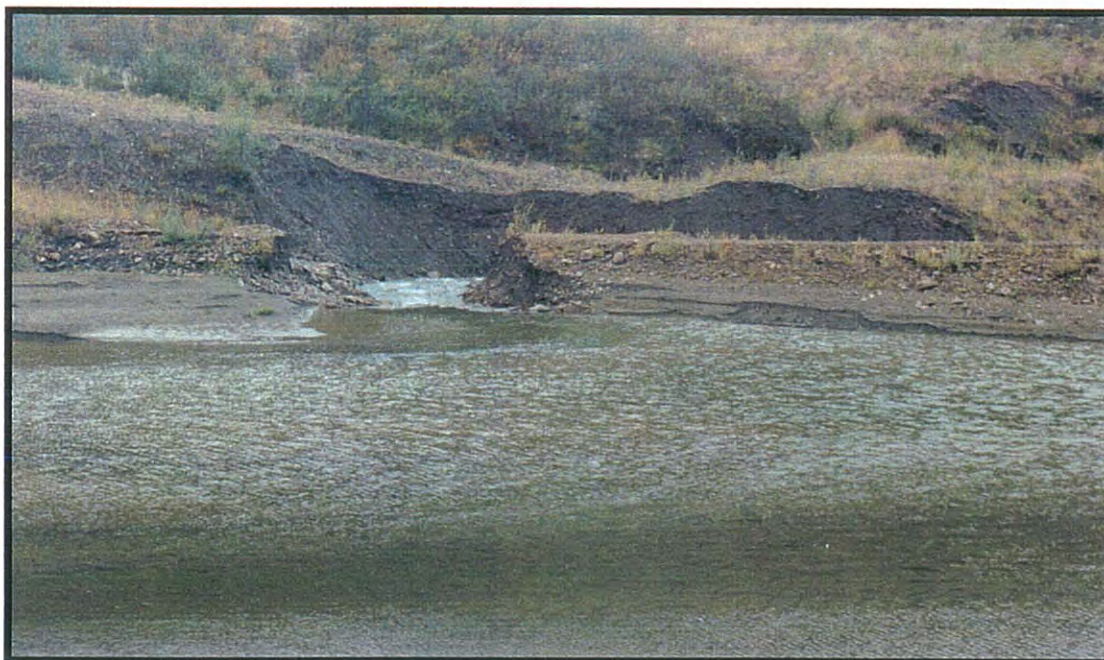
MM 02 - 71 - 03

Plate 4.1.7: Looking downstream on a settling pond constructed on the mainstem of Left Clear Creek.

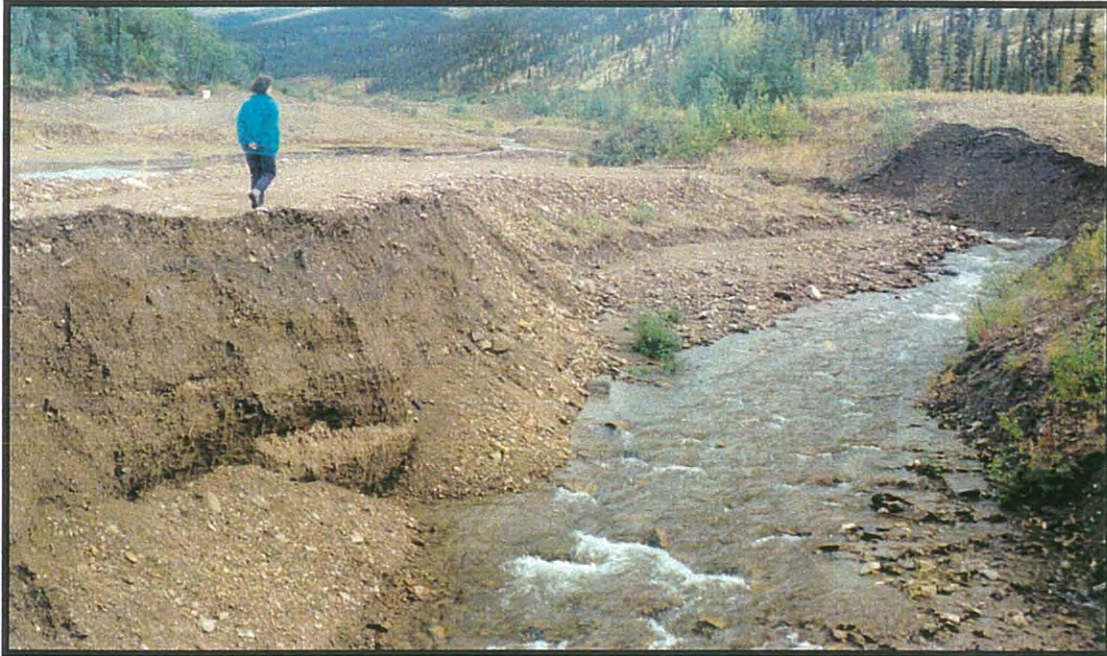
MM 02 - 71 - 06A

Plate 4.1.8: Looking downstream showing the breached outlet on the above settling pond.

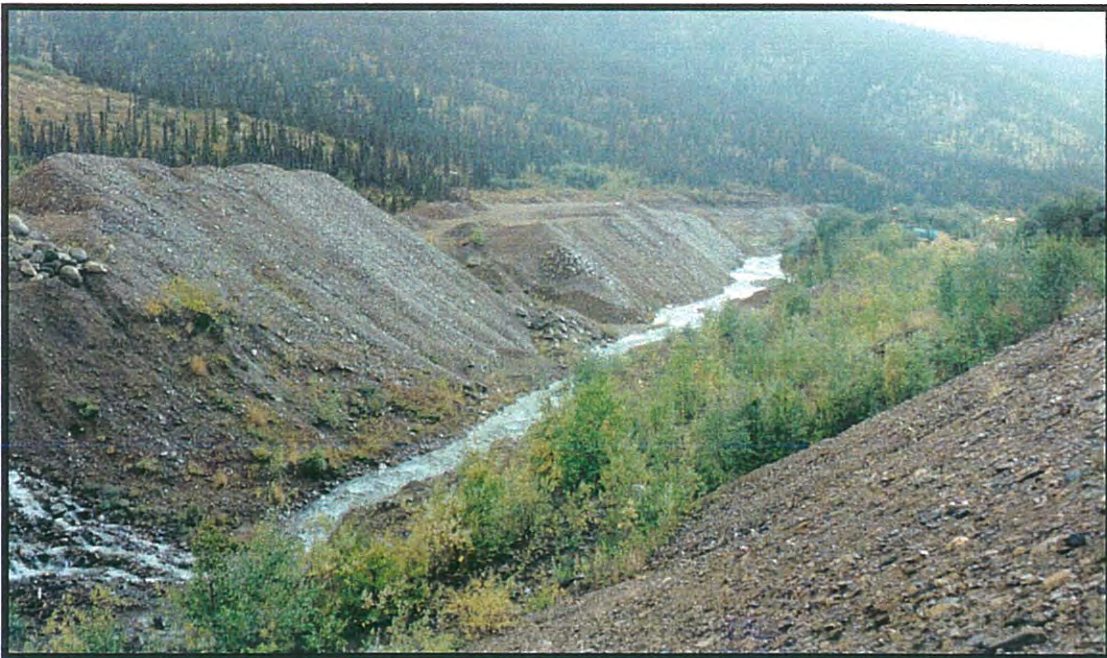
MM 02 - 71 - 08

Plate 4.1.9 Looking downstream on a diverted section of Left Clear Creek showing the erodible banks, scarcity of riparian vegetation and lack of instream structure or complexity.

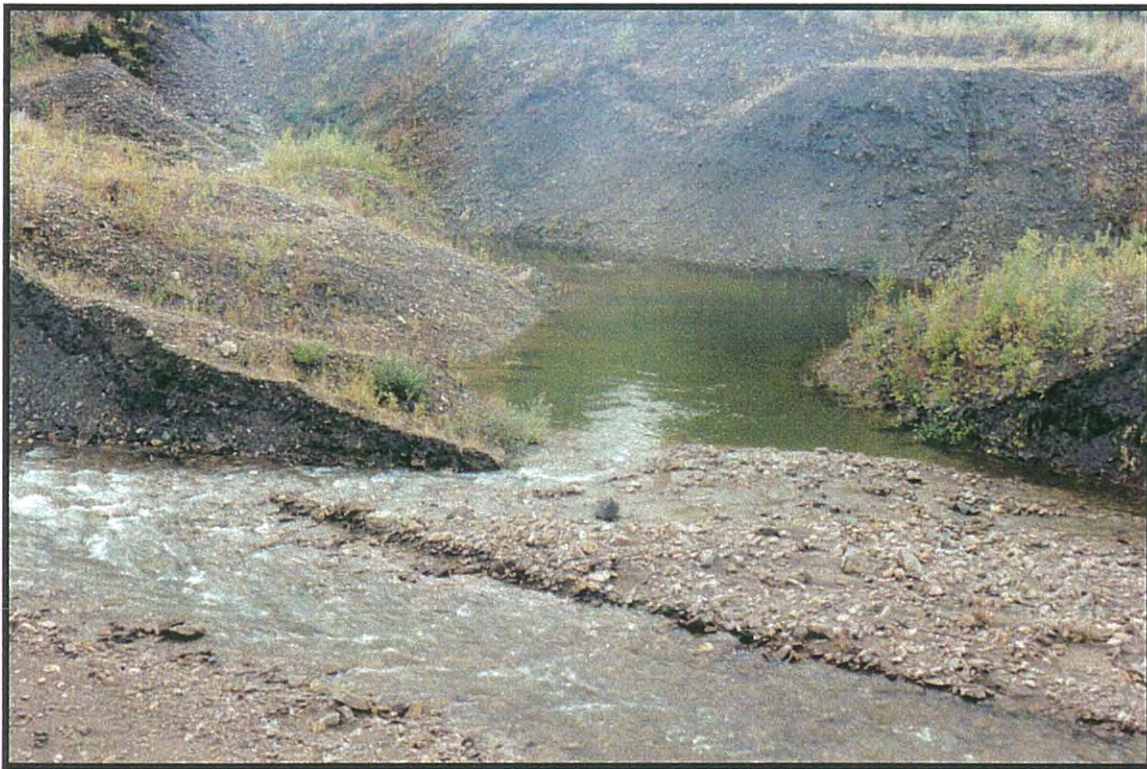
MM 02 - 70 - 31A

Plate 4.1.10: Looking downstream on a diverted section of Left Clear Creek, showing the straight confined channel which lacks a flood plain.

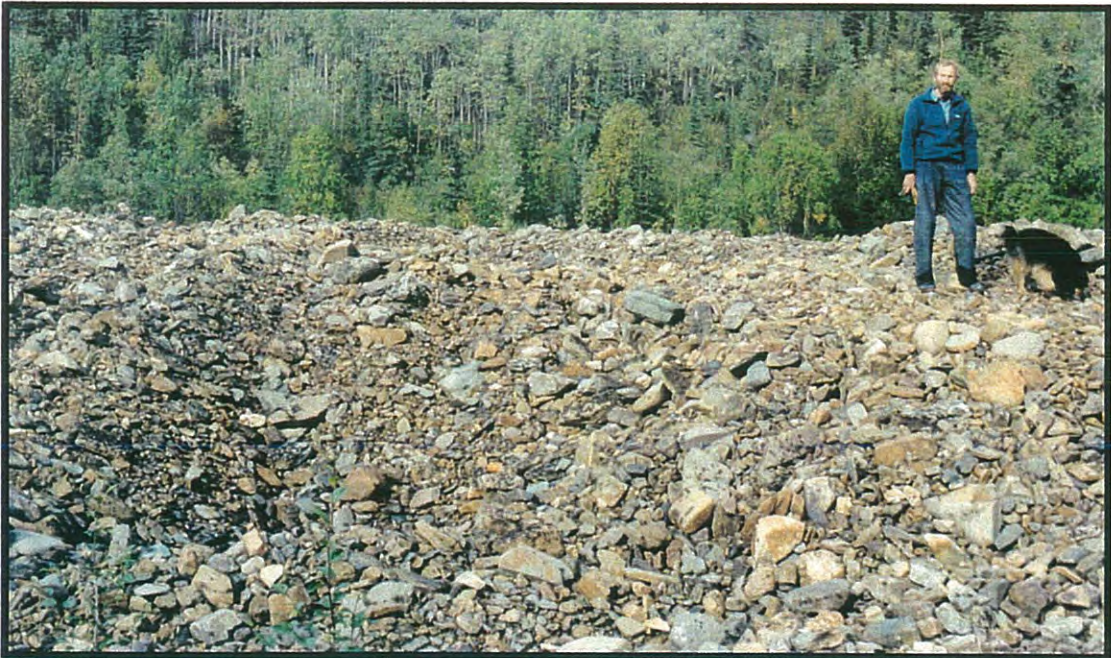
MM 02 - 71 - 12

Plate 4.1.12: Looking downstream showing the hummock topography associated with dredge mining in lower Left Clear Creek.

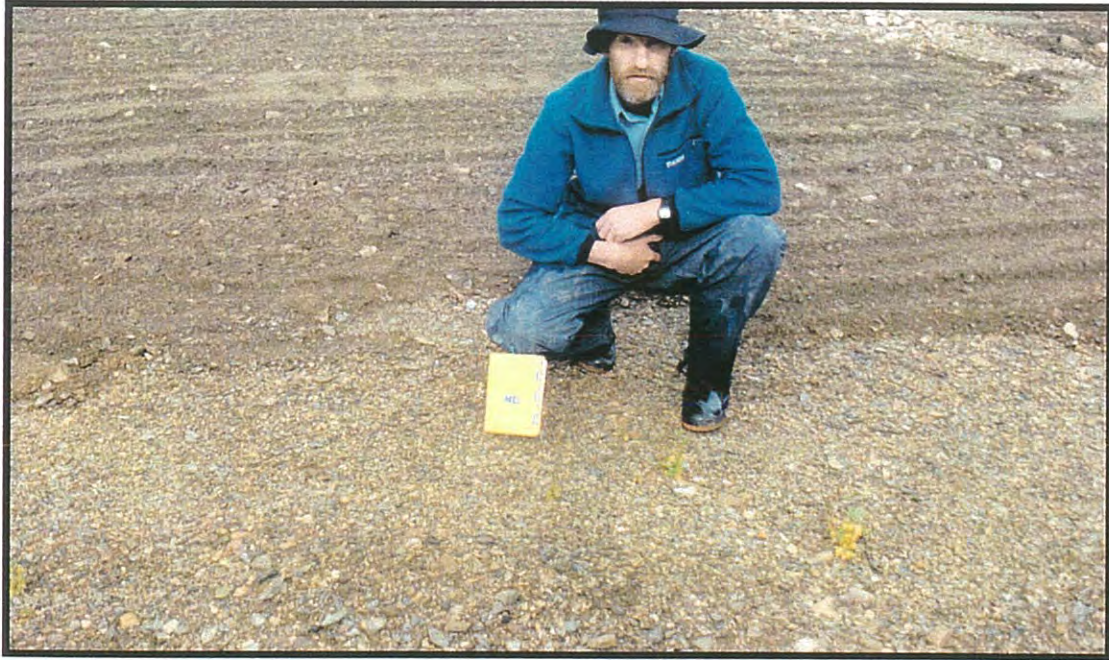
MM 02 - 71 - 15

Plate 4.1.13: Surface materials on spoil piles from old dredges typically lack fine sediments. It is difficult to establish vegetation on these well drained materials.

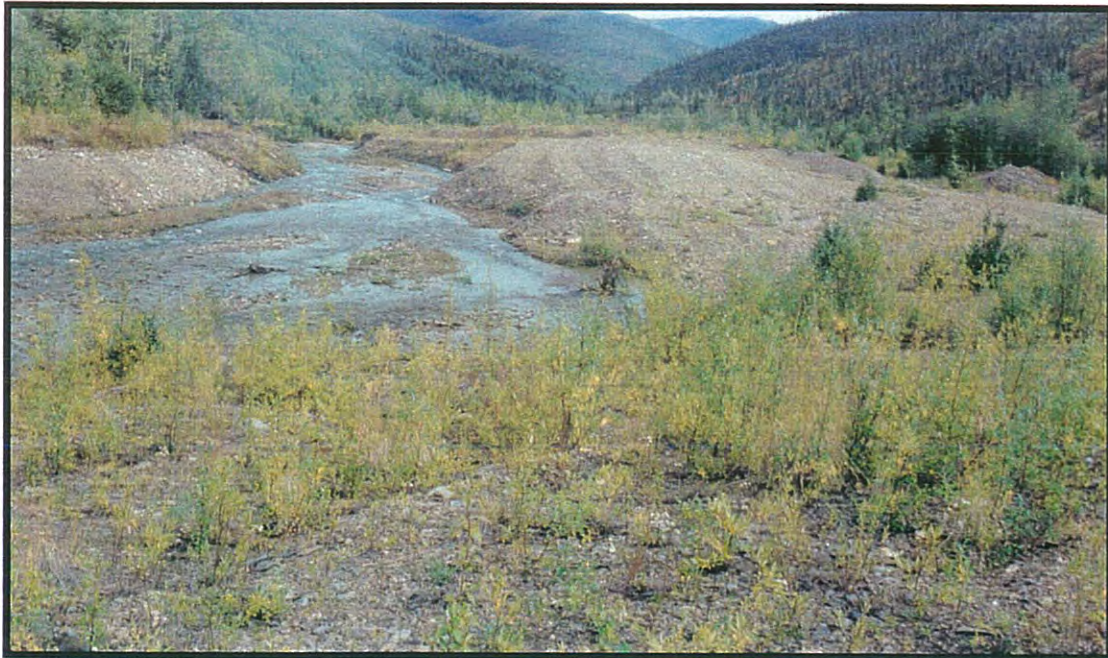
MM 02 - 71 - 11

Plate 4.1.14: Reworked dredge spoil piles exposed fine sediments, some of which are phyllite rich and weather rapidly.

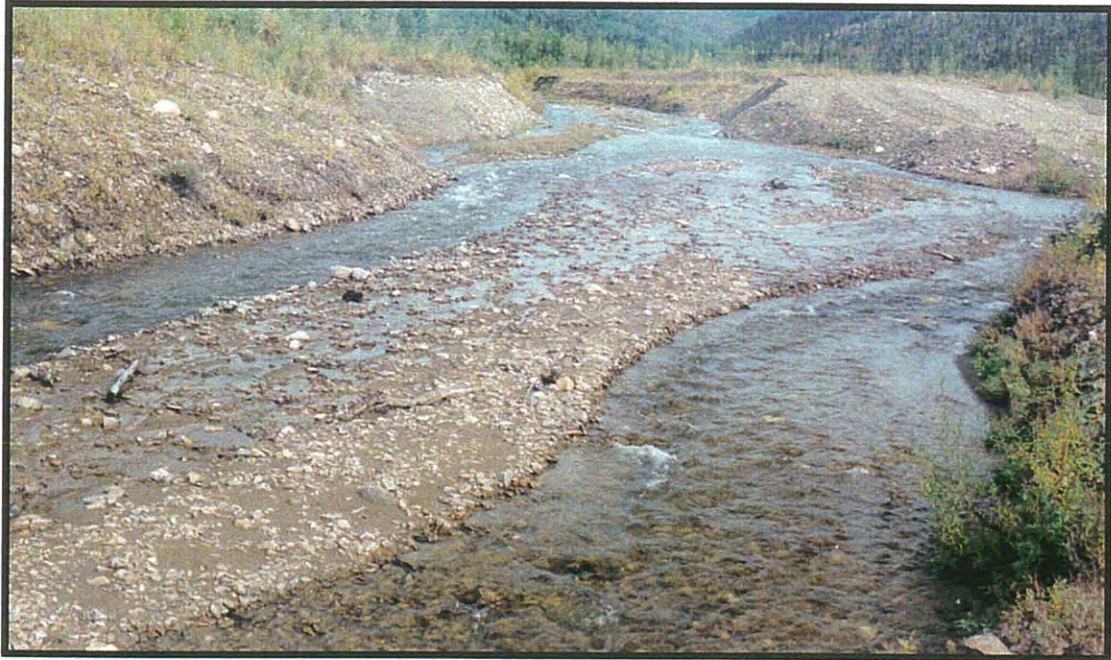
MM 02 - 71 - 17

Plate 4.1.15: Reworked spoil piles are less well drained and easier to revegetate.

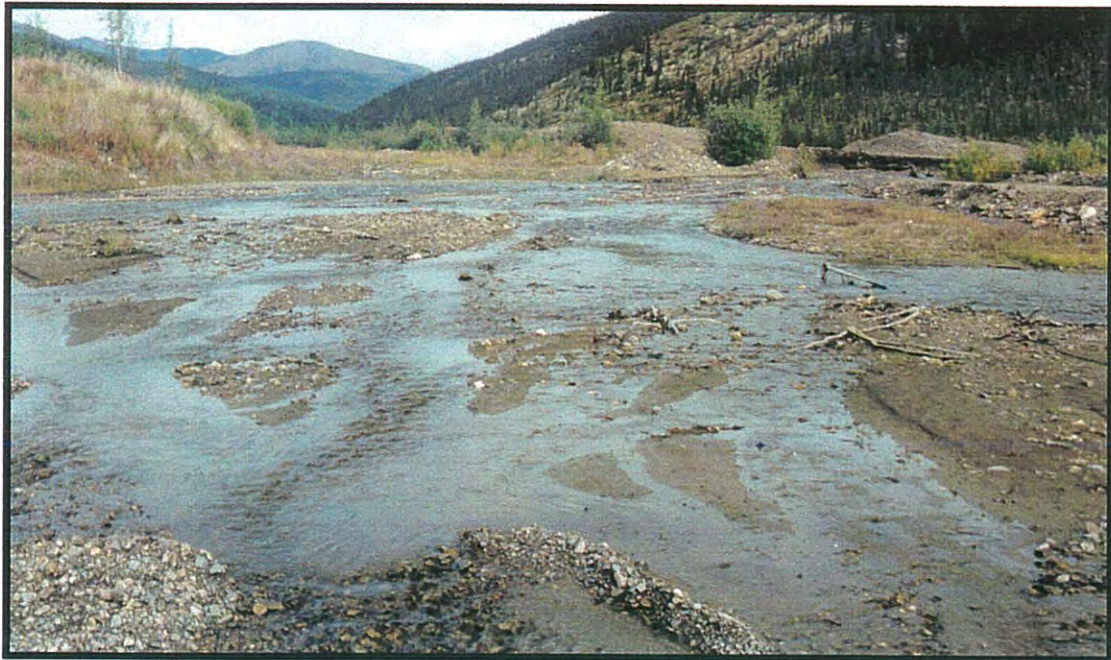
MM 02 - 71 - 18

Plate 4.1.16: Well developed active, unvegetated bars indicate that elevated rates of sediment transport are occurring in the lower section of Left Clear Creek.

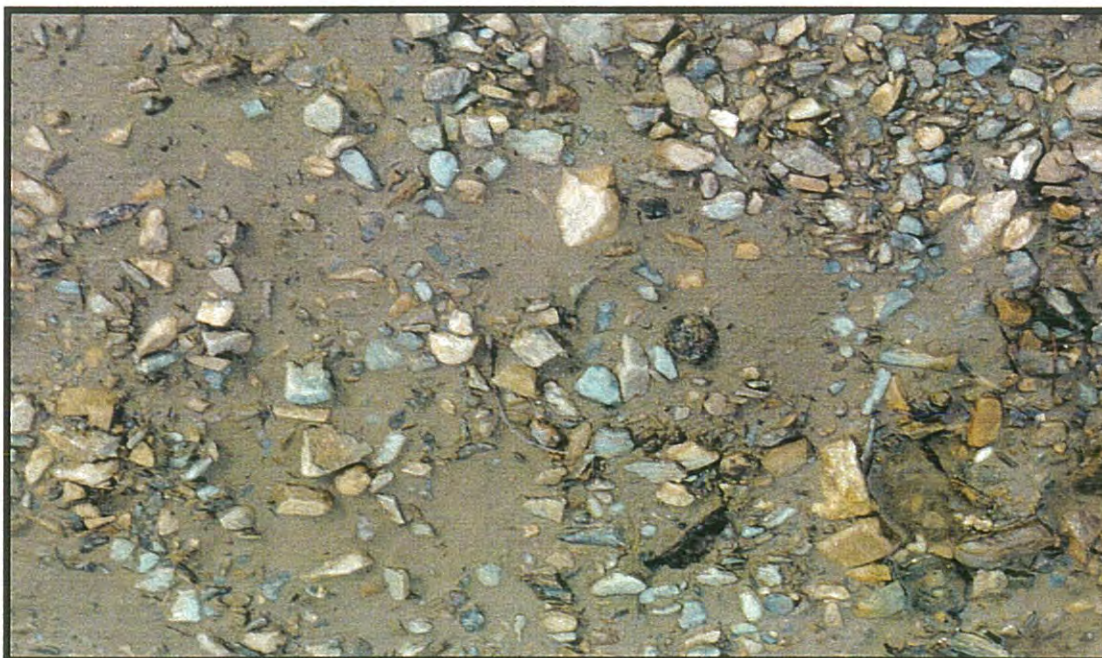
MM 02 - 71 - 25

Plate 4.1.17: Elevated rates of sediment transport have resulted in the formation of wide, shallow sections of river channel.

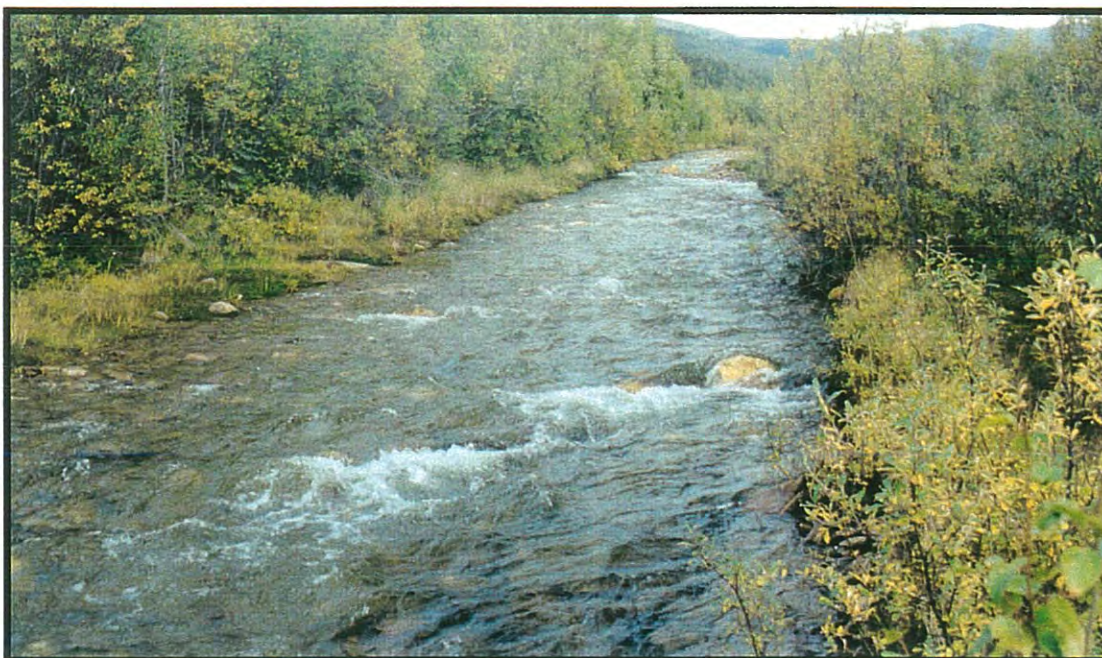
MM 02 - 71 - 26

Plate 4.1.18: Elevated rates of sediment transport result in fine-textured material being deposited on the river bed.

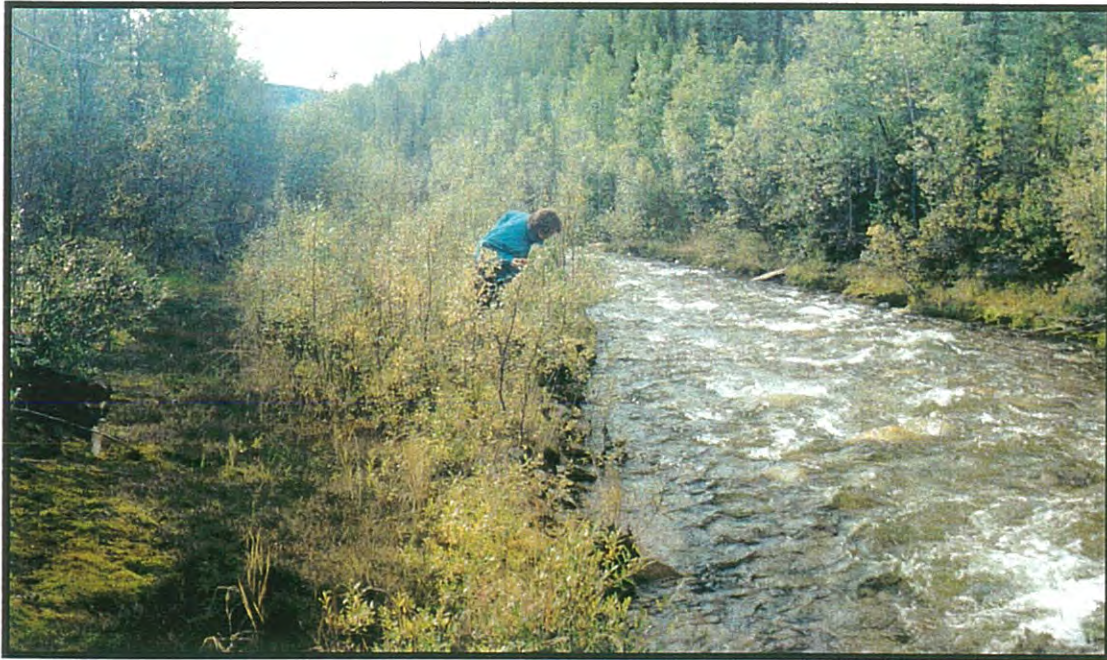
MM 02 - 71 - 23

Plate 4.1.19: Riparian vegetation has developed along old sections of relocated channel. These straight sections still lack woody debris or complexity.

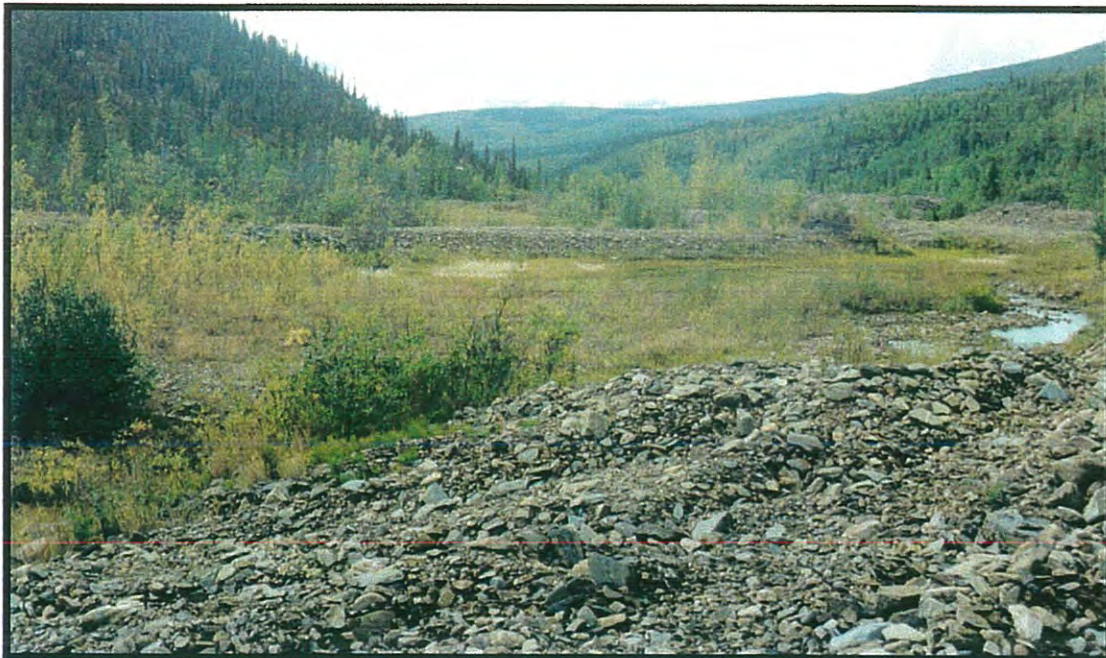
MM 02 - 71 - 24

Plate 4.1.20: Looking downstream on an old section of channelized stream, showing the narrow flood plain which has developed.

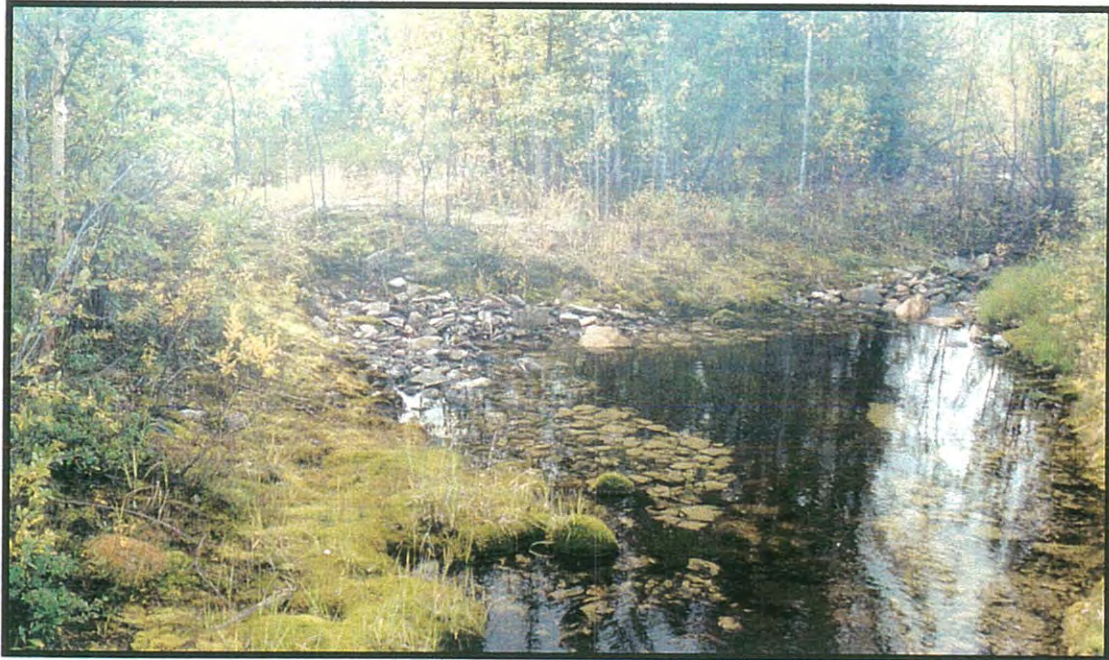
MM 02 - 71 - 14

Plate 4.1.21: Wetland areas have developed between old dredge spoil piles on Lower Left Clear Creek.

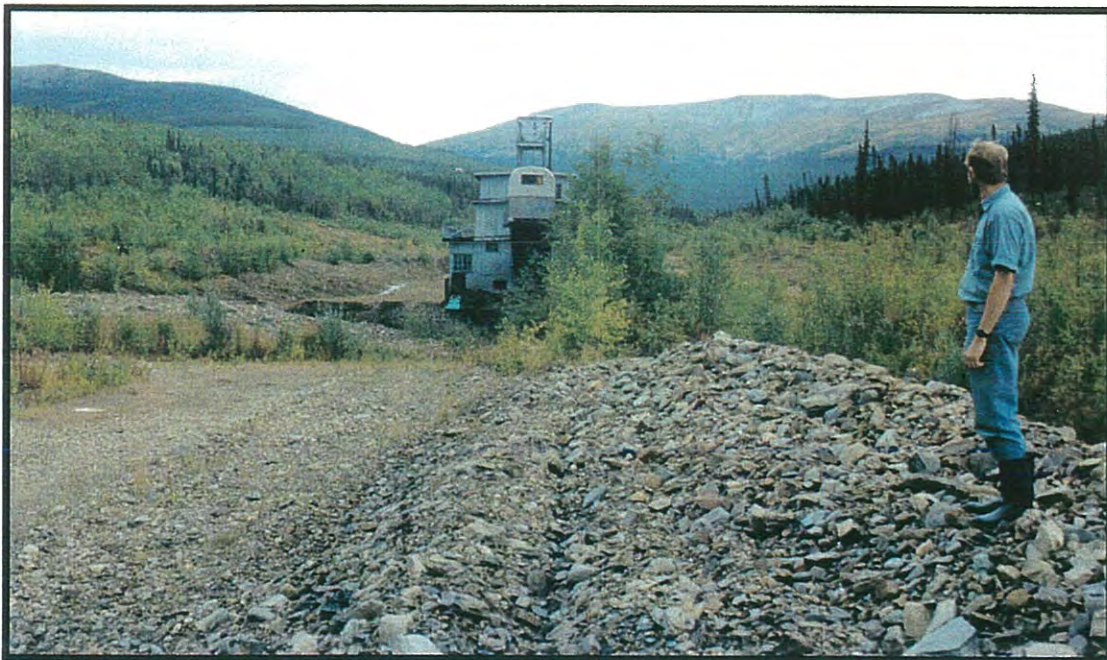
MM 02 - 71 - 27

Plate 4.1.24: Pre-1989 dredging on Upper Right Clear Creek has resulted in the formation of wetland areas between the valley walls and the spoil piles.

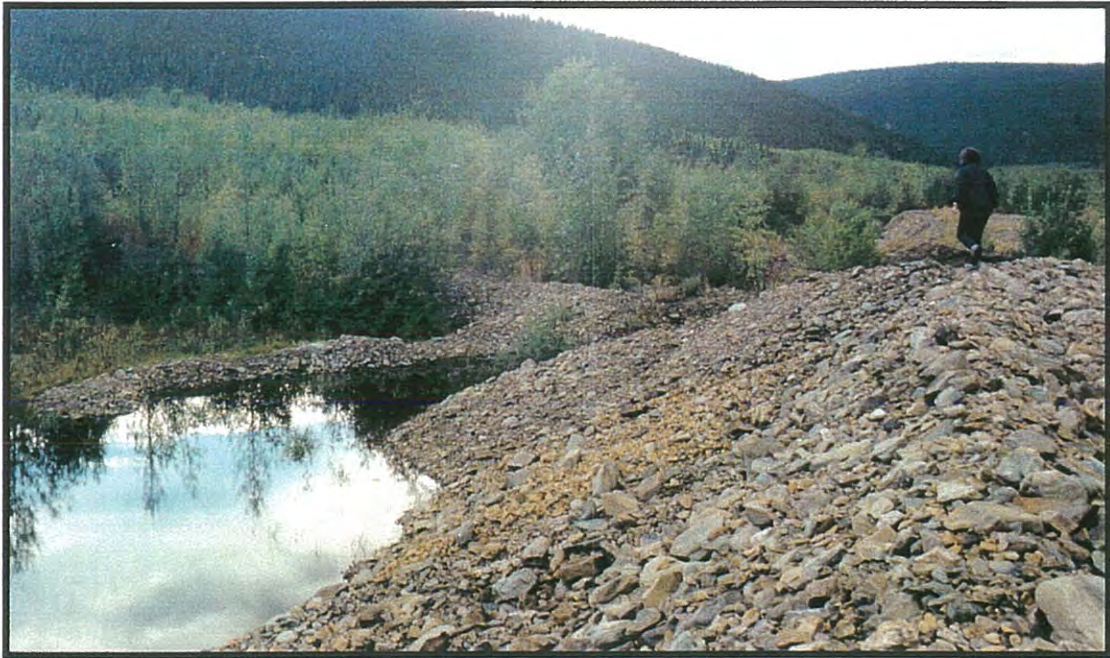
MM 02 - 72 - 13A

Plate 4.1.25: Dredge spoil piles are coarse textured and well drained making them difficult to revegetate.

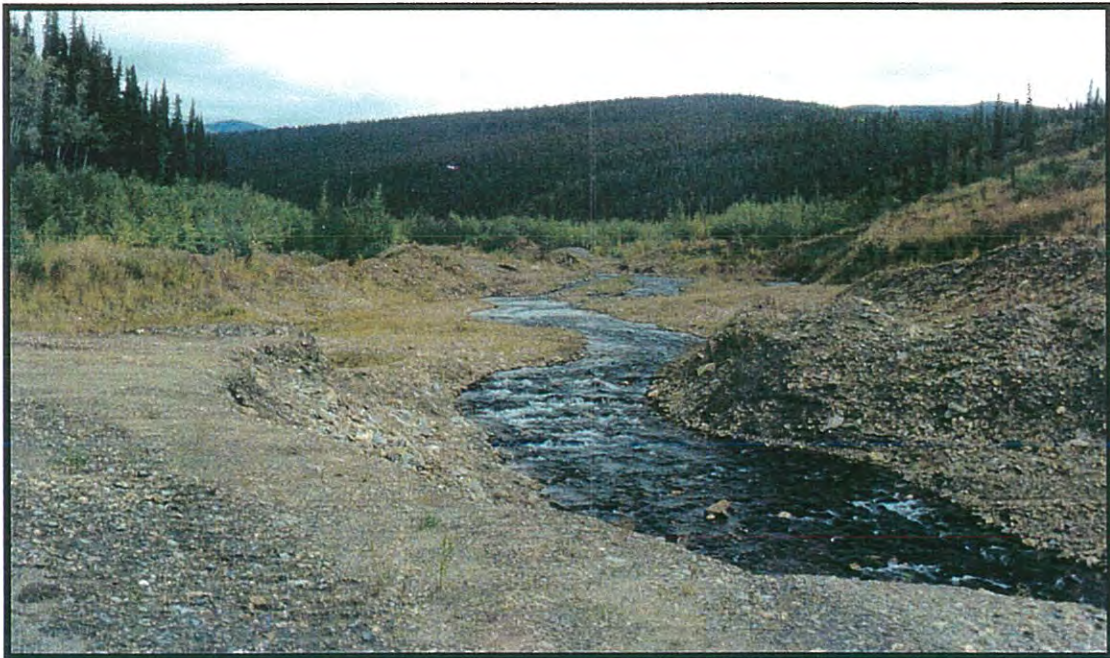
MM 02 - 72 - 10A

Plate 4.1.26: Dredge spoil piles can be difficult to revegetate even along riparian areas.

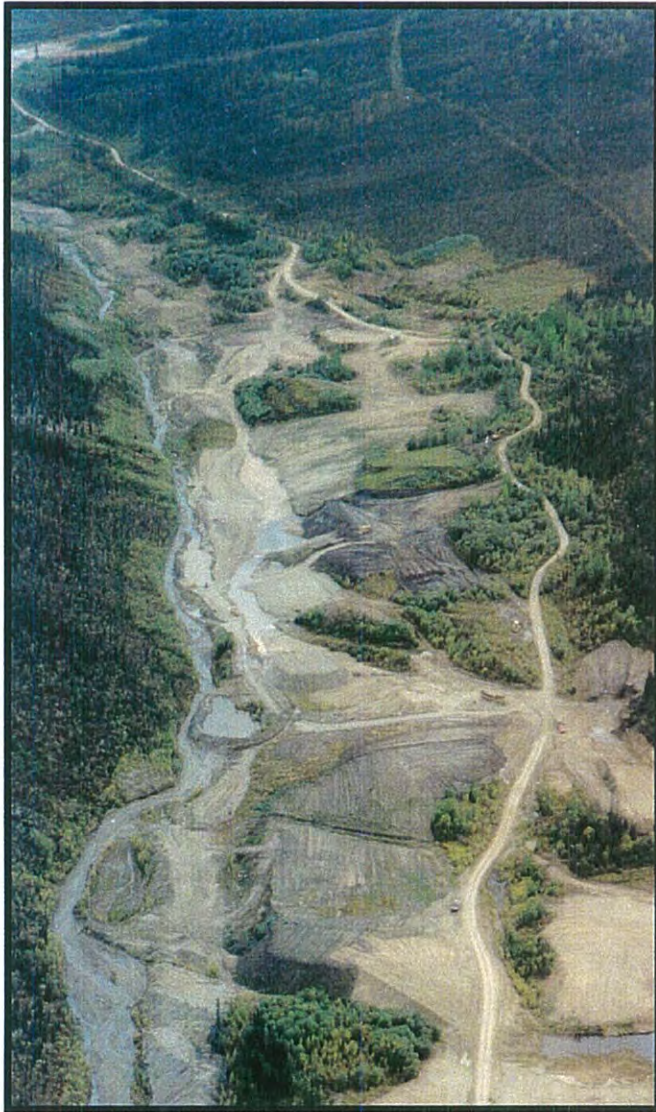
MM 92 - 40 - 20

Plate 4.2.2: An example of recent sediment deposits along Lower Indian River.

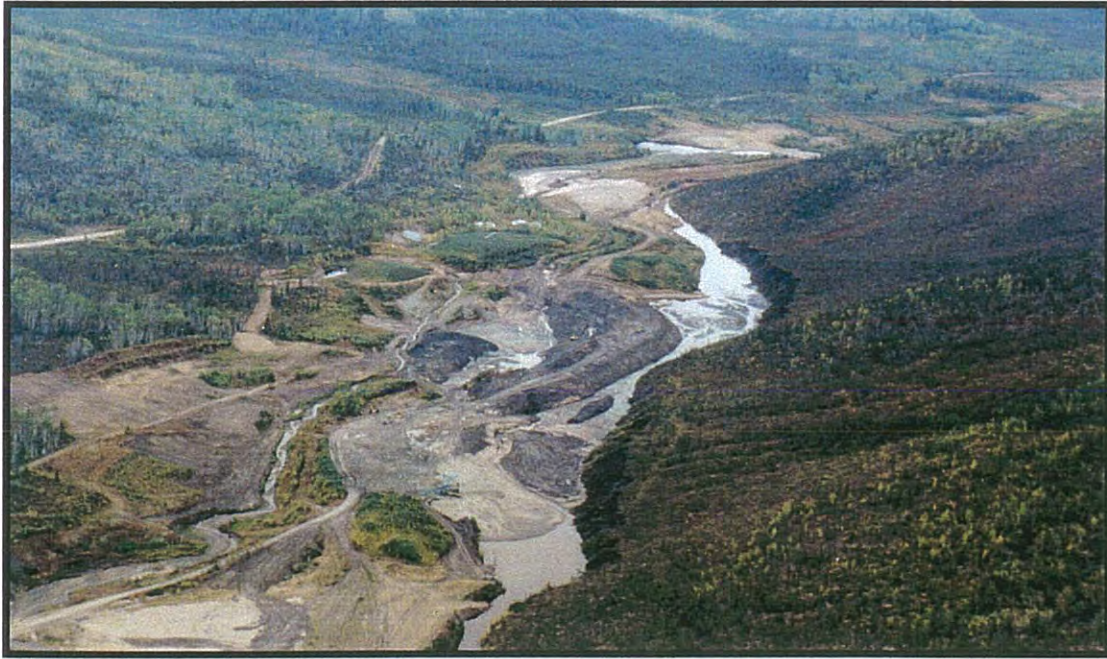
MM 02 - 77 - 21

Plate 4.2.3: Looking downstream in upper Dominion Creek, showing the effects of comparatively recent placer mining activity.

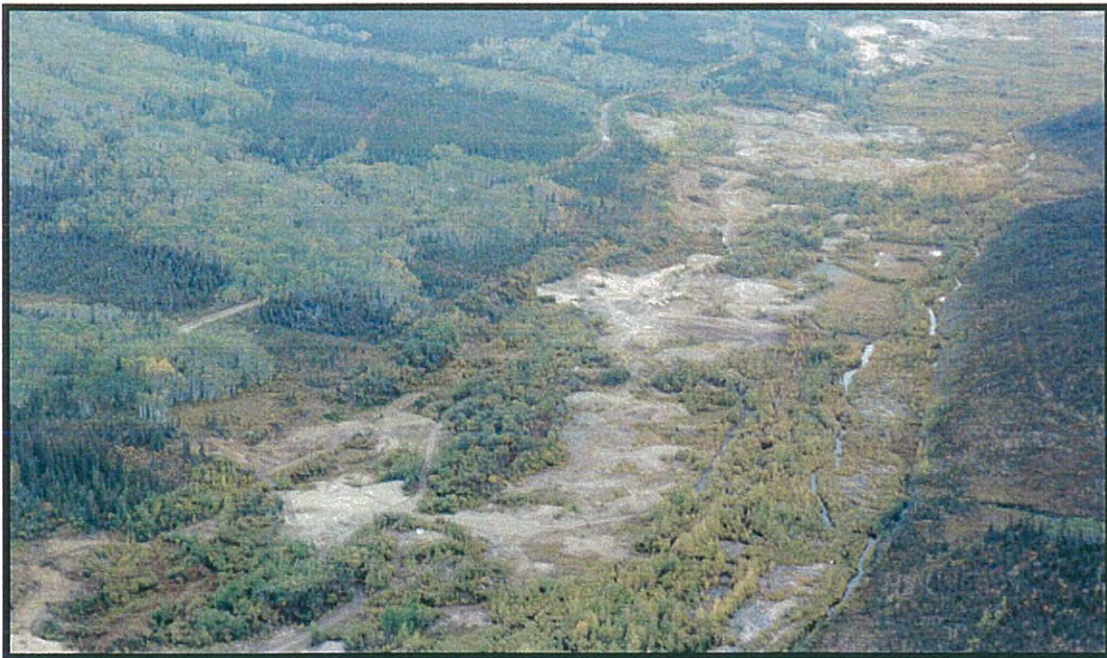
MM 02 - 77 - 22

Plate 4.2.4: Looking downstream to eroding placer spoil piles and undercut sections of valley walls. Dominion Creek at GPS location 65.

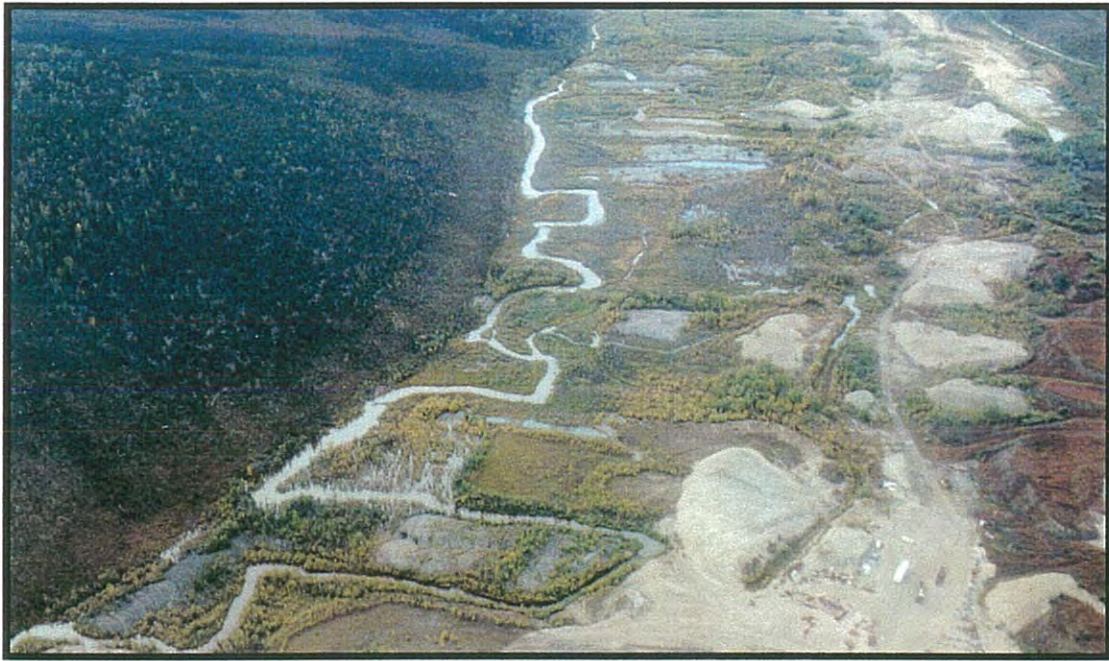
MM 02 - 77 - 26

Plate 4.2.5: Looking downstream to older placer excavations showing valley flat revegetation and the narrow width of the stream channel. Dominion Creek at GPS location 68.

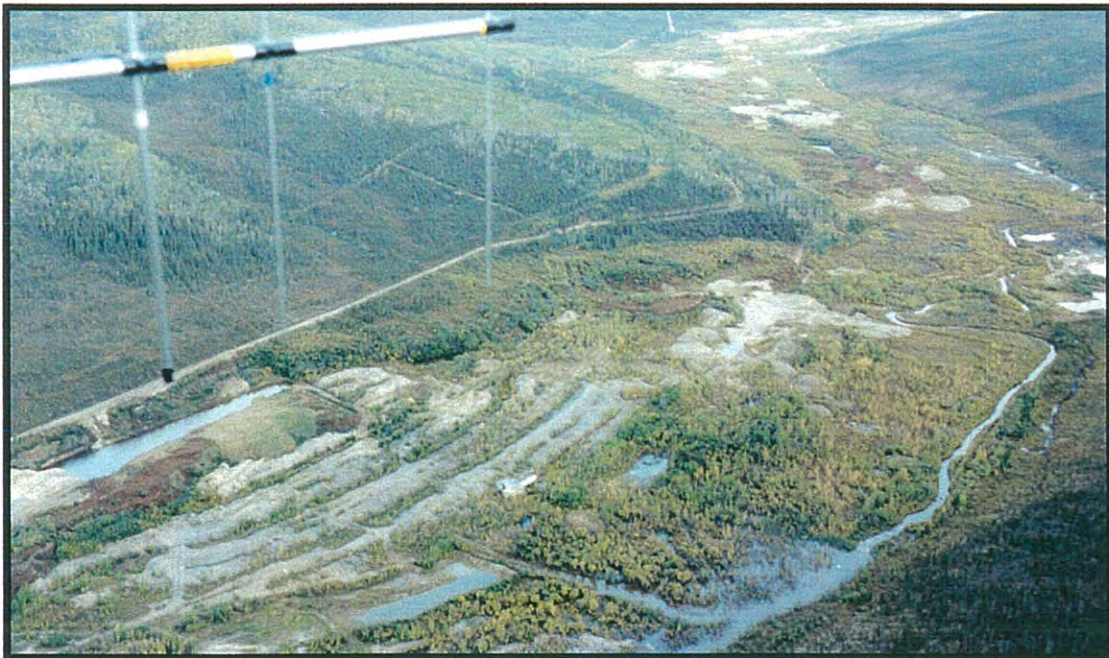
MM 02 - 77 - 30

Plate 4.2.6: Looking upstream on Dominion Creek at GPS Location 70, showing the rectangular stream channel pattern (likely reflecting old excavation boundaries), local flood plain development and the re-establishment of riparian vegetation.

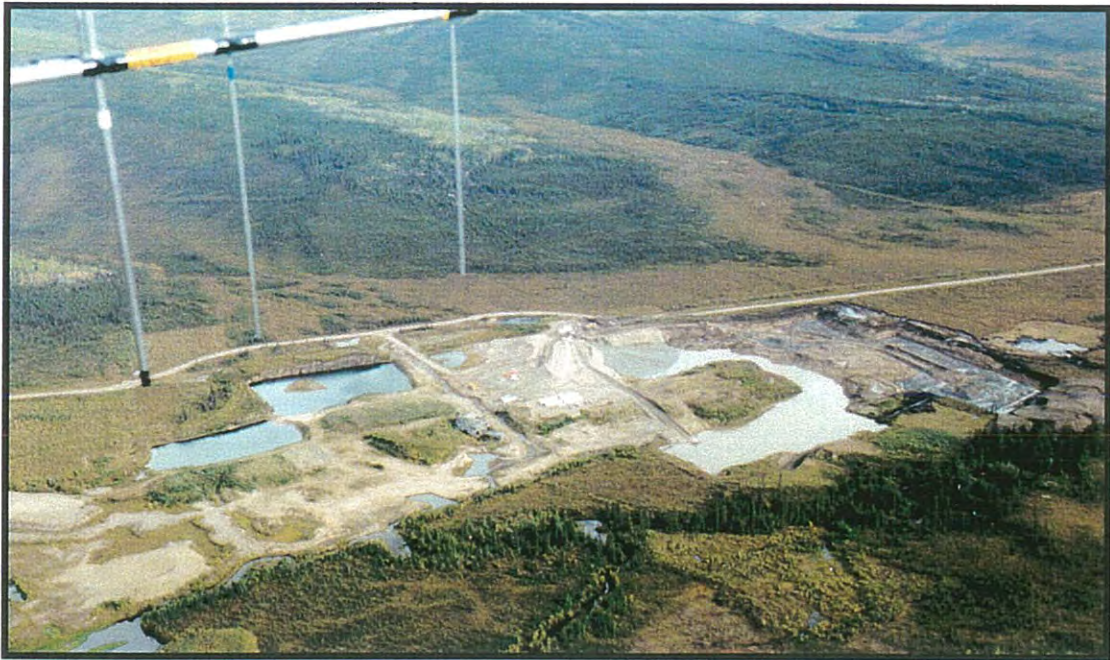
MM 02 - 77 - 31

Plate 4.2.7: Looking downstream on Dominion Creek near Hunter Creek [GPS Location 71], showing channel recovery in an area that was mined by dredge.

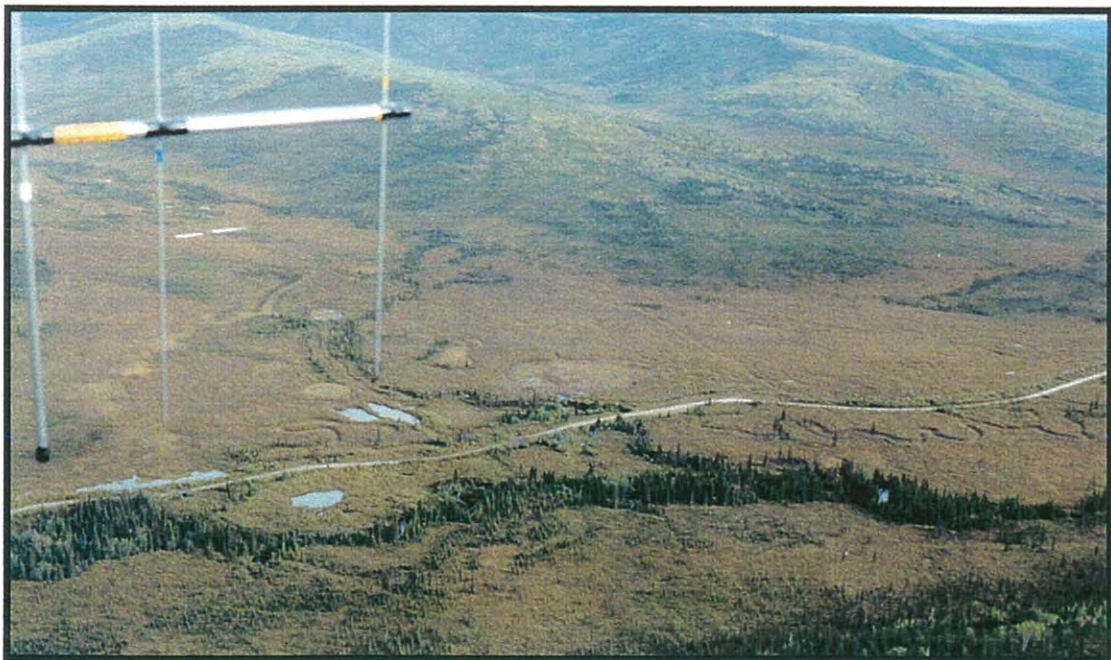
MM 02 - 77 - 34

Plate 4.2.8a: Looking downstream to recent excavator mining activity in or near an area that was formerly dredged downstream of Jensen Creek. Dominion Creek at GPS Location 74.
