CRE - 86 - 02

RESTORATION OF PLACER MINED STREAMS: IDENTIFICATION OF STRATEGIES TO EXPEDITE RECOVERY

Prepared by:
M. MILES & ASSOCIATES LTD.
645 Island Road
Victoria, B.C.
V8S 2T7
Phone: 250-595-0653
email: mmaa@coastnet.com

MAY 2003

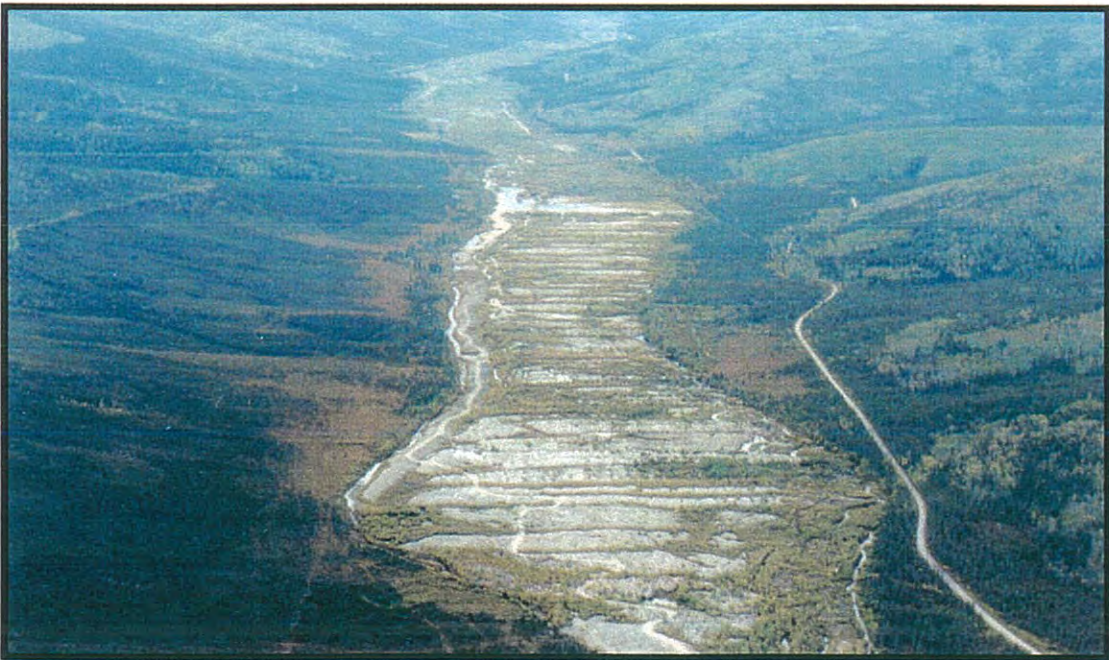
MM 02 - 78 - 04

Plate 4.2.10: Looking downstream on the Dominion Creek valley flat, showing the extensive series of ponds which have developed as a result of placer mining. GPS Location 74.

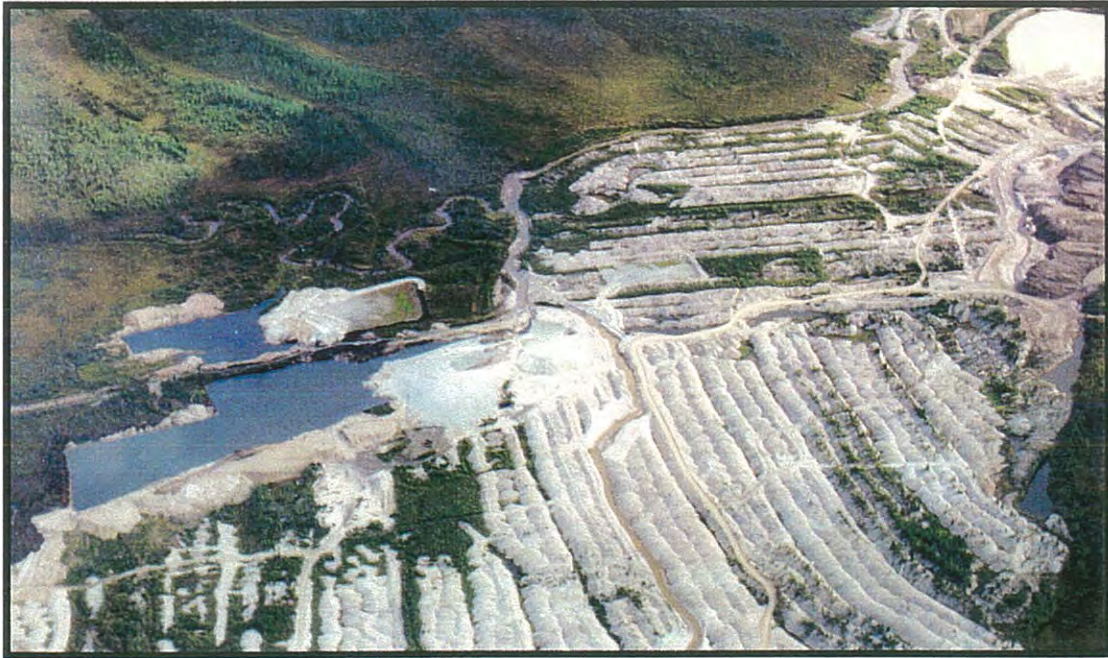
MM 02 - 78 - 07

Plate 4.2.11: Looking upstream on Lower Sulfur Creek showing valley bottom revegetation and the small confined residual channels at the base of both valley walls.

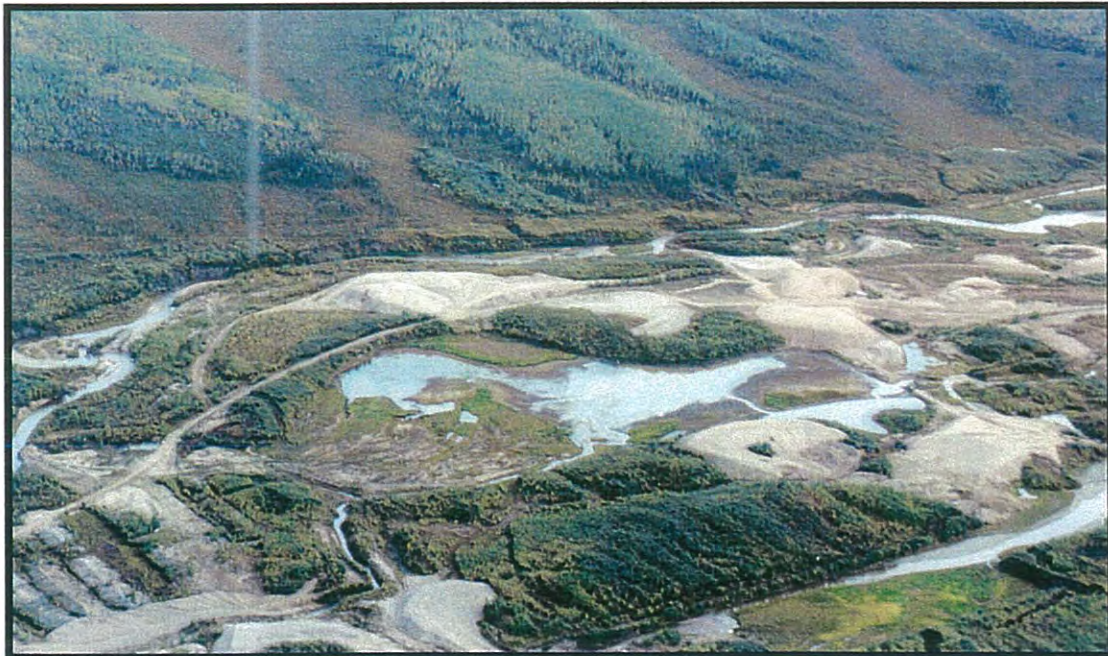
MM 92 - 42 - 26

Plate 4.2.12: Looking downstream on the channelized section of Sulfur Creek above the confluence with Dominion Creek. GPS Location 80.

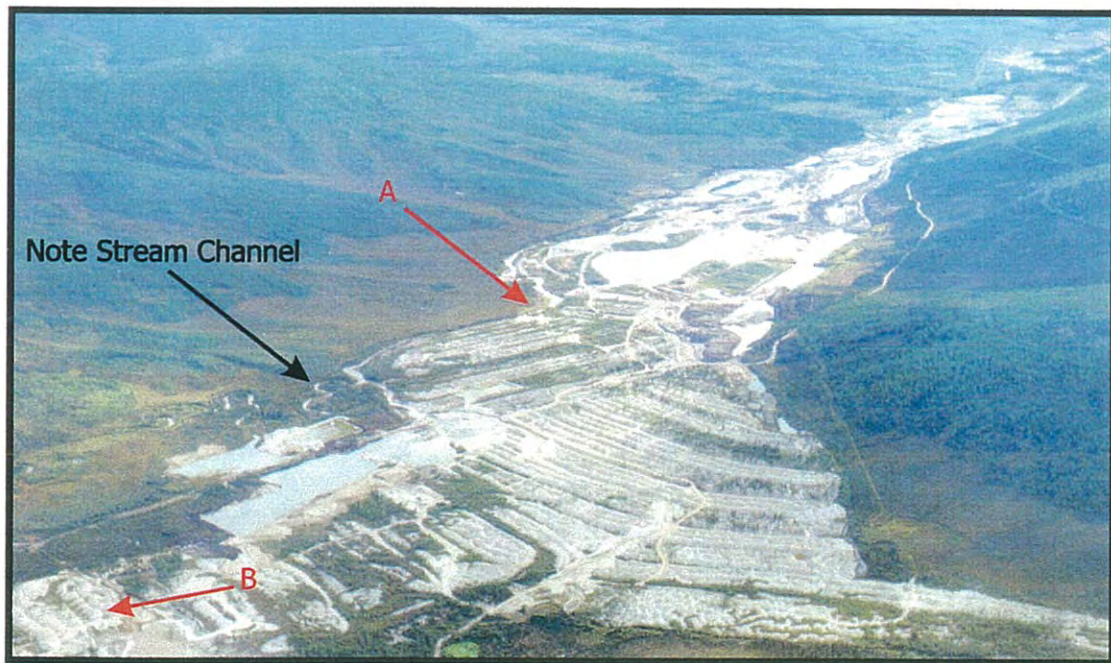
MM 02 - 78 - 09

Plate 4.2.13: Looking downstream on the Dominion Creek, showing vegetation and wetland development below the Sulfur Creek confluence. GPS Location 81.

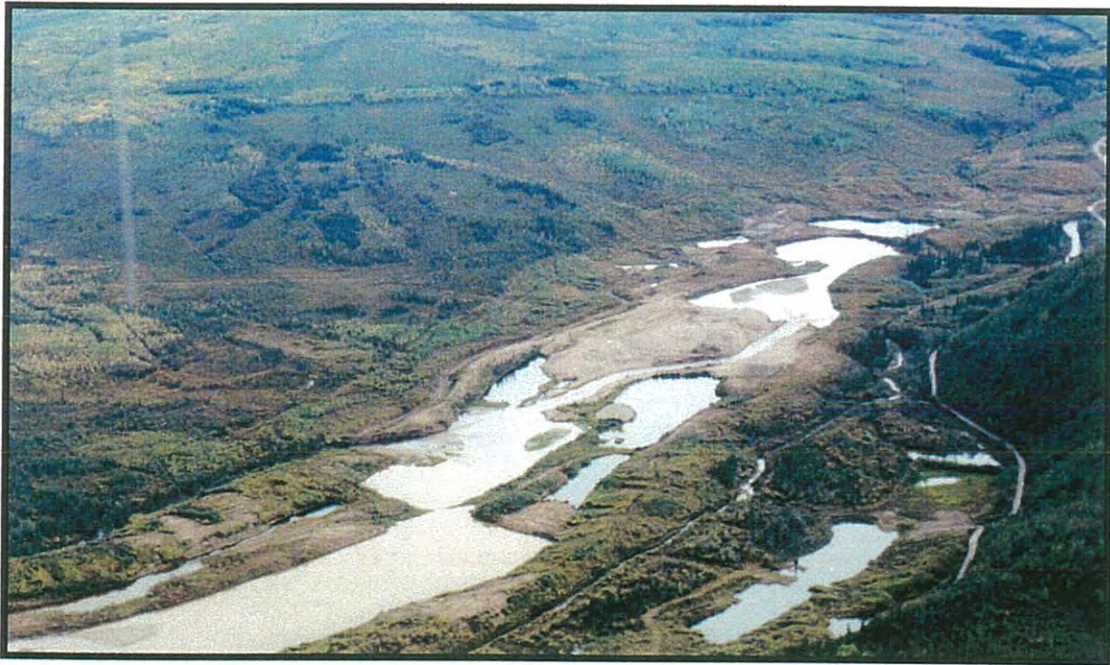
MM 02 - 78 - 05

Plate 4.2.14: Looking downstream on Dominion Creek showing the changes in valley flat conditions opposite Sulfur Creek in the period between 1992 and 2002. GPS Location 80.

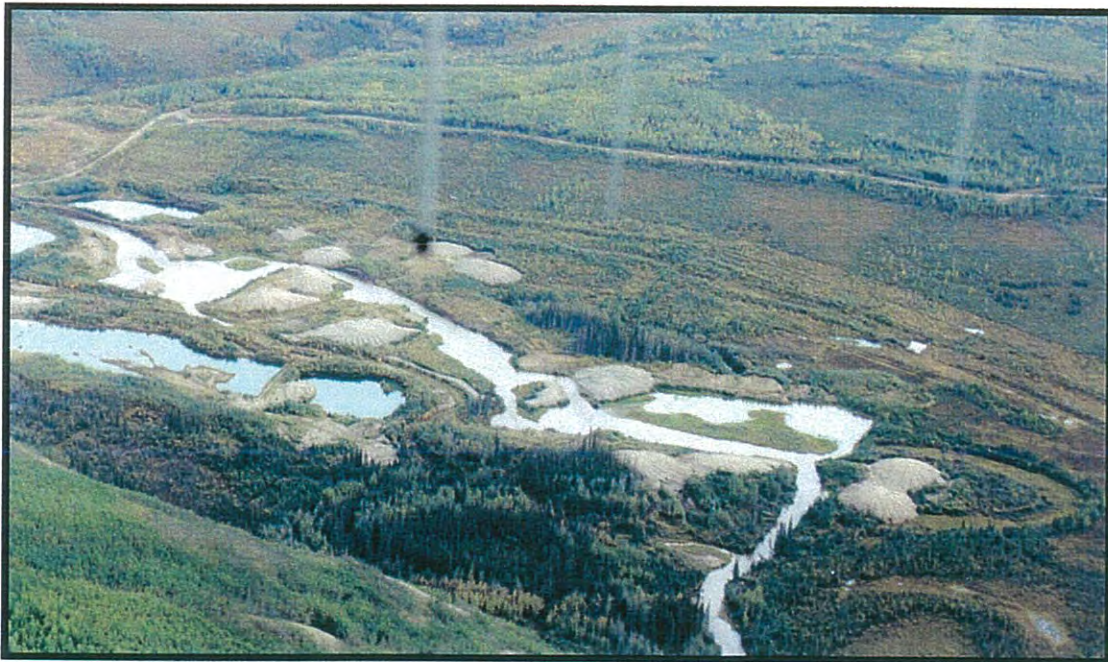
MM 02 - 78 - 12

Plate 4.2.15: Looking downstream on Dominion Creek/Indian River at GPS Location 84, showing how the channel is flowing through a series of excavated pits. Note the formerly diverted channel along the base of the right bank valley wall.

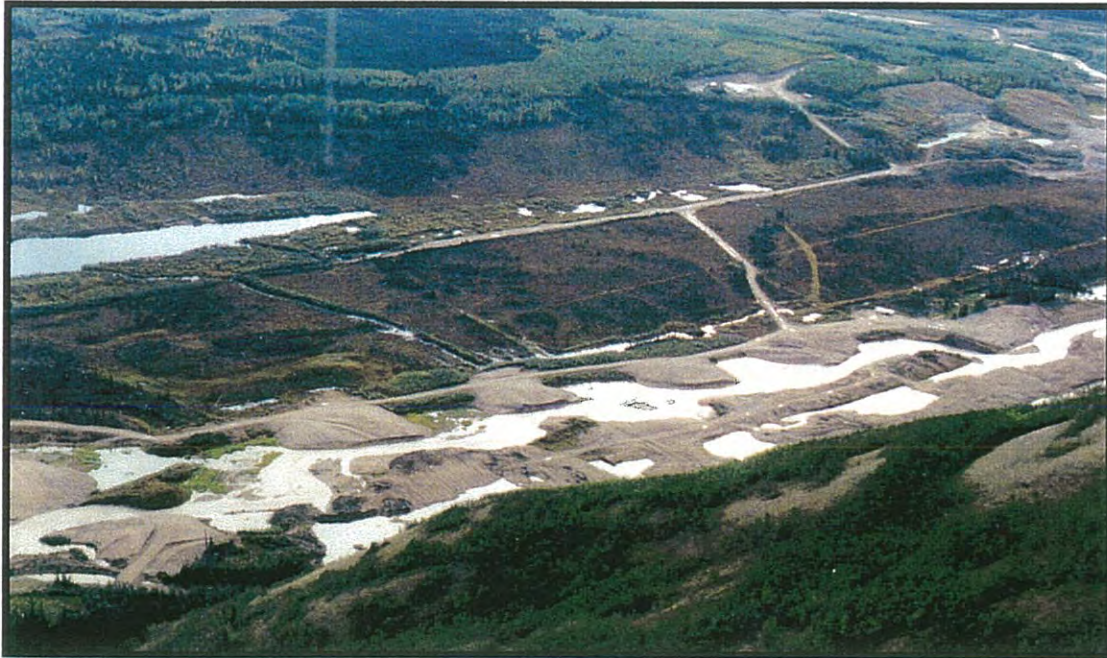
MM 02 - 78 - 14

Plate 4.2.16: Looking upstream to a diverted section of channel at GPS Location 85.

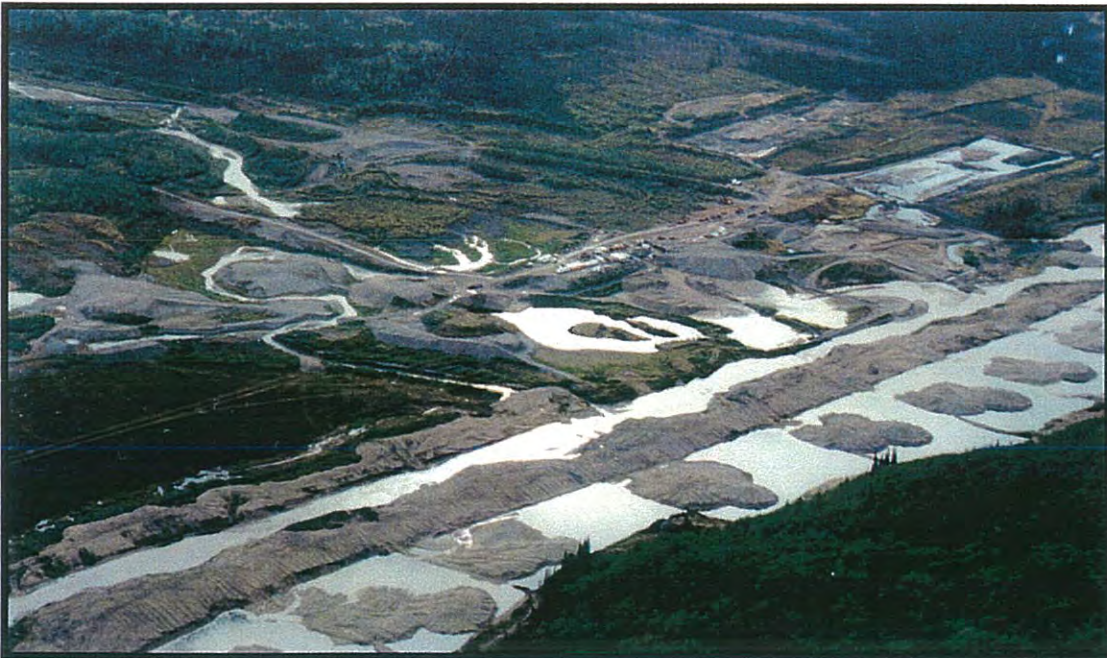
MM 02 - 78 - 16

Plate 4.2.17: Looking downstream to an excavated section of channel at GPS Location 87.

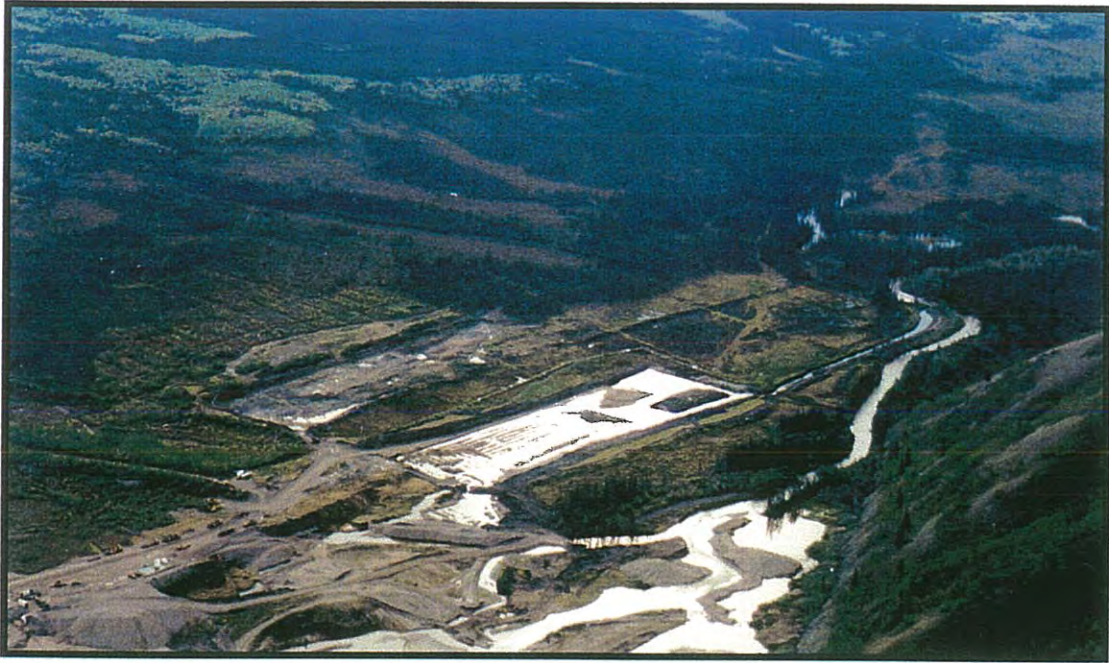
MM 02 - 78 - 18

Plate 4.2.18: Looking downstream to an excavated section of channel at GPS Location 88.

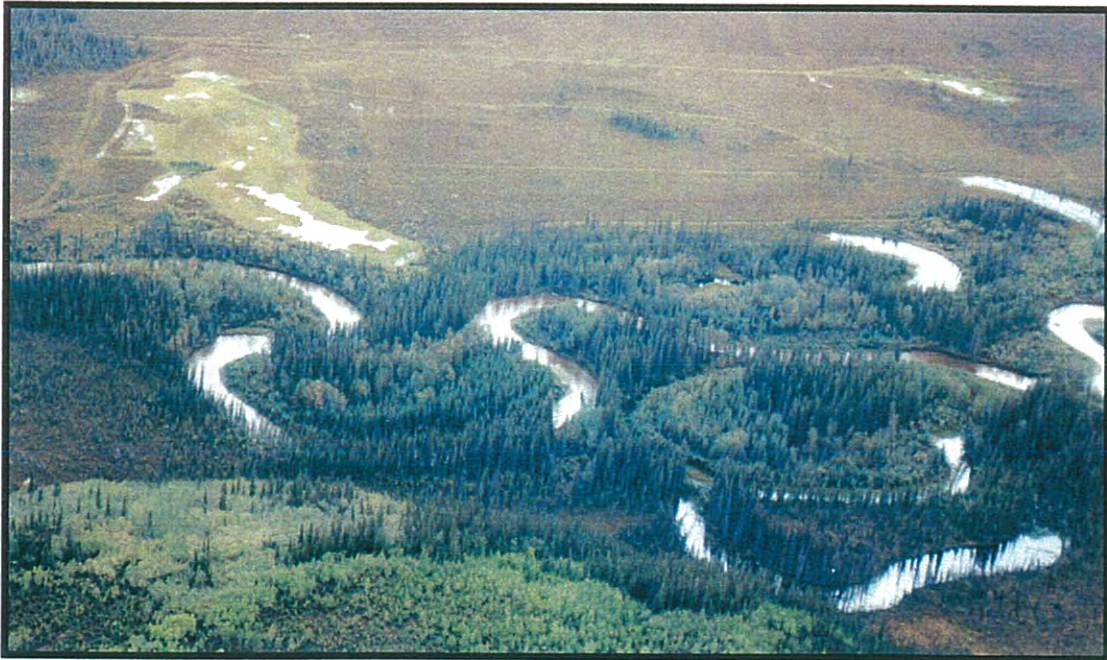
MM 02 - 78 - 19

Plate 4.2.19: Looking downstream at GPS Location 89 illustrating recent stripping activities upstream of an undisturbed section of Indian River.

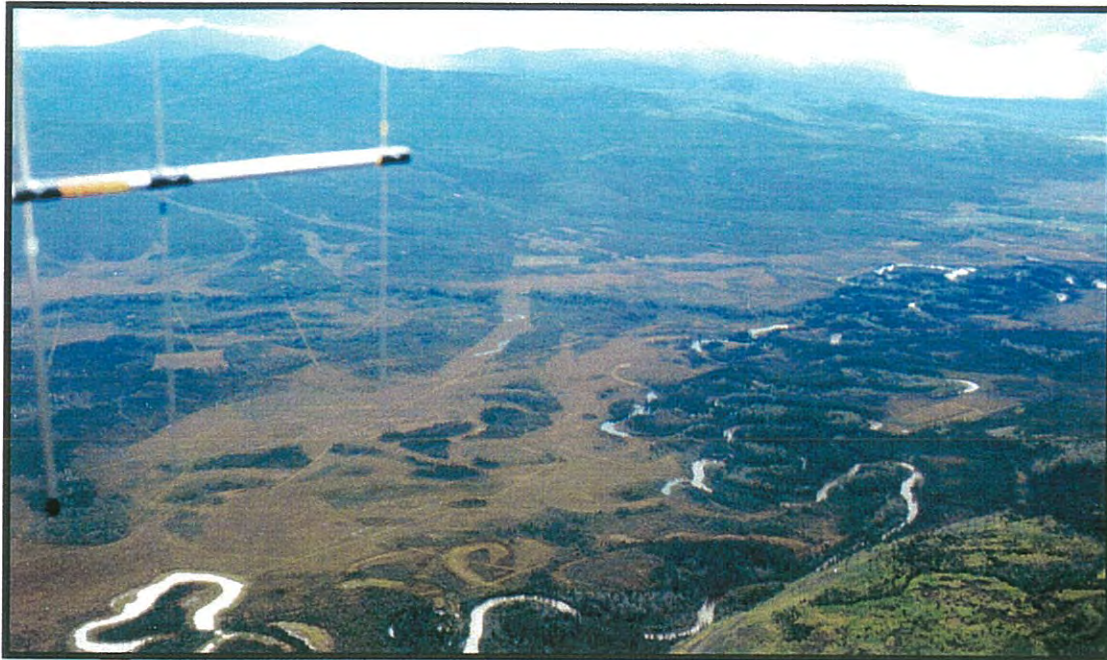
Plate 4.2.22: Looking upstream from GPS Location 94 comparing mined and unmined sections of channel.

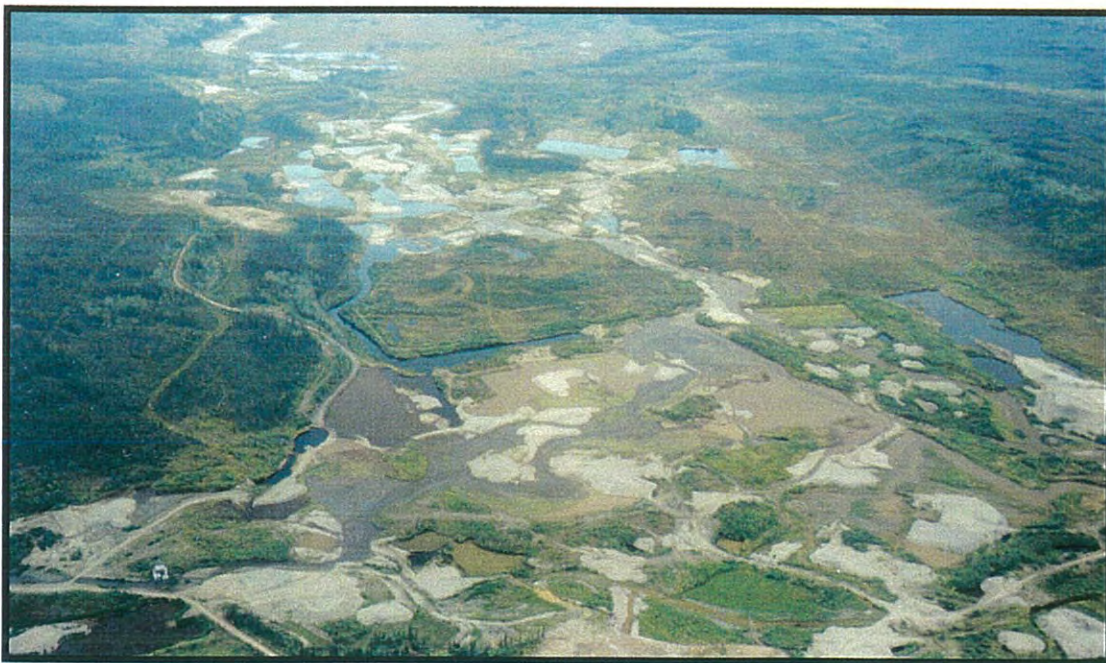
Plate 4.2.23: Looking downstream from GPS Location 98 showing the section of unmined channel which occurs between GPS Locations 92 and 100.

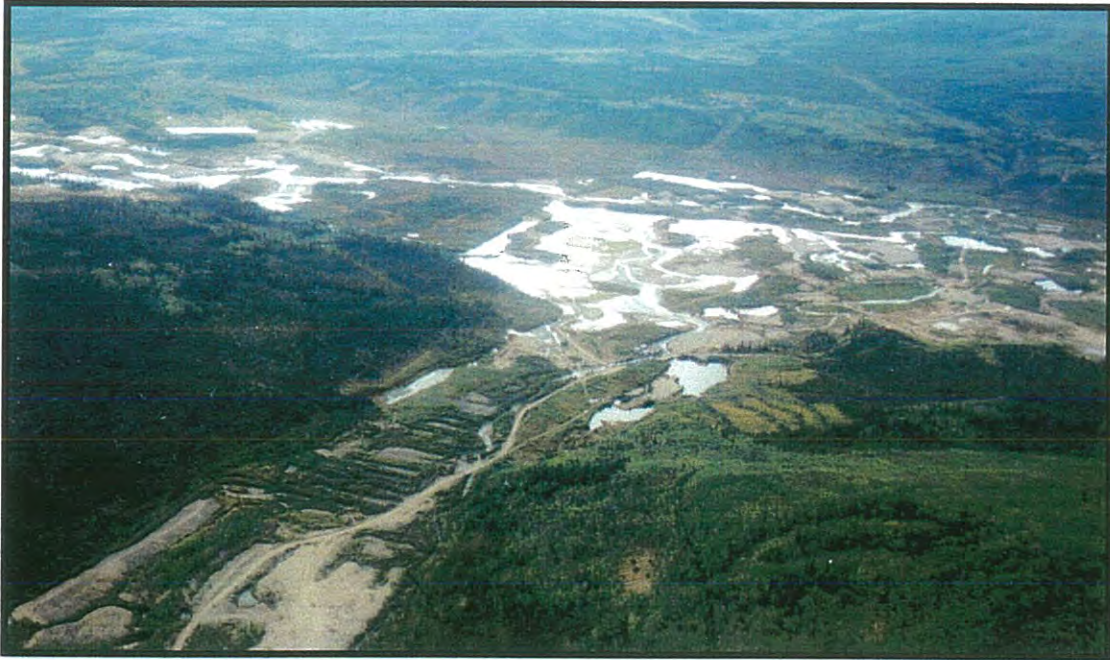
Plate 4.2.24: Looking upstream on Indian River from the Quartz Creek confluence. GPS Location 116.

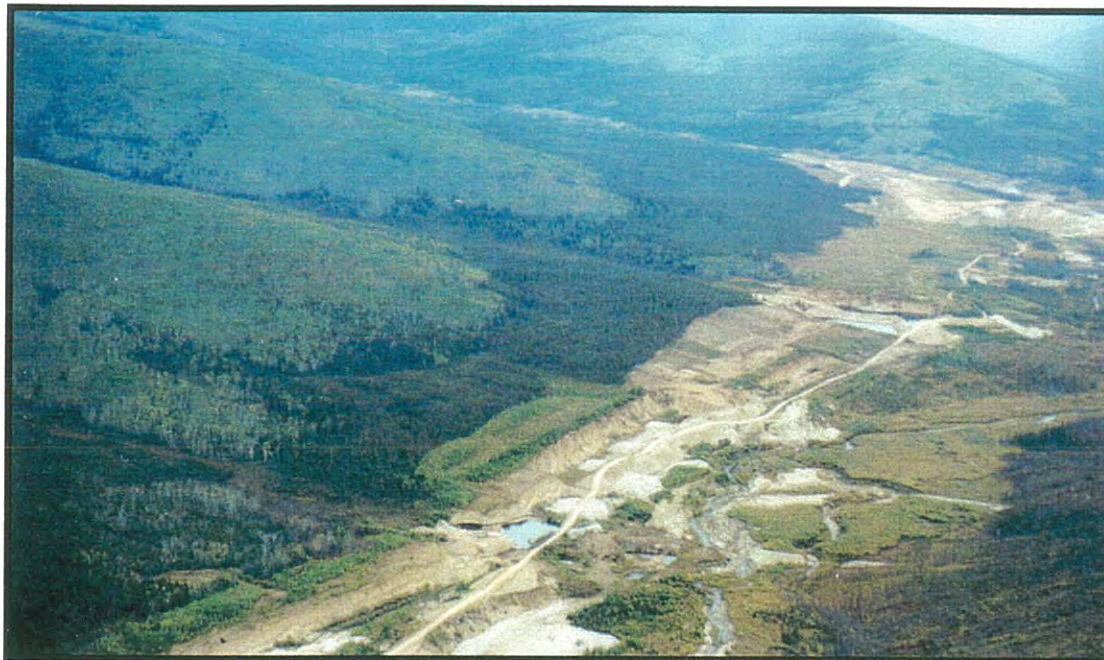
Plate 4.2.26: Low-lying moist areas between dredge spoil piles in Lower Quartz Creek support well established deciduous vegetation.

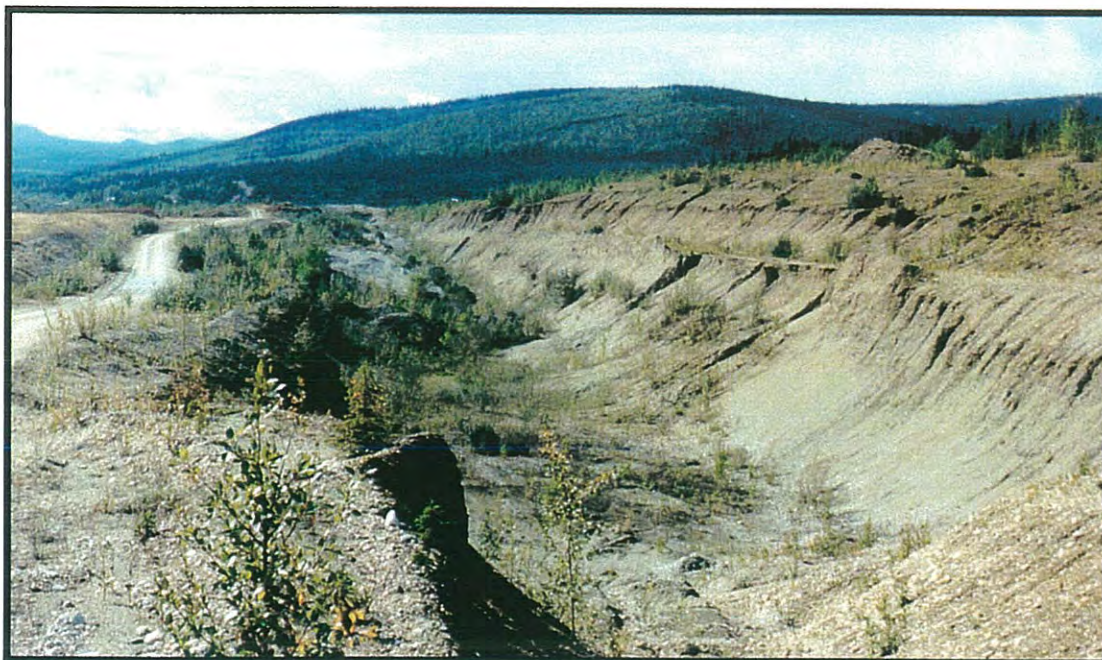
Plate 4.2.27: Looking upstream on Quartz Creek from GPS Location 118, showing the extensive valley bottom clearing and mining.

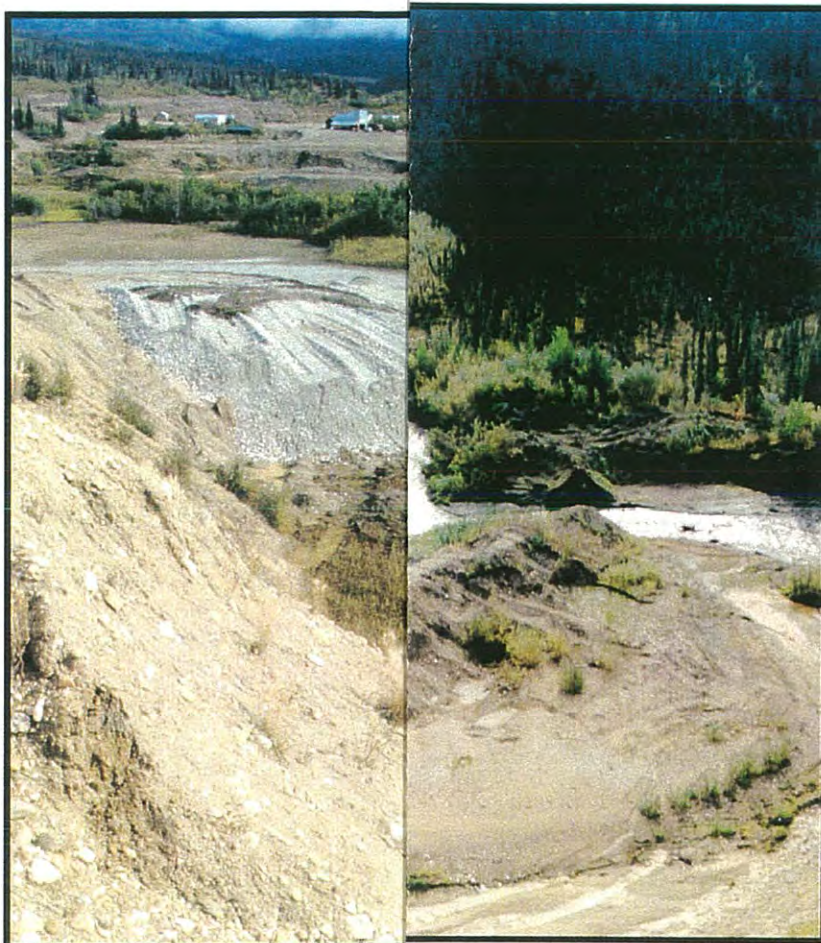
Plate 4.2.28: Looking downstream along right margin mining of white gravels near GPS Location 118.

Margin mining was commonly observed to result in over-steepened sections of valley wall with associated thermokarst in ice-rich material. Providing a toe berm on which failed material can collect would commonly facilitate the establishment of angle of repose slopes and revegetation. In some areas it could be desirable to move waste spoil piles into the margin excavations to expedite re-vegetation of both the source and disposal areas.

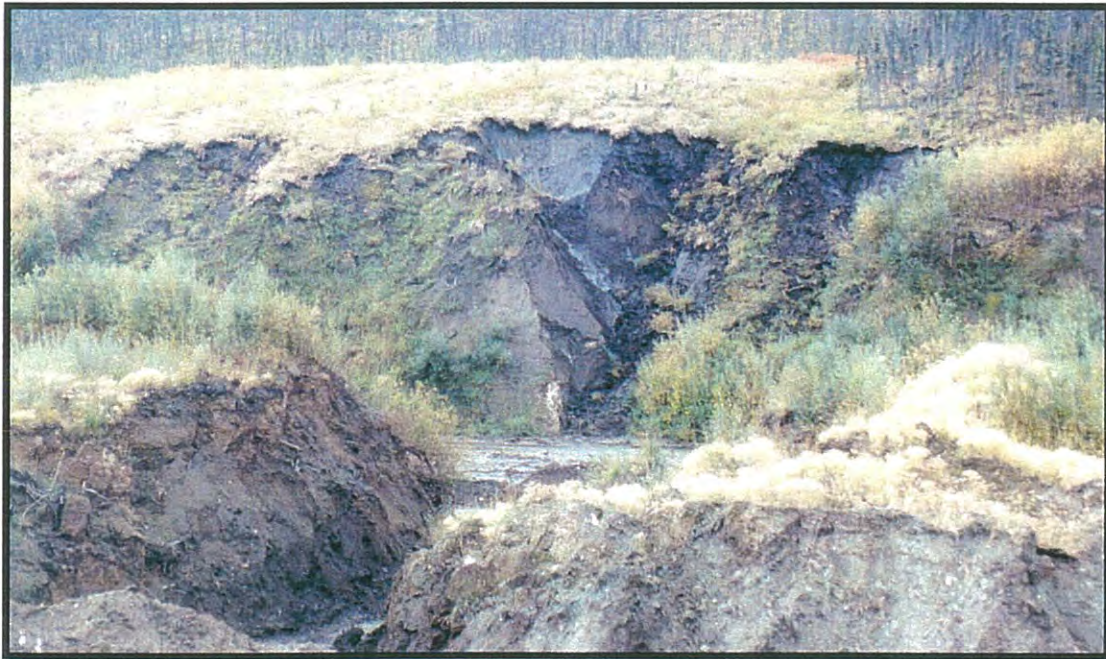
Plate 4.2.29: Looking upstream on Quartz River erosion in the diverted and laterally constrained channel is eroding

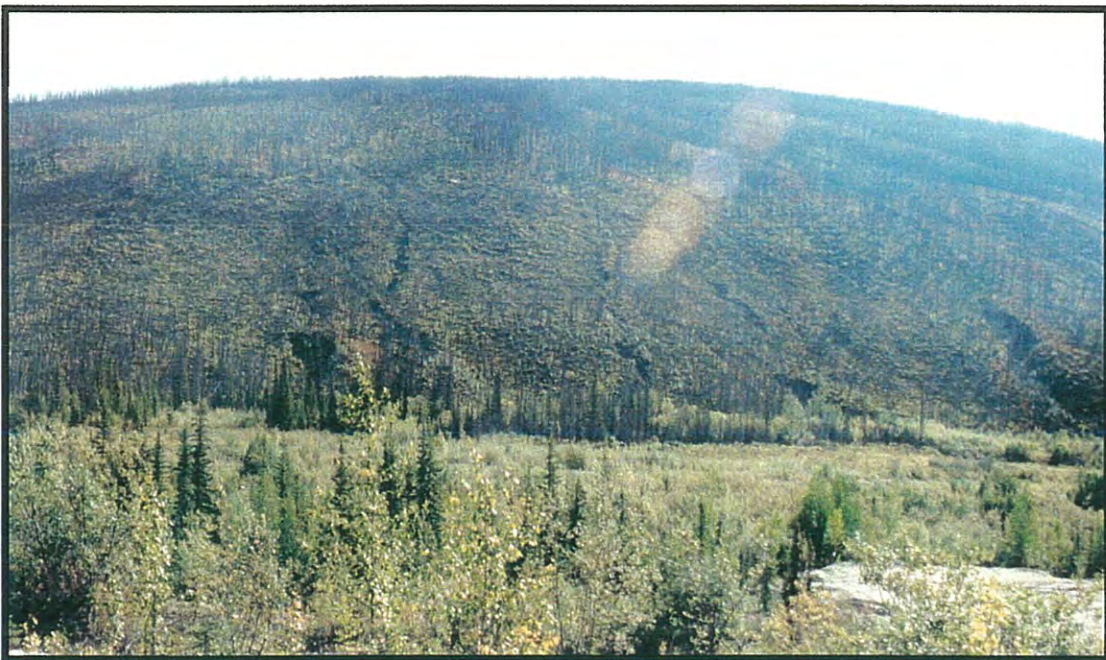
Plate 4.2.30: The toe of many overburden stock piles, such as that illustrated on Plate 4.2.29 is eroding and subject to thermokarst.

The historic disposal of overburden on the valley wall was observed to create long term slope stability problems in areas where underlying ice-rich sediments subsequently began to fail. The transport of this material back onto the valley flat is likely not warranted (or economically feasible) in most inspected sites. However, bio-engineering could be used to stabilise local problem areas and, in some areas, the re-contouring of over-steepened spoil piles may be needed to allow vegetation to develop.

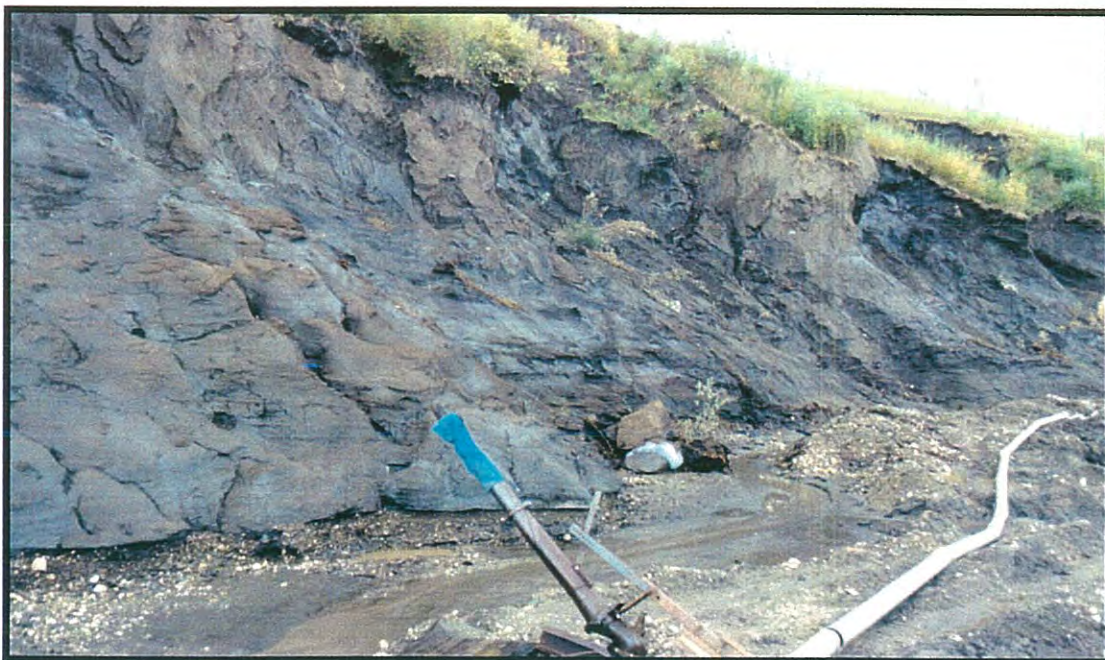
Plate 4.2.32: Looking upstream to a left bank tributary to Quartz Creek, showing hydraulic mining in 1992. [Near GPS Location 121.]

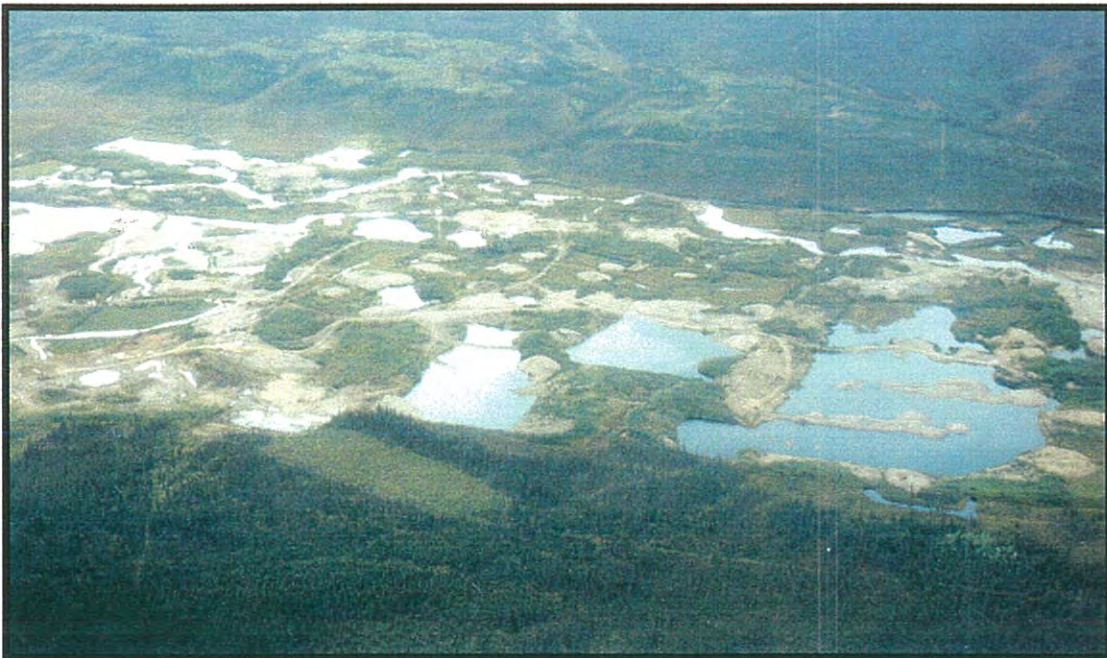
Plate 4.2.37: Looking south showing sediment deposits in the newly formed mainstem of Indian River downstream of Quartz Creek. [GPS Location 116.]

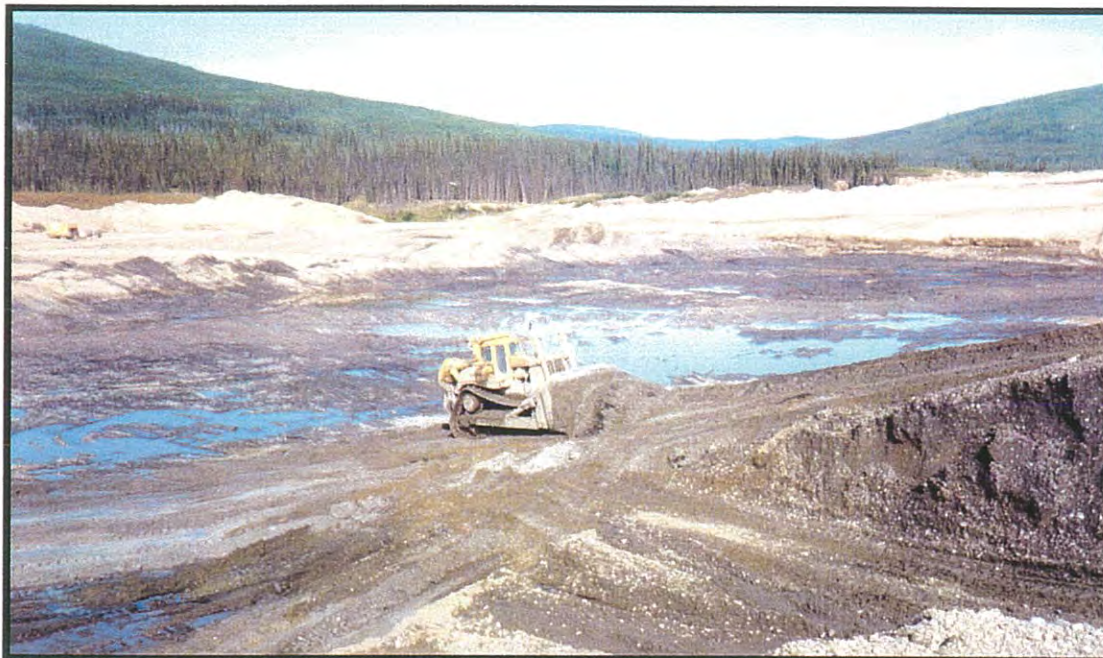
Plate 4.2.38: Looking south showing the extensive network of pits and former settling ponds on Indian River downstream of Quartz Creek. [GPS Location 115.]

As discussed in SECTIONS 5.3 and 5.4, there often appears to be an opportunity to connect excavated pits and ponds to the mainstem river, or re-route the channel through these areas. Our field observations suggest that grayling may be using off-channel or wetland areas formed by mining activities. Moose and waterfowl were also observed in these areas. Utilization of these area by rearing chinook does not presently appear to be well understood. This may, again, be an area where more research is needed.

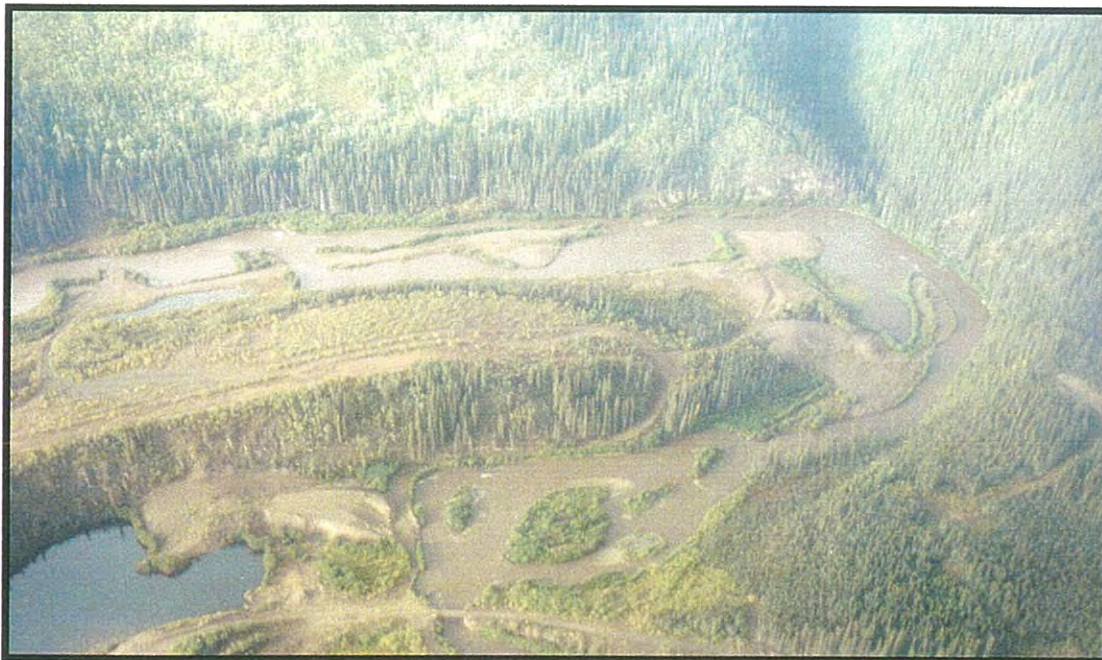
Plate 4.2.42: Looking upstream on Indian River in 1992, showing an unprotected access road and a mid-channel overburden pile.

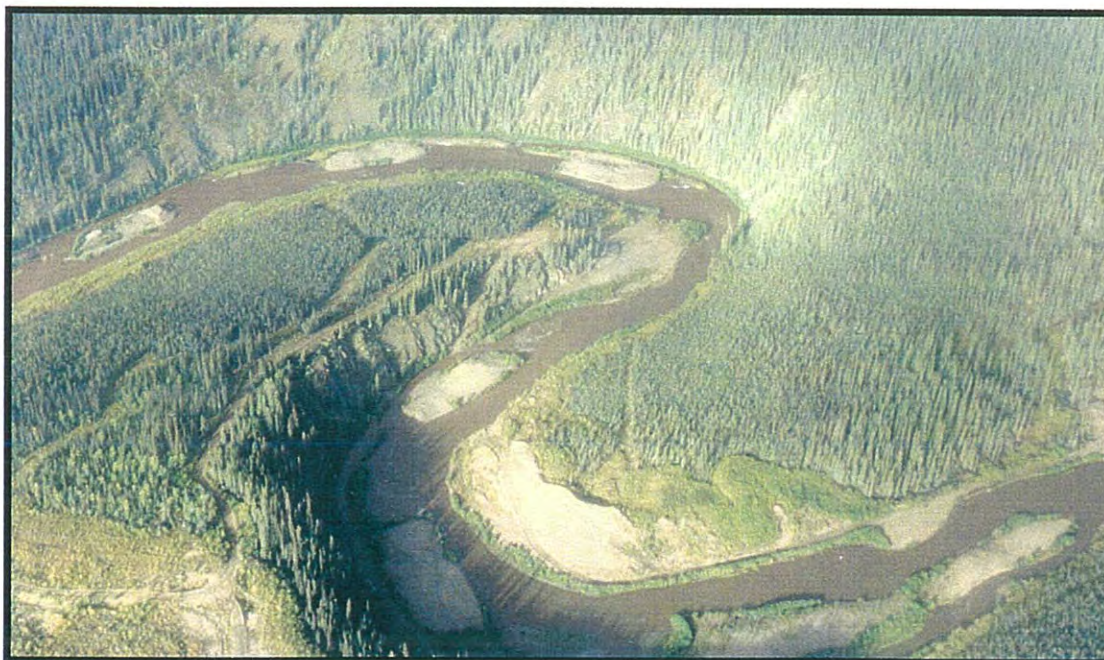
Plate 4.2.43: Looking downstream to a mined section of valley flat at GPS Location 12 BRD6.

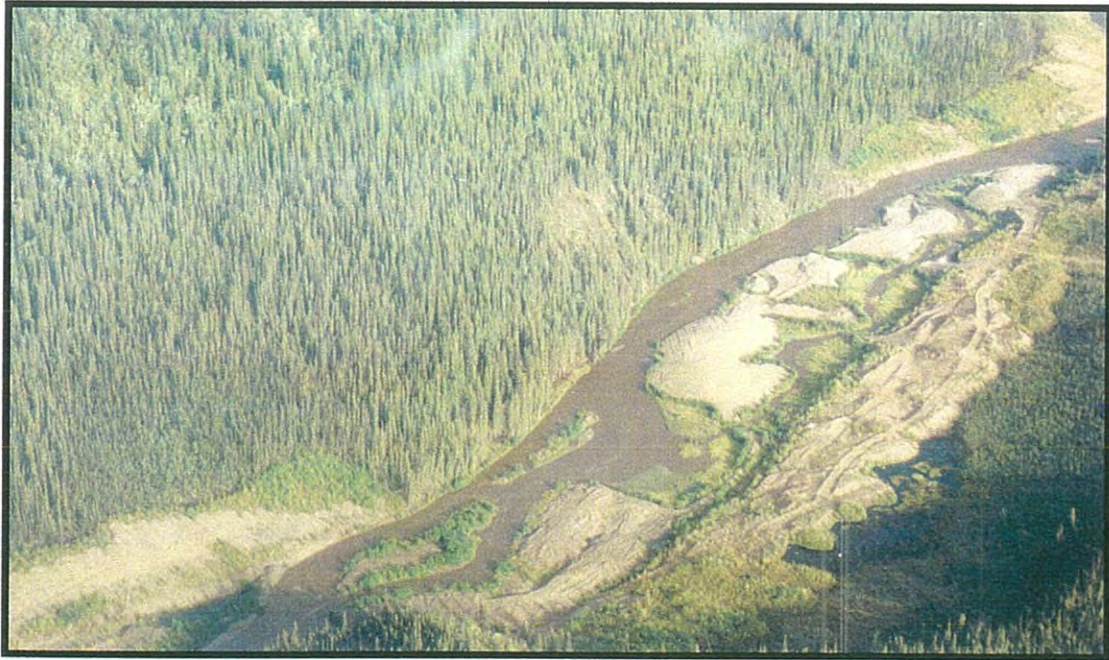
Plate 4.2.44: Looking downstream to a mined section of valley flat at GPS Location 107.

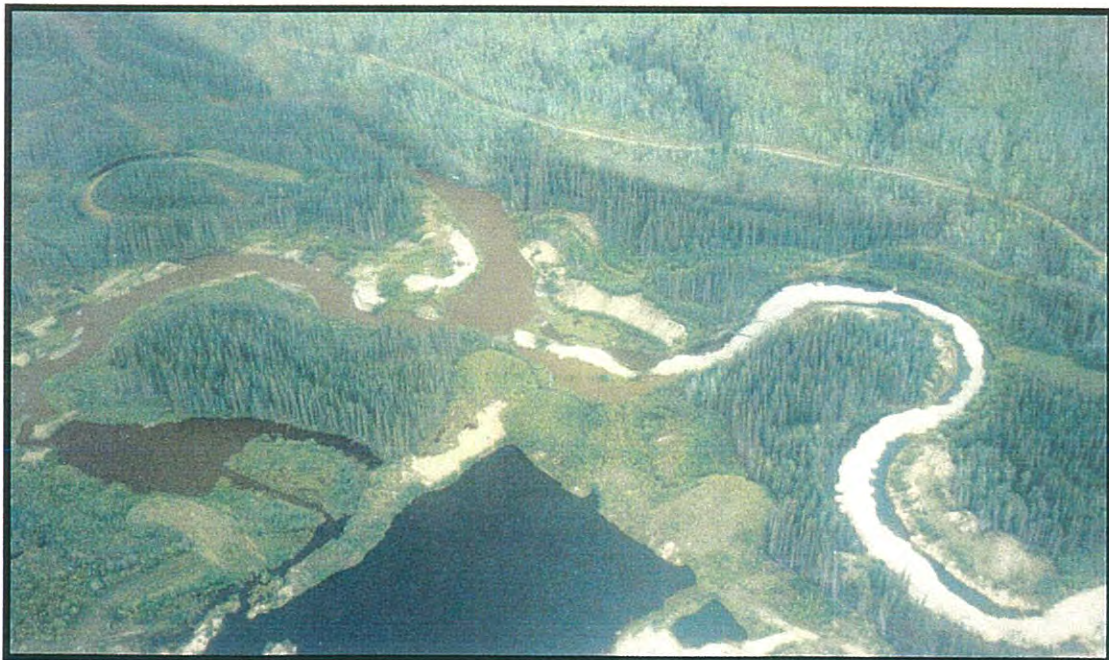
Plate 4.2.45: Looking upstream to a mined section of valley flat at GPS Location 108.

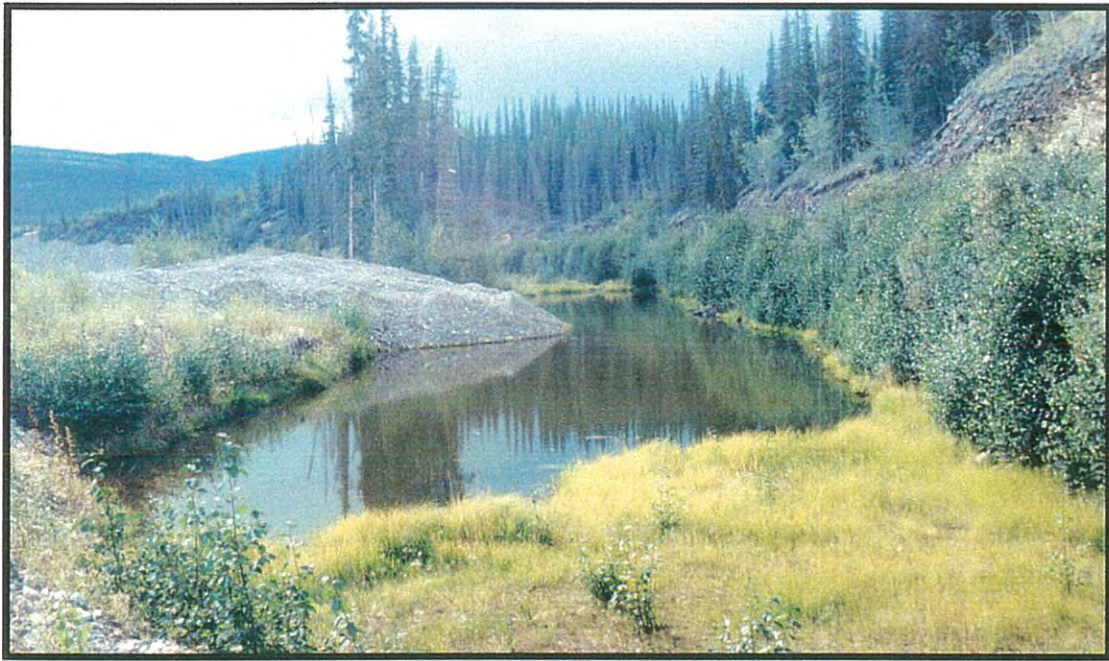
Plate 4.2.46: Looking upstream to a linear spoil pile located in what used to be the mainstem channel. [GPS Location 115.]

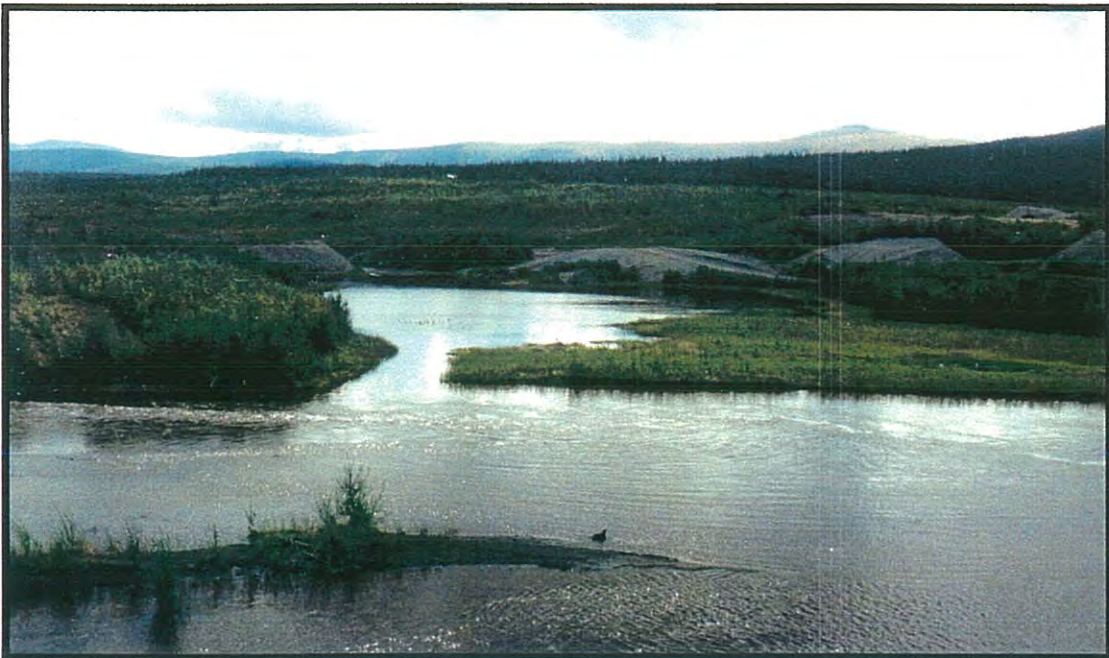
Plate 4.2.47: Looking downstream along a revegetated section of side-cast road fill and a cut-off section of channel.

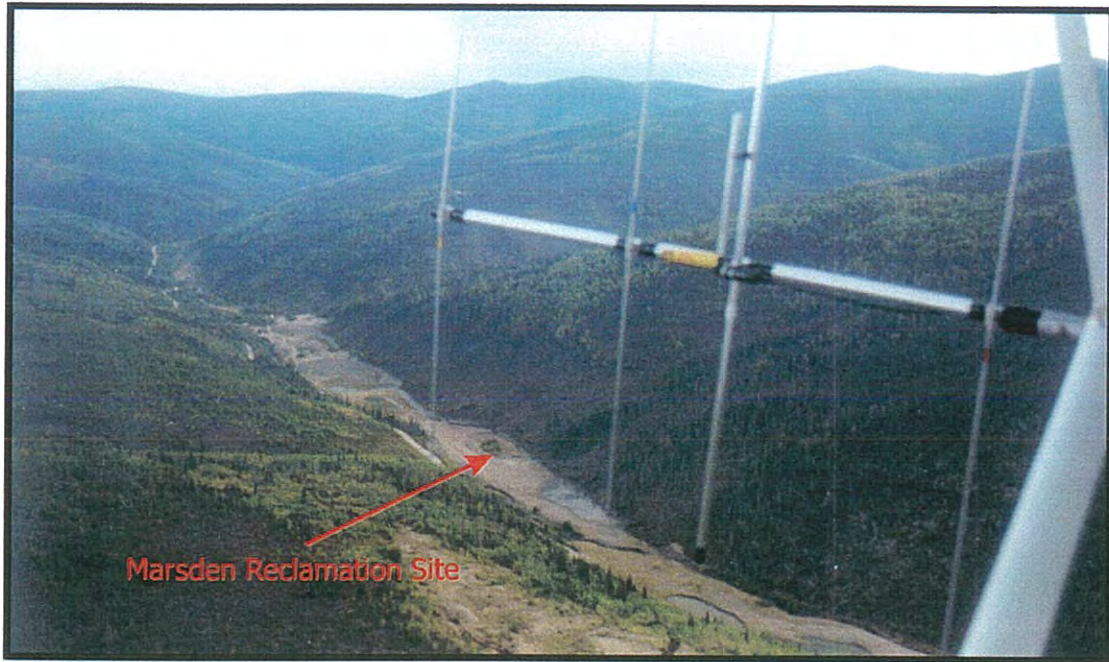
Plate 4.3.1: Looking downstream on Gold Bottom Creek from GPS Location 123.

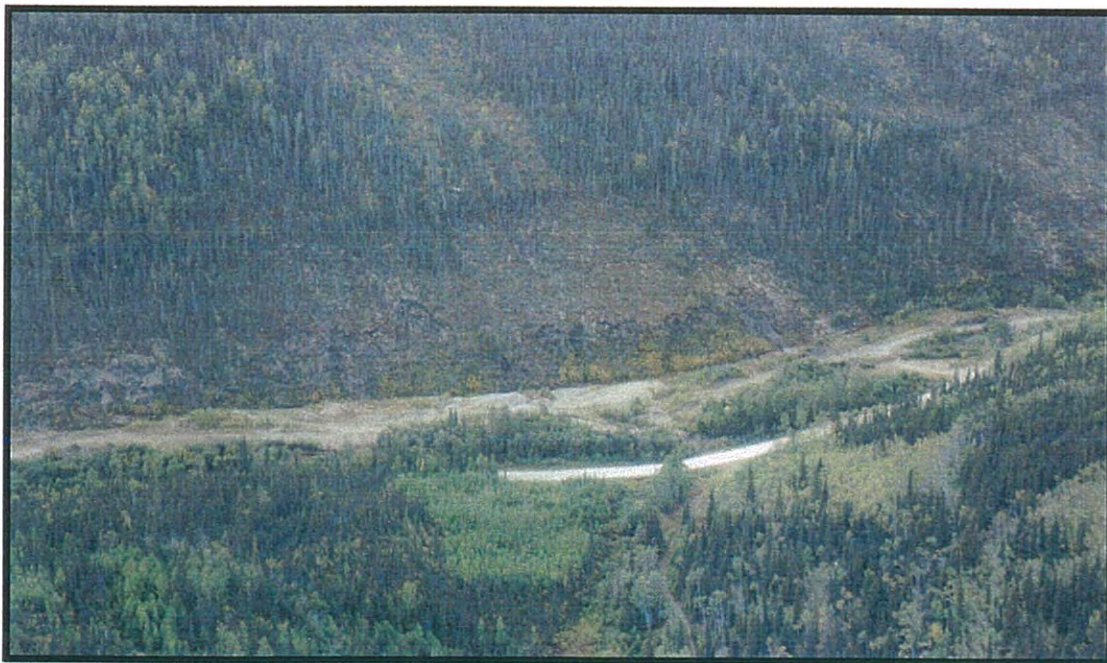
Plate 4.3.2: Looking upstream to the headwaters of Hunker Creek showing the nearly continuous mining activity. [GPS Location 57.]
