CRE - 86 - 02

RESTORATION OF PLACER MINED STREAMS: IDENTIFICATION OF STRATEGIES TO EXPEDITE RECOVERY

Prepared by:
M. MILES & ASSOCIATES LTD.
645 Island Road
Victoria, B.C.
V8S 2T7
Phone: 250-595-0653
email: mmaa@coastnet.com

MAY 2003

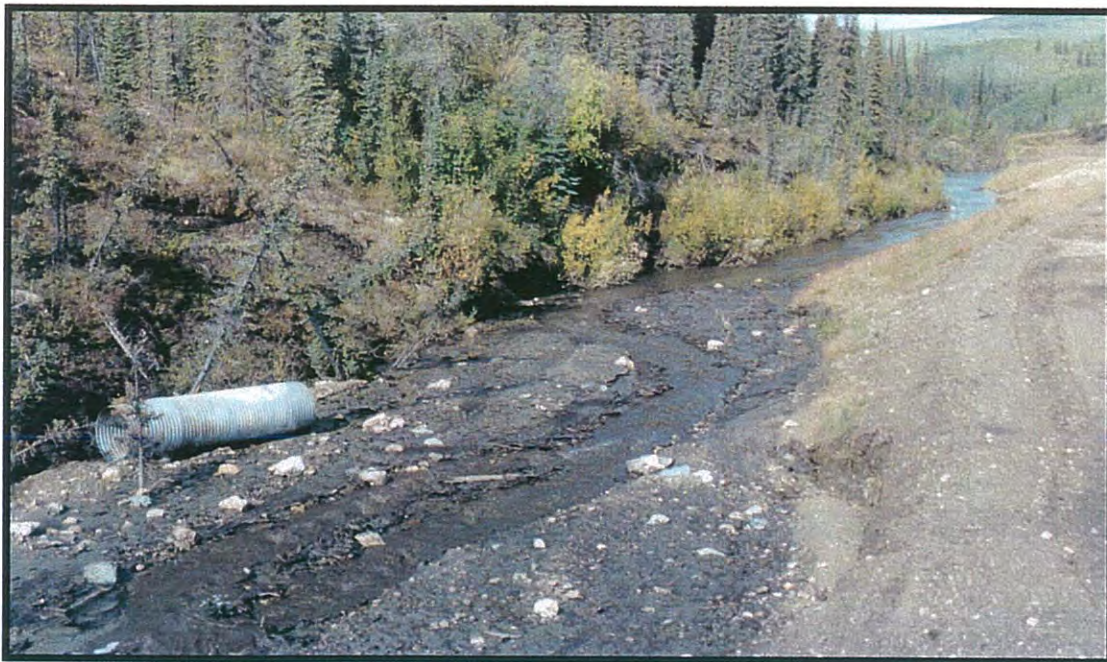
Plate 4.3.7: Looking upstream to the failed settling pond outlet.

Another important issue is the need for the on-going maintenance of settling ponds. Our field observations suggest that these structures typically infill, the toe dam overtops, the outlet fails and much of the collected sediment is washed downstream. Periodic sediment removal, until such time as the sediment source areas stabilize, would be a relatively inexpensive and beneficial activity. This material could possibly be used to top dress poorly re-vegetating sites.

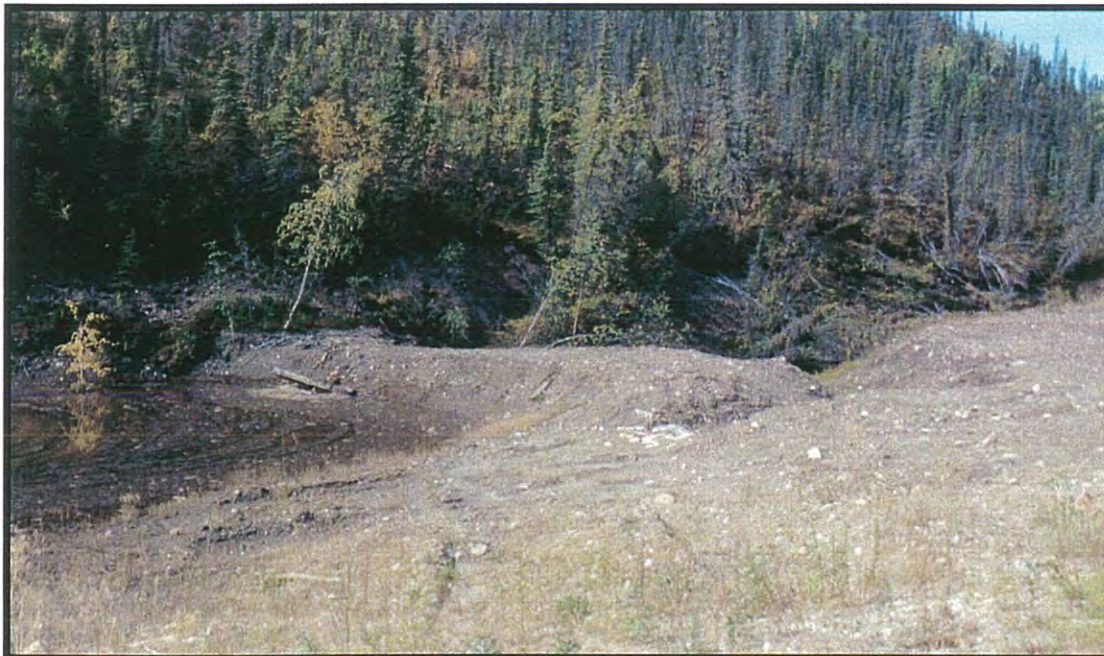
Plate 4.3.8: Looking downstream showing the eroded culvert and the sediment being delivered to the wall based channel.

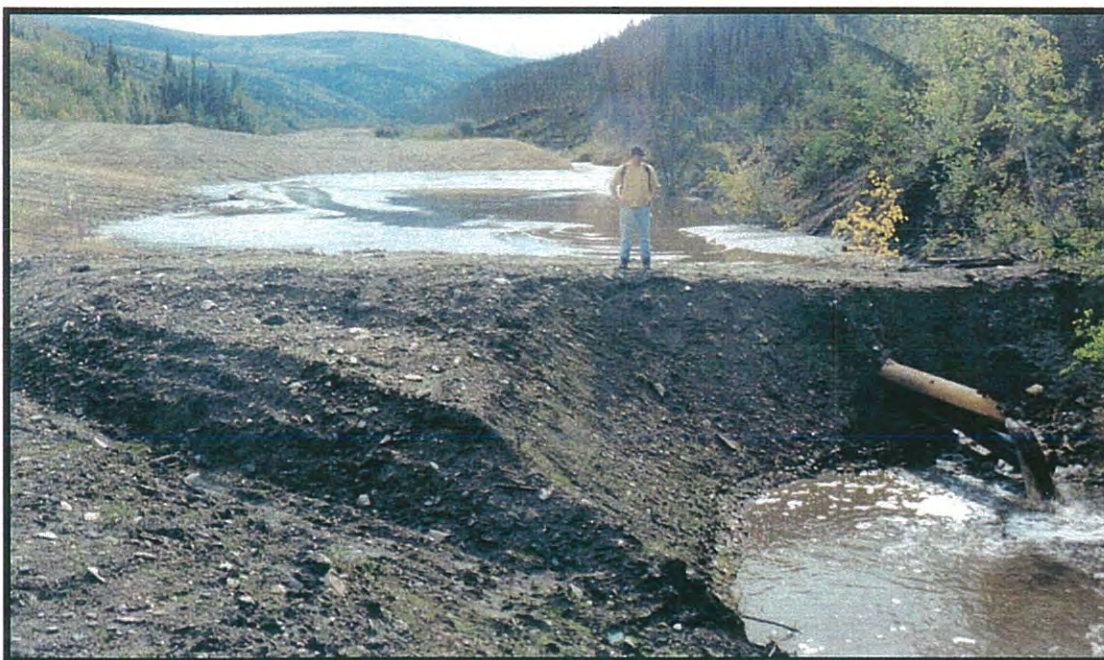
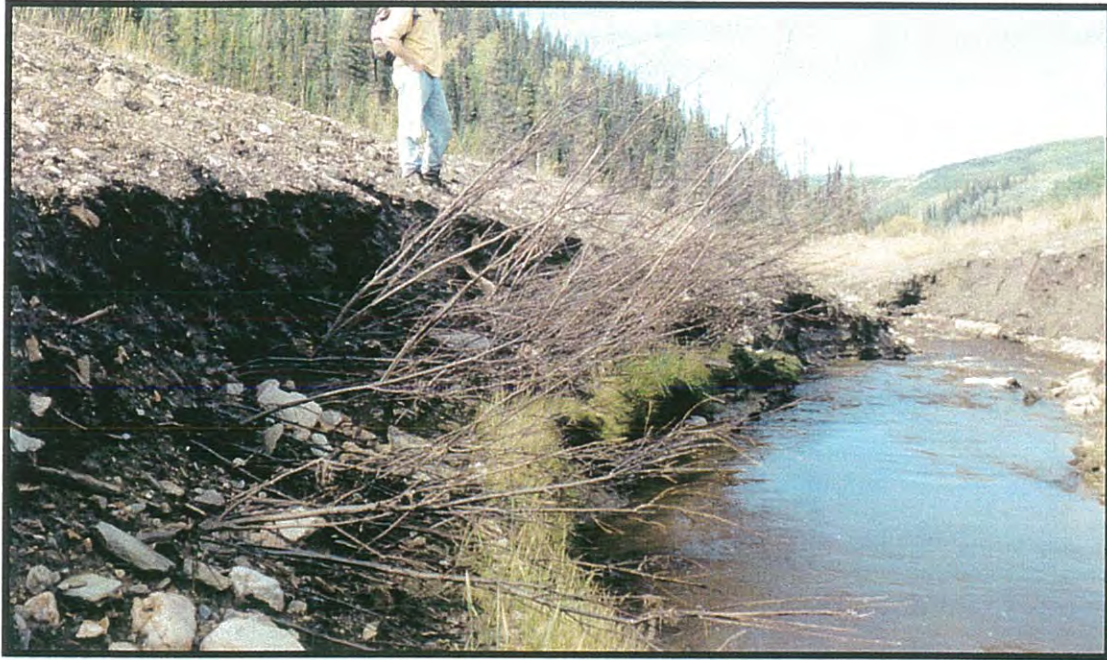
Looking downstream to the toe dam

Looking upstream over the toe dam

Plate 4.3.9: Photographs of the second settling pond on the Marsden Site which appears likely to suffer from the same fate as the upper structure.

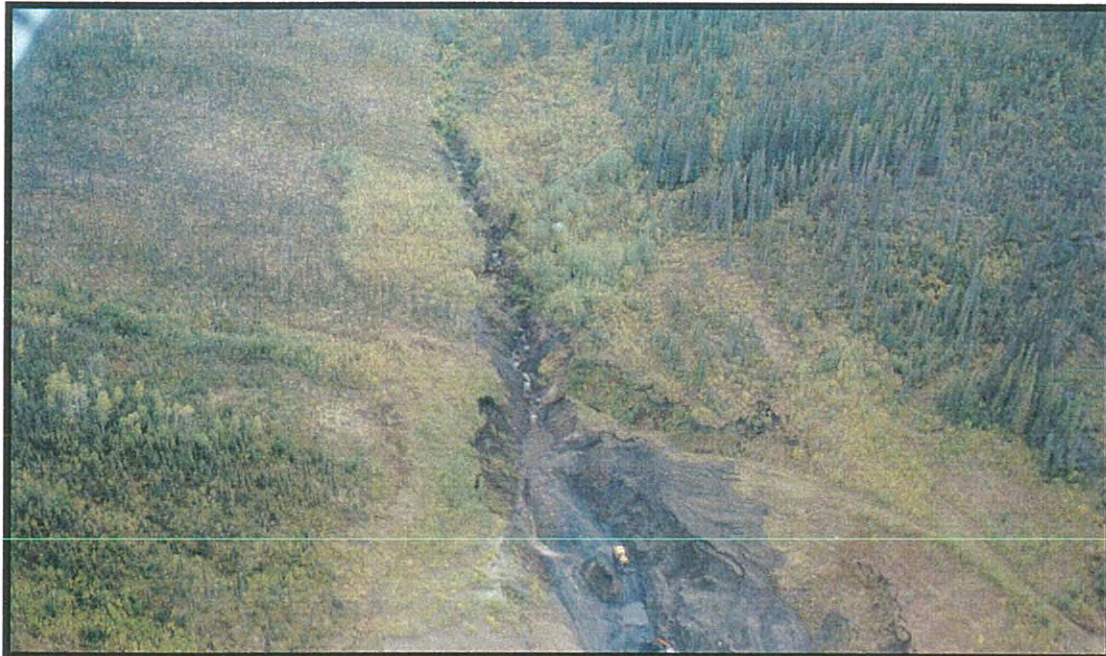
Plate 4.3.11: Looking upstream on Hunker Creek showing the valley flat revegetation in the vicinity of GOS Location 35.

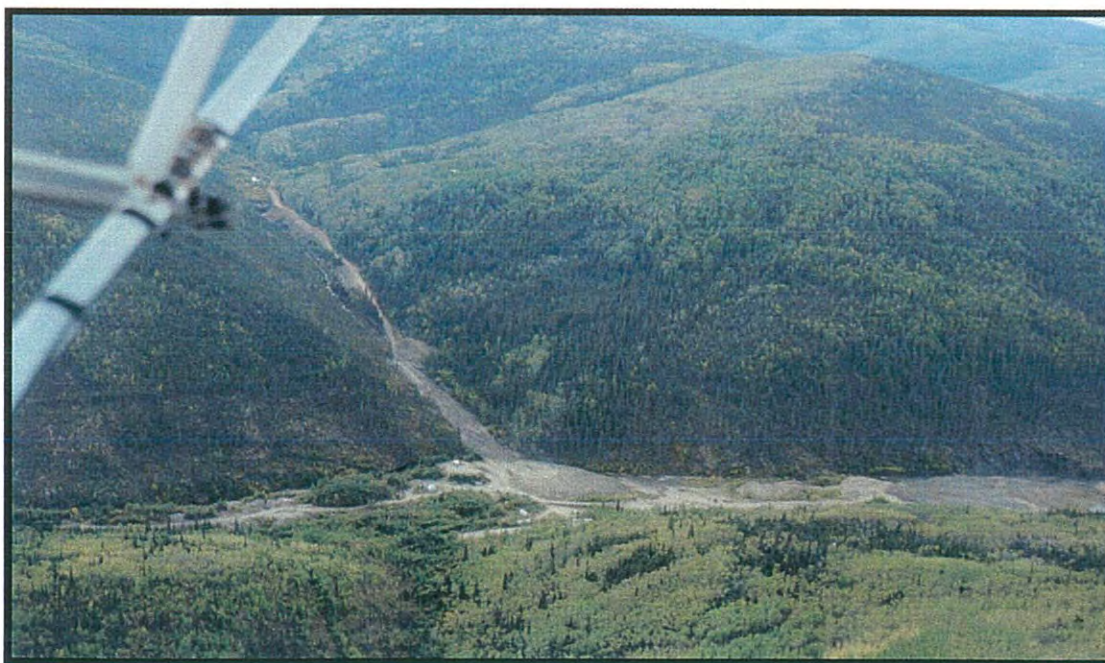
Plate 4.3.12: Looking upstream showing the channel downcutting which is occurring above the active mining area on this 'pup'. [GPS Location 52.]

of the channel bed and the adjacent valley walls in areas of ice-rich permafrost. Re-establishment of the original channel bed elevation by importing waste material or by constructing check dams may be required to prevent some sites from retrogressing upstream. Similarly, bio-engineering techniques could be used to expedite the stabilisation of eroding sections of valley wall. The cost of undertaking this type of work would, however, be substantial.

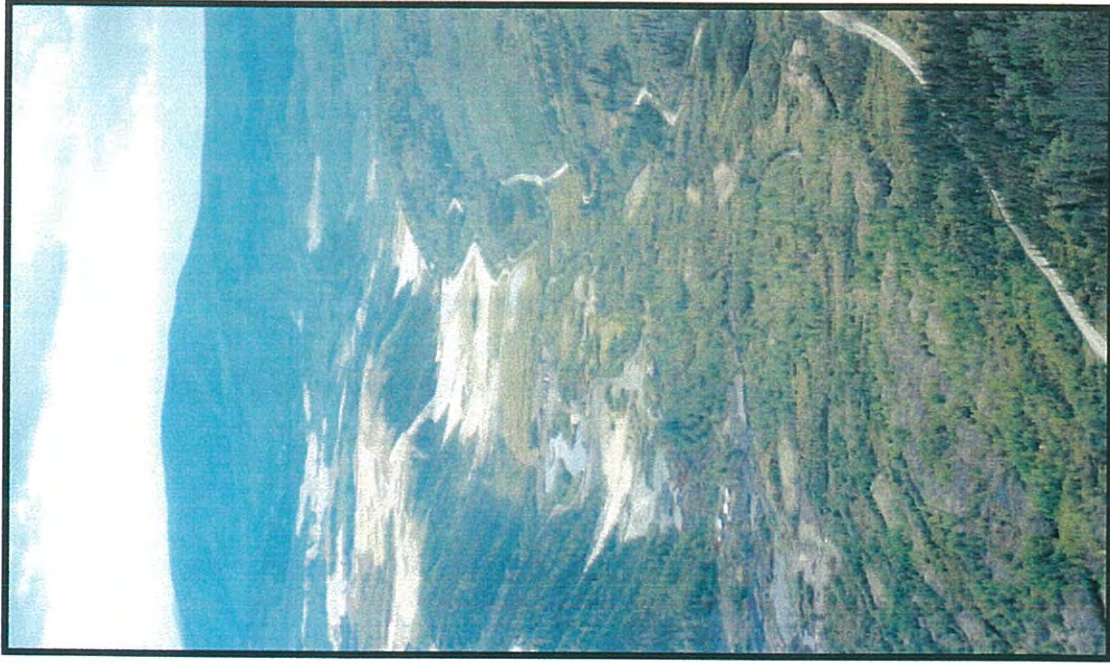
Plate 4.3.13: Looking upstream on a mined tributary showing the fan which has formed at the Confluence with Hunker Creek. [GPS Location 58.]

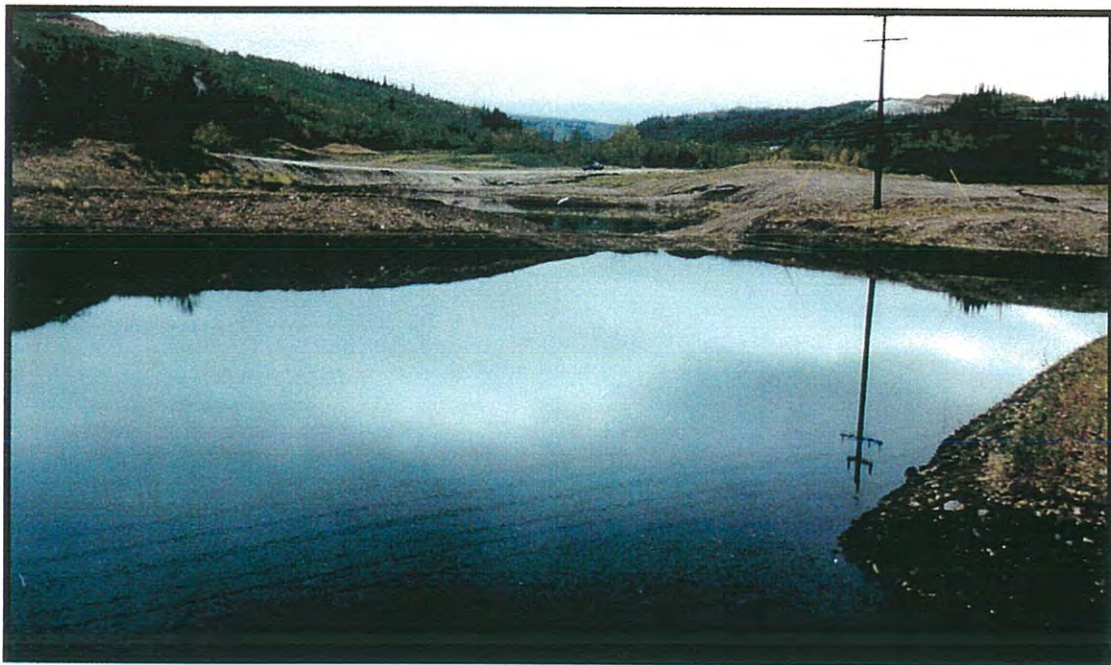
Plate 4.3.16: Looking downstream on Lower Hunker Creek showing upslope mining activity and large settling ponds in the Hunker Creek valley bottom. [GPS Location 125.]

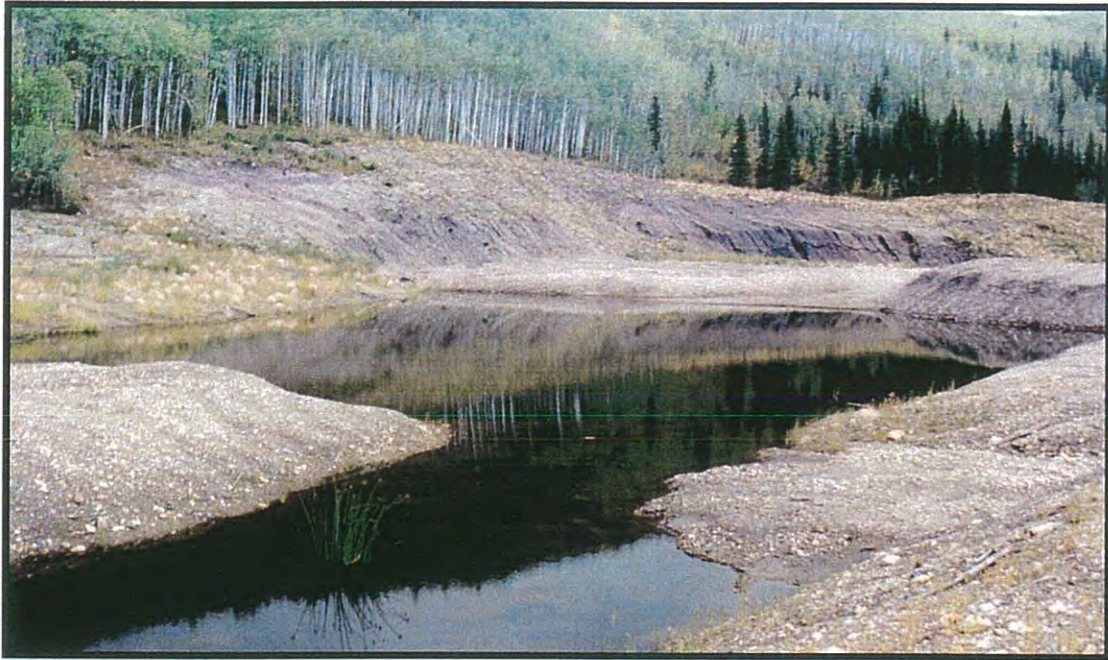
Plate 4.3.17: Looking up valley to the ponds constructed by D. Busat below the Hunker Creek Access Road.

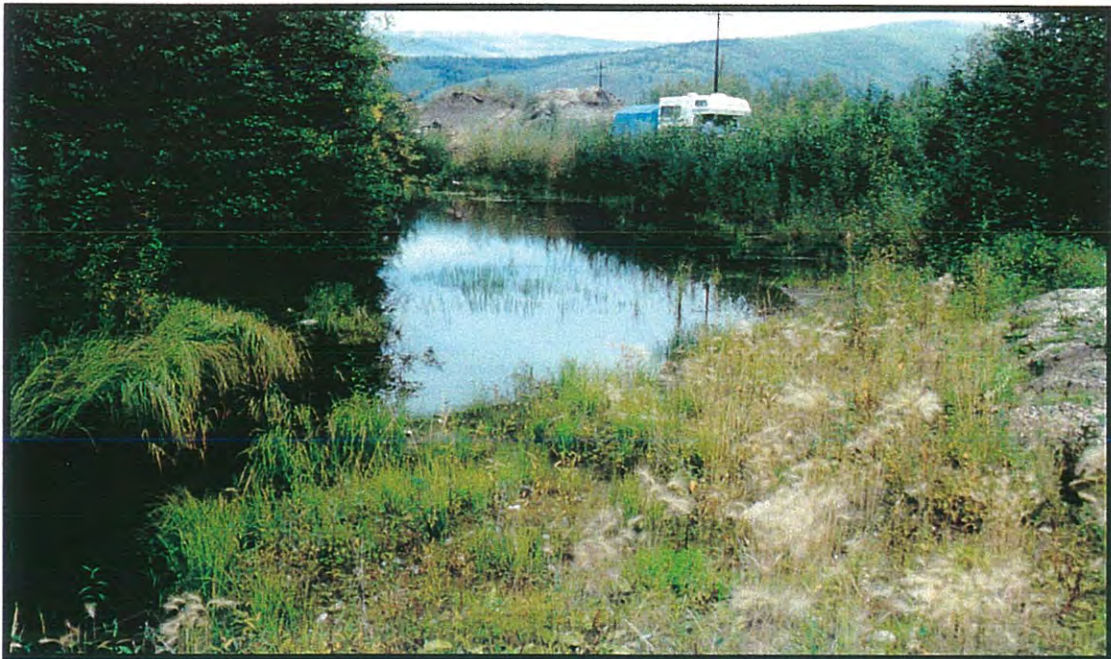
Plate 4.3.18: Looking up valley to the ponds constructed by D. Busat upstream of the Hunker Creek Access Road.

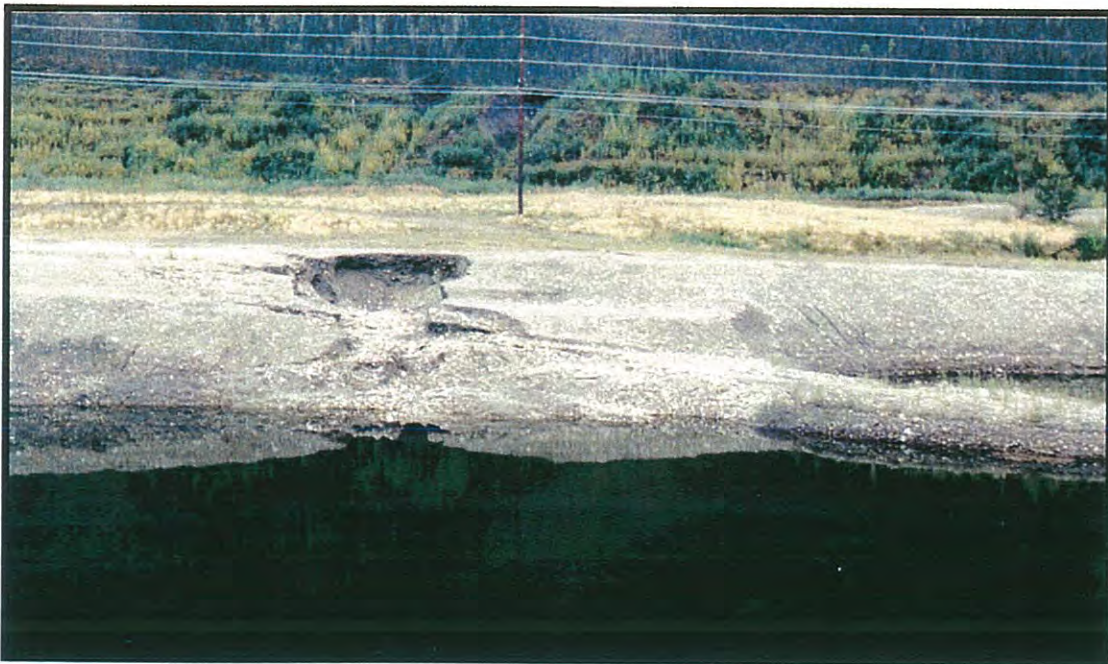
Plate 4.3.20: Annual and perennial vegetation is establishing on many stable re-contoured surfaces.

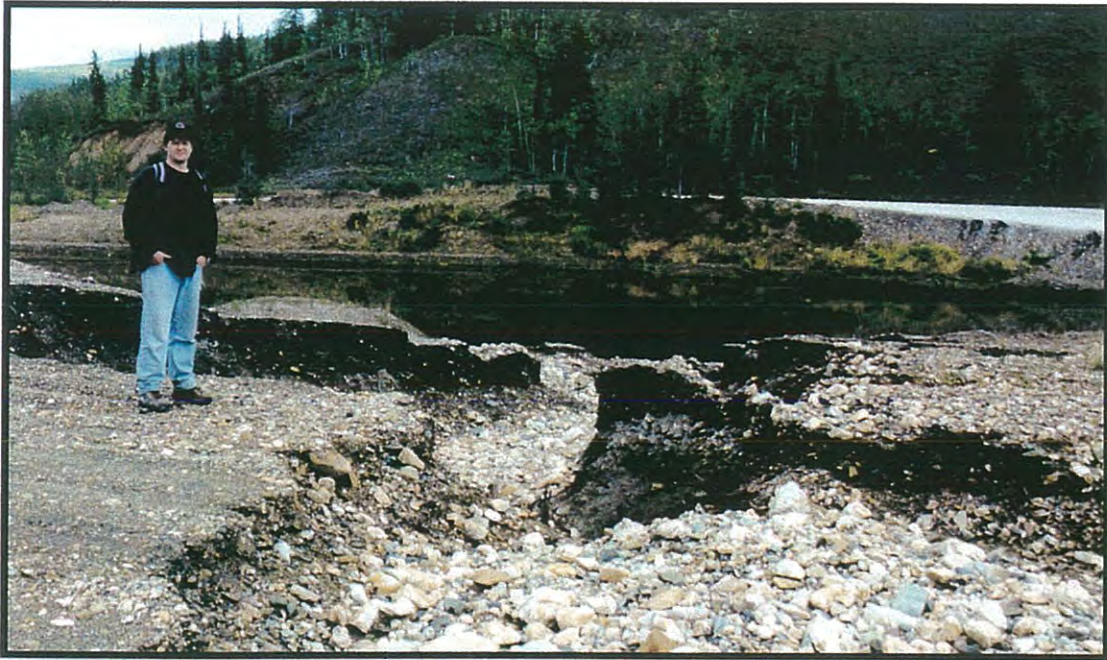
Plate 4.3.21: Revegetation is less successful on more recently contoured, well drained or unstable sites.

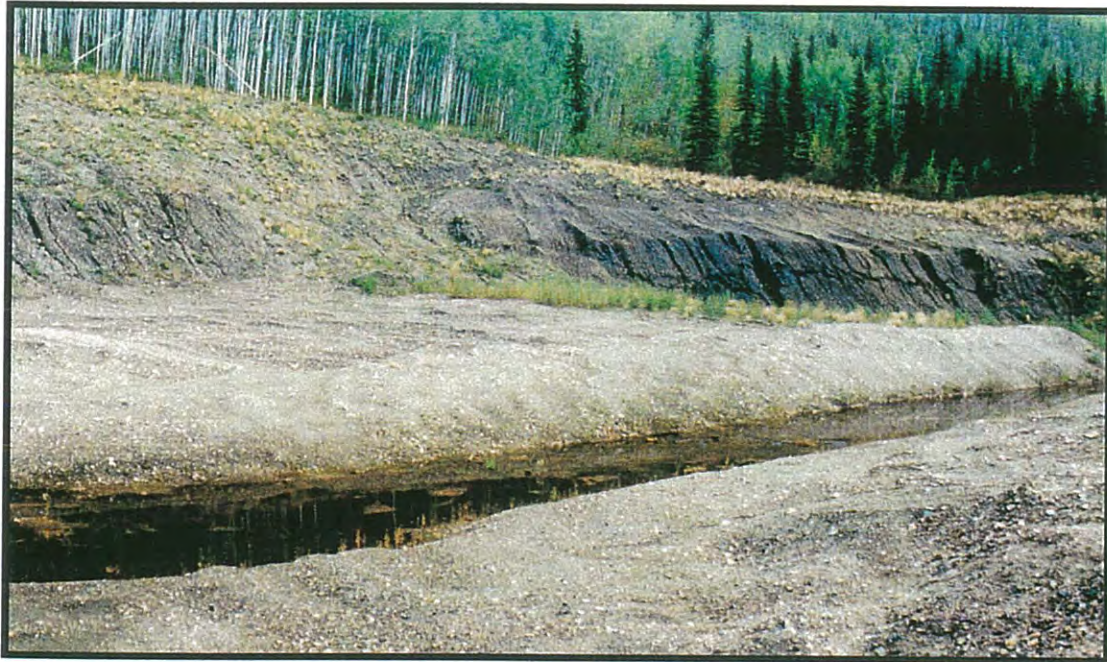
MM 02 - 75 - 32A

Plate 4.3.23: Gullies are also forming on steep fine-textured cut slopes.

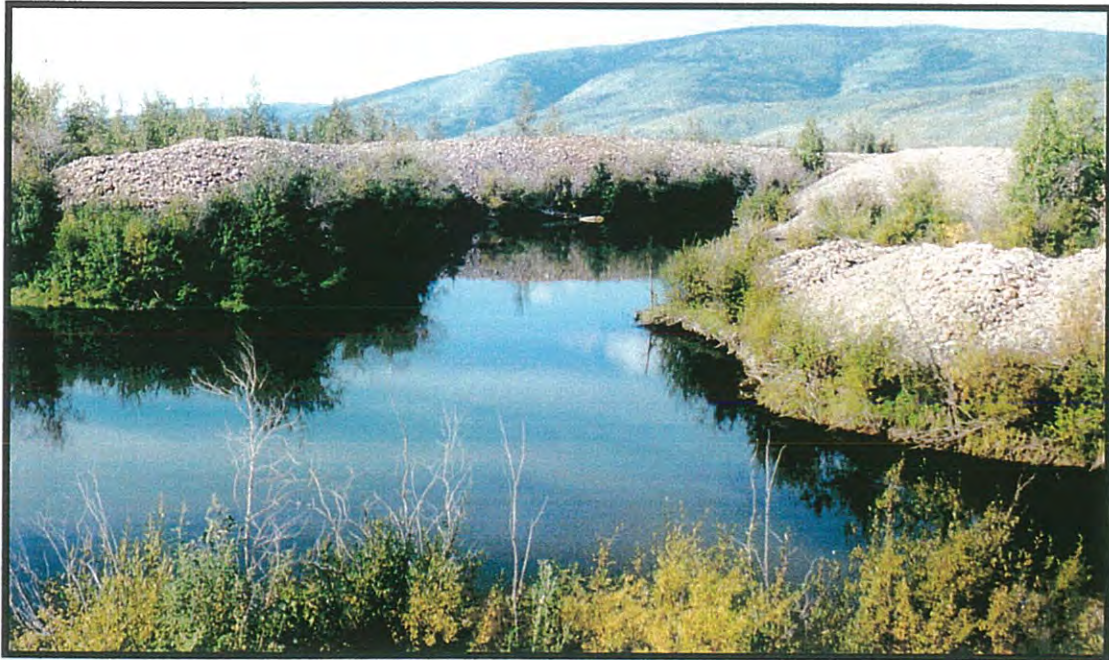
MM 02 - 76 - 36

Plate 4.4.2: Low-lying areas between dredge spoils can form small isolated wetlands.

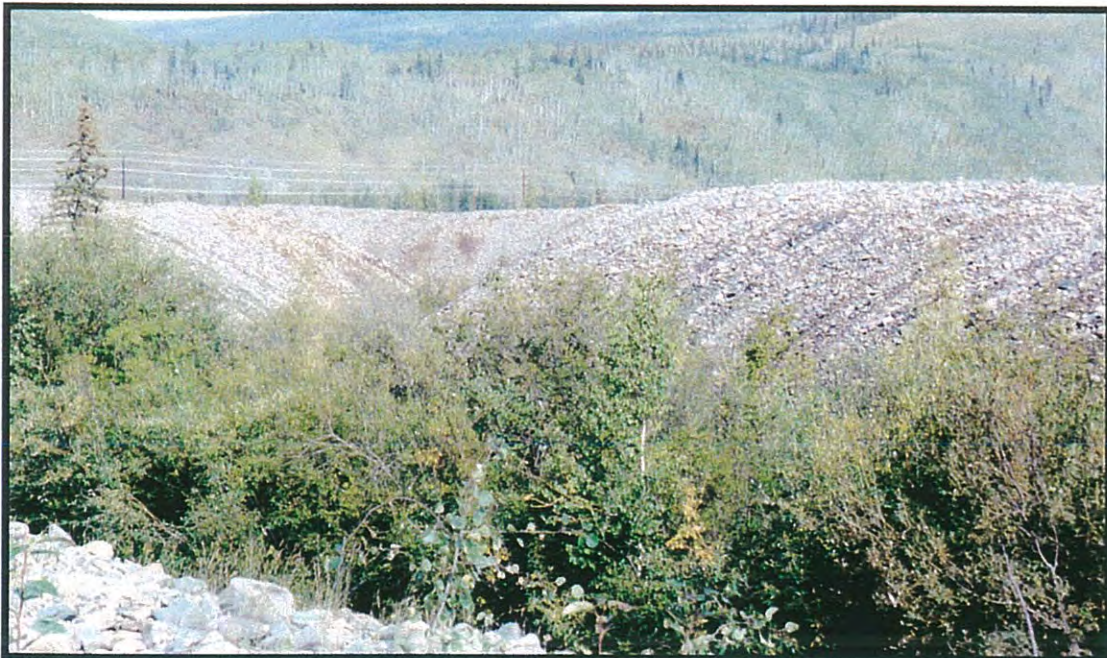
MM 02 - 76 - 34

Plate 4.4.3: Some low-lying areas between spoil piles form channels which are connected to Klondike River.

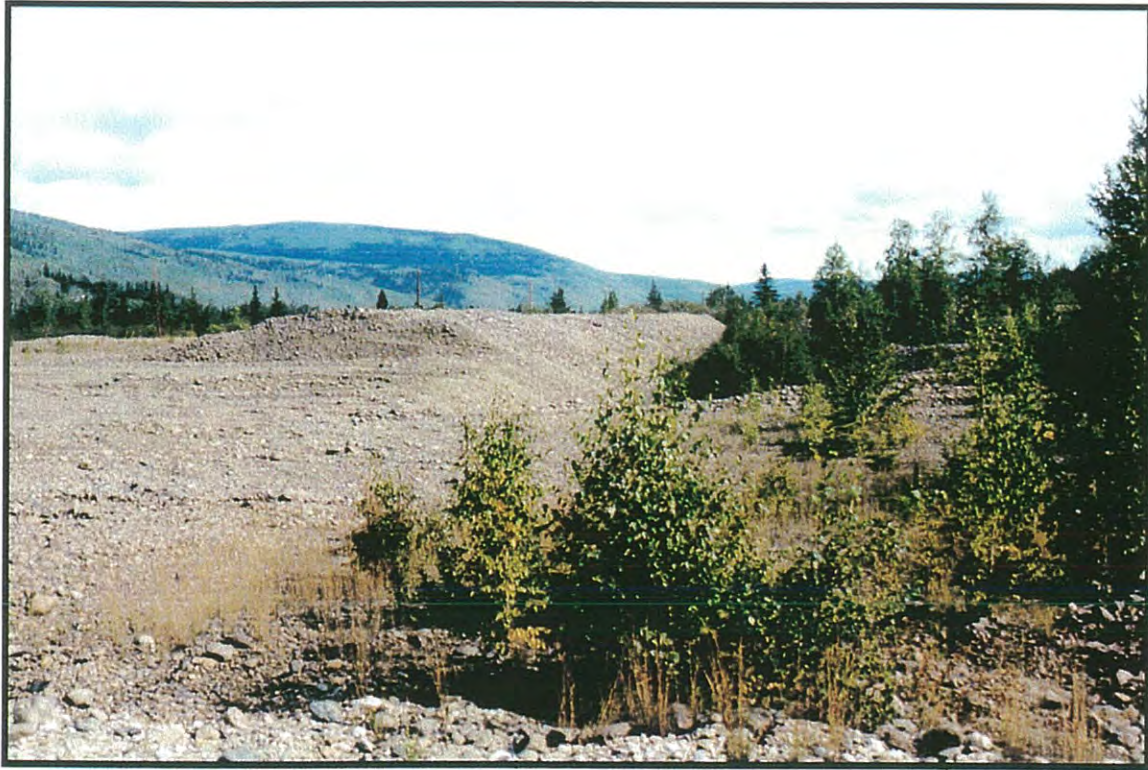
MM 02 - 76 - 35

Plate 4.4.4: Undisturbed spoil piles tend to be poorly vegetated.
